# Product Safety Recall

## N202292780 Front Seat Belt Webbing Sensor

**Release Date:** January 2020

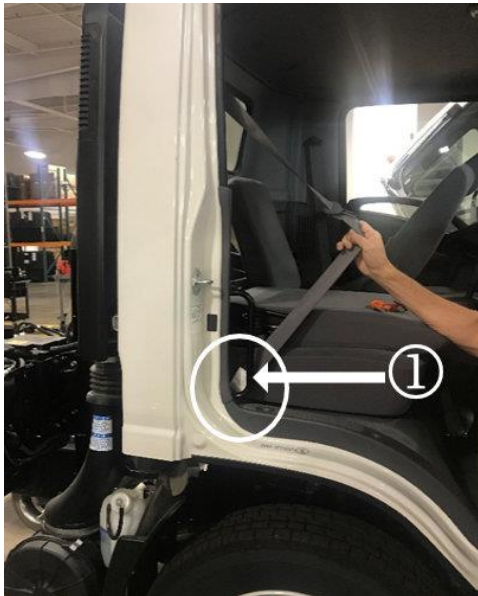
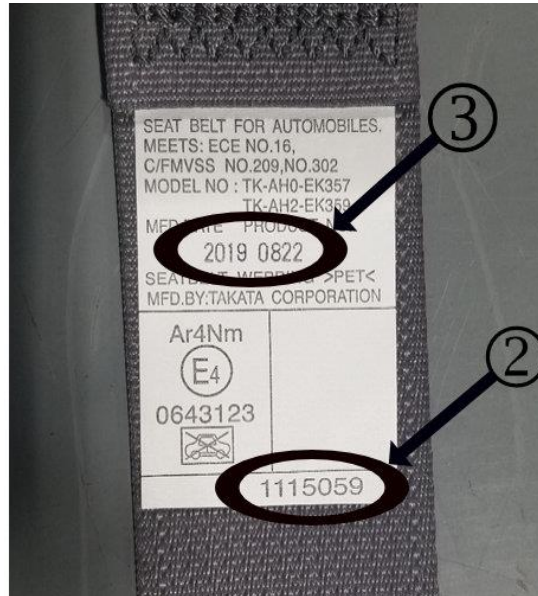
5488390

2. Inspect both driver and passenger side tongue seat belt assembly tags product number (2) and manufacturing date (3) which are located near the seat belt’s lower anchor point (1). Record these numbers on the repair order for the vehicle.
