CONDITION OF CONCERN

PARTS AND WARRANTY INFORMATION
Recall Campaign 4320A

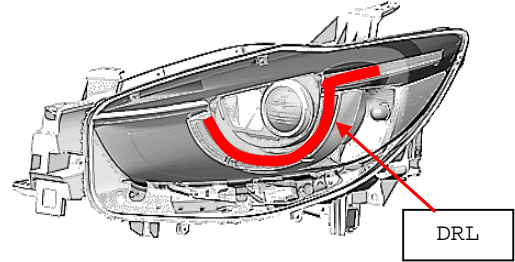
The LED type daytime running lights (DRL) may flicker or fail to illuminate while driving.

If one or both DRLs fail to illuminate, the vehicle's visibility may be reduced to other drivers on the road, increasing the risk of a crash.

Due to an inappropriate material specification of the sealing gasket attached to the LED daytime running light (DRL) wiring connector, the gasket can release sulfur which may corrode the LED circuit controlling the DRL. If corrosion of the circuit develops, the circuit may lose continuity, causing flickering and/or failure of DRL illumination. One or both front DRLs on affected vehicles could be affected by this defect.

Inspect the DRL headlights, and if needed, replace the sealing gaskets with improved ones and attach desulfurizing materials (gas adsorption sheets). If the DRL headlight(s) is/are exhibiting affected condition (flicker/fail to illuminate), replace the head lamp unit(s).
