## Safety Recall: Third Row Accessory Power Outlet

Supersedes 20-012, Dated February 7, 2020, to revise the information highlighted in **yellow**.

Year	Model	Trim	VIN Range
2018-20	Odyssey	EX-L, EX-L with Navigation and RES, Touring, and Elite	Check the iN VIN status for eligibility.

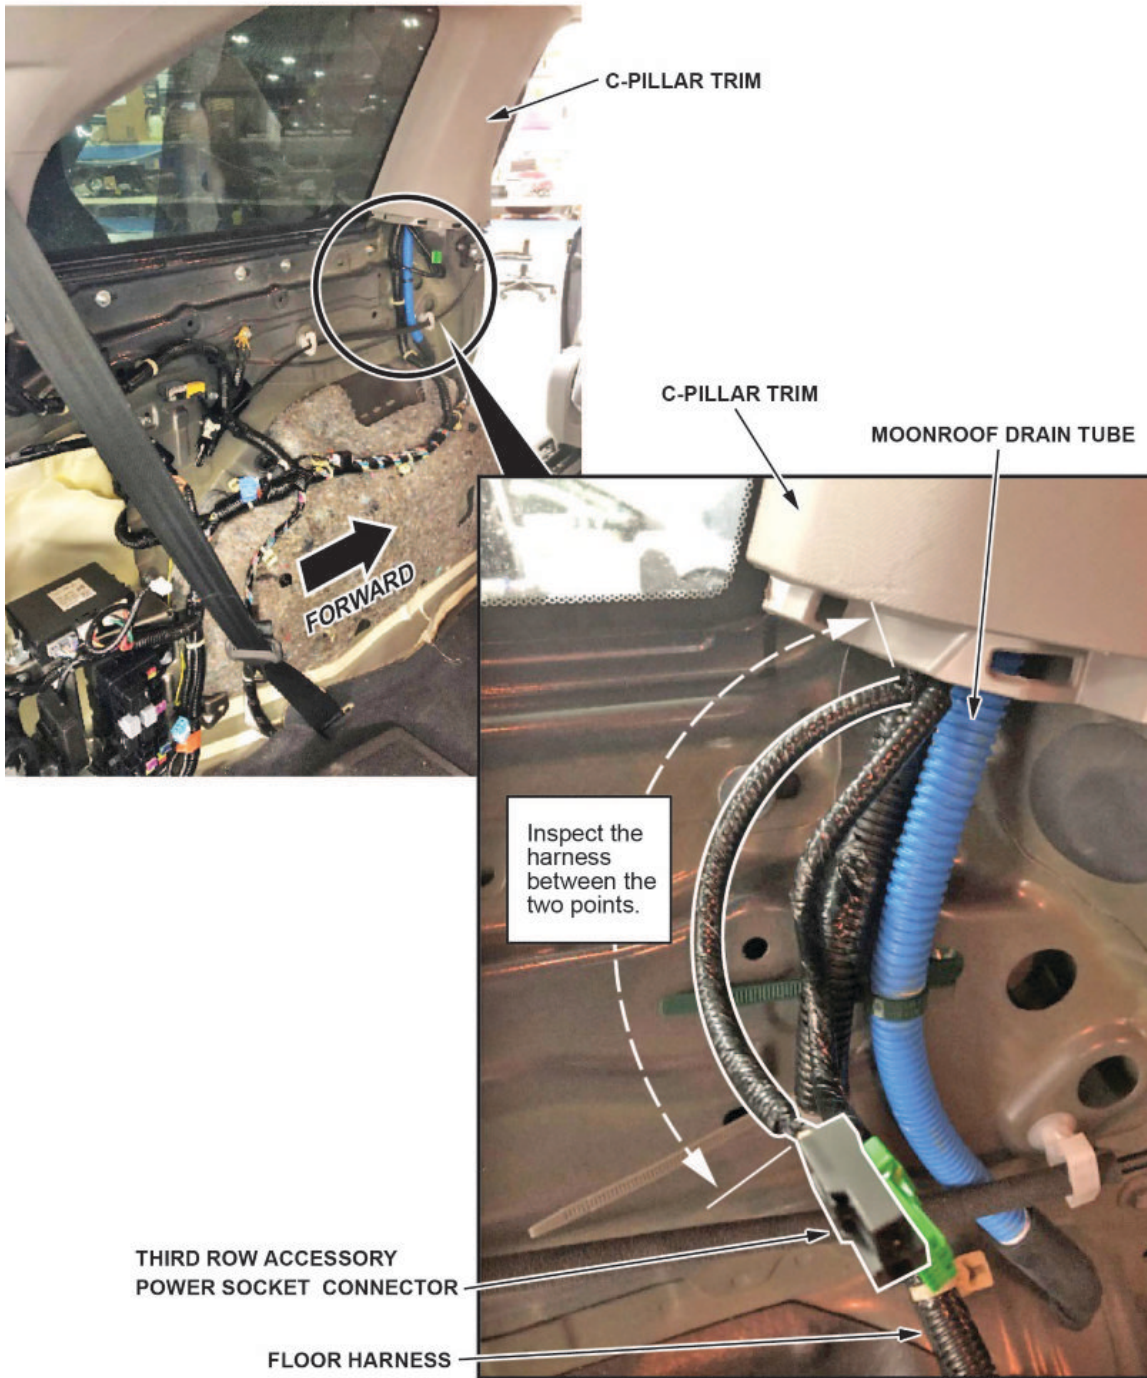
8. If the third row accessory power socket harness branch of the floor harness was improperly routed, the harness may be deformed. Inspect this part of the harness from the C-pillar trim to the third row accessory power socket connector for any exposed copper wiring. **Do not remove the electrical tape.**

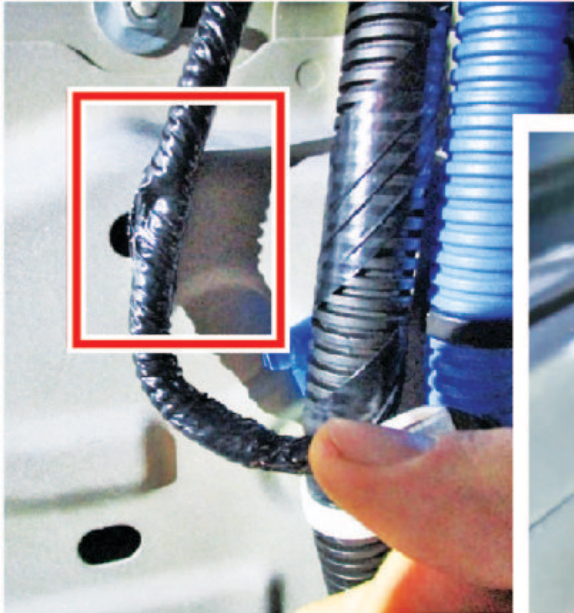
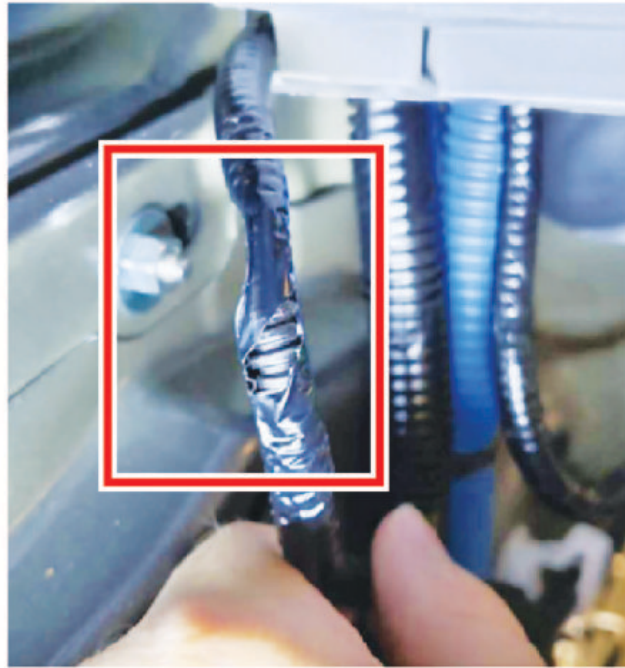
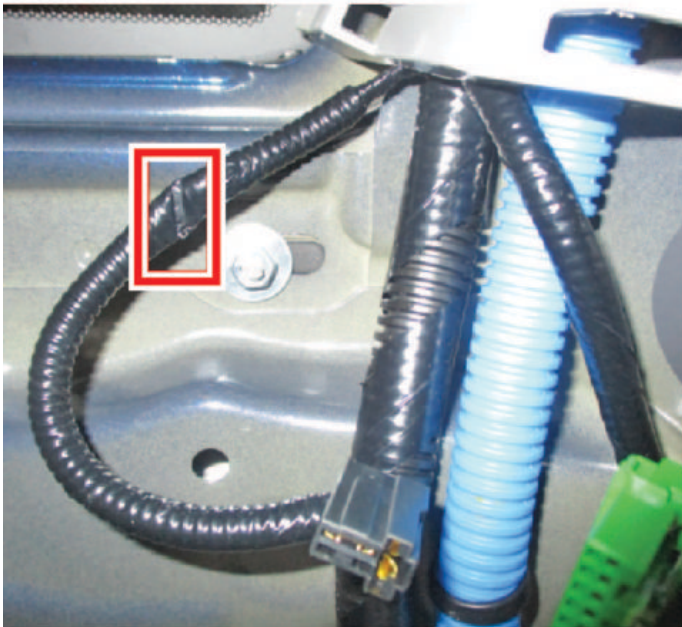
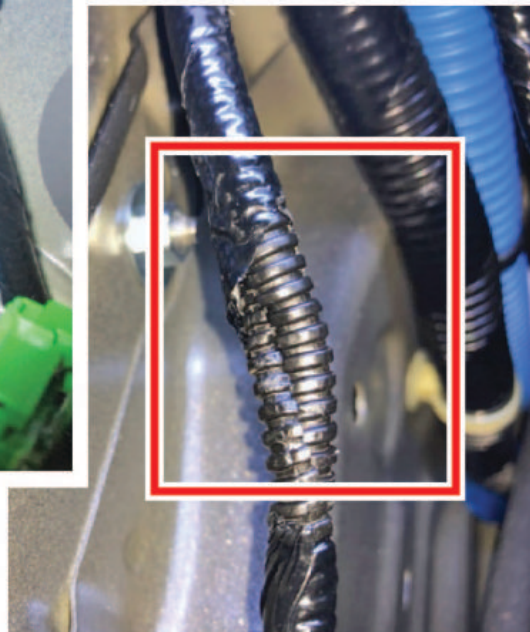
Below are examples of deformation on the power socket harness branch that **do not have exposed copper wire**, which require wrapping the harness branch with electrical tape to proceed with the repair.

- **NO** - Copper wire is not exposed. Wrap the third row accessory power socket harness branch from the pillar trim to the connector with electrical tape as shown, then go to step 9.

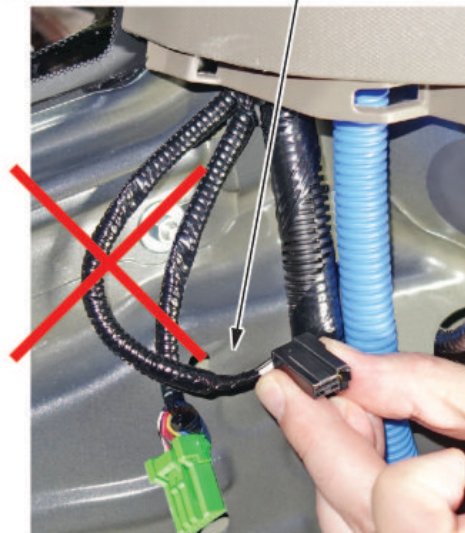
**DO NOT** route the third row accessory power socket harness and the rear entertainment harness (if equipped) as shown.
