# Service Bulletin

20-012

# **Safety Recall: Third Row Accessory Power Outlet**

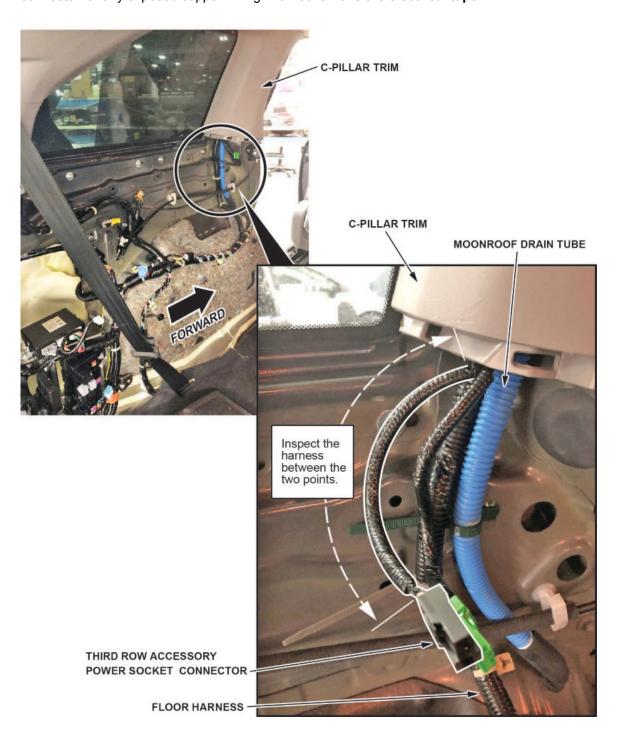
8. If the third row accessory power socket harness branch of the floor harness was improperly routed, the harness may be deformed. Inspect this part of the harness from the C-pillar trim to the third row accessory power socket connector for any exposed copper wiring. **Do not remove the electrical tape**.

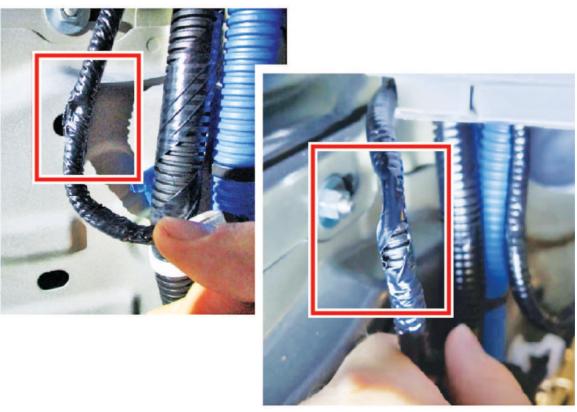
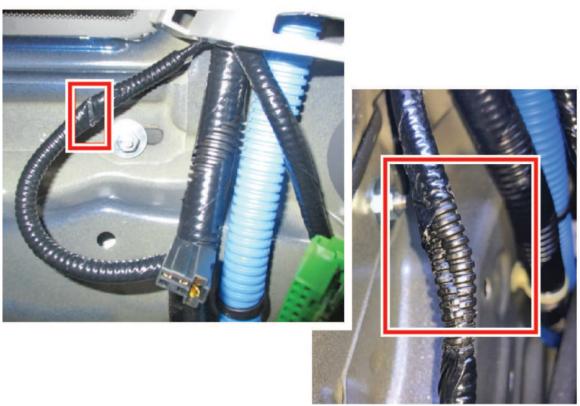
Below are examples of deformation on the power socket harness branch that **do not have exposed copper wire**, which require wrapping the harness branch with electrical tape to proceed with the repair.

• **NO** - Copper wire is not exposed. Wrap the third row accessory power socket harness branch from the pillar trim to the connector with electrical tape as shown, then go to step 9.
