TO: Mercedes-Benz and Freightliner Dealer Principals, General Managers, Sales Managers, Service Managers, Parts Managers	FROM: Anthony Washington, Department Manager, Regulations and Certifications
RE: Recall Campaign Notification Model 907 (Sprinter) Model Years 2019 EGR Screw Connection	DATE: April 27, 2020

Campaign No. 2020040009, April 2020

SUBJECT: **Model 907 (Sprinter), Model Year 2019**
EGR Screw Connection

Order No. V-RC-2020040009

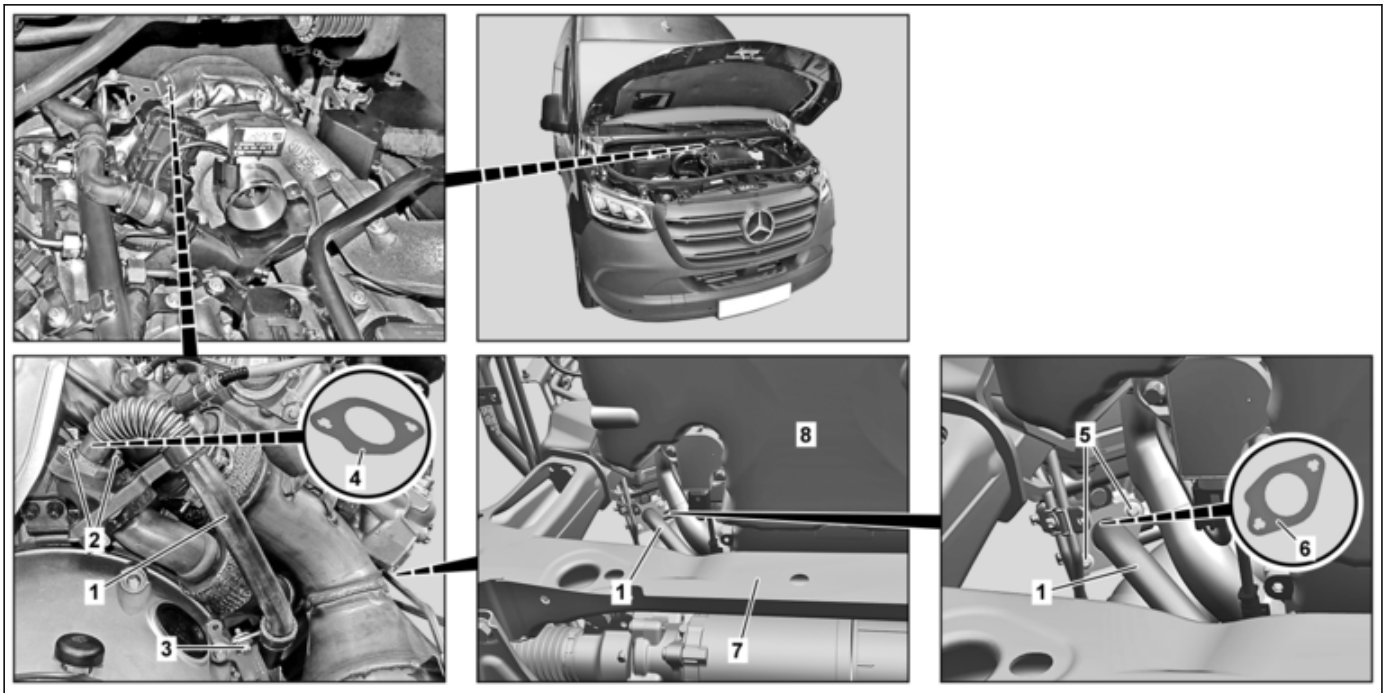
D14.20-A023-09

Mercedes-Benz AG (“MBAG”), the manufacturer of Mercedes-Benz and Freightliner vans, has determined that on certain Sprinter vehicles from platform 907 (VS30), certain screw connections on the exhaust gas recirculation (EGR) pipe (between the exhaust gas collection pipe and the exhaust gas recirculation controller) may not have been carried out according to specification. If the connecting screws are not tightened according to specification, the flange surface at the end of the EGR pipe may not be completely sealed. In that case, hot exhaust gas could leak into the engine compartment and cause a potential fire and/or fire damage to immediately surrounding components. An authorized Mercedes-Benz or Freightliner Sprinter dealer will renew the affected screw connection and the flange seals on the exhaust gas recirculation pipe.

AR	Loosen screw (3).

6	Remove screws (2) from exhaust gas recirculation line (1).

Install		
8	Position new seal (4) on exhaust gas recirculation line (1) and fit new screws (2).

Make sure that the seal (4) is correctly aligned with the exhaust gas recirculation line (1). Otherwise, leaks can occur in the exhaust system.

Install		
14	Position new seal (6) on exhaust gas recirculation line (1) and fit new screws (5).

Make sure that the seal (6) is correctly aligned with the exhaust gas recirculation line (1). Otherwise, leaks can occur in the exhaust system.
