## Field campaign

<b>Topic</b>	Curta n a rbag rep acement (RE20/04)
<b>Market area</b>	Ch na 796 VW Import Comp. Ltd (V co), Be j ng (6796),Germany E02 Bent ey rest Europe (6E02),Japan E03 Bent ey Japan (6E03),Un ted Arab Em rates E06 Bent ey M dd e East and Afr ca (6E06),Un ted States E05 Bent ey USA and rest Amer ca (6E05)
<b>Brand</b>	Bent ey
<b>Transaction No.</b>	2058235/1
<b>Campaign number</b>	RB46
<b>Note</b>	
<b>Type</b>	
<b>US code</b>

## Repair instructions

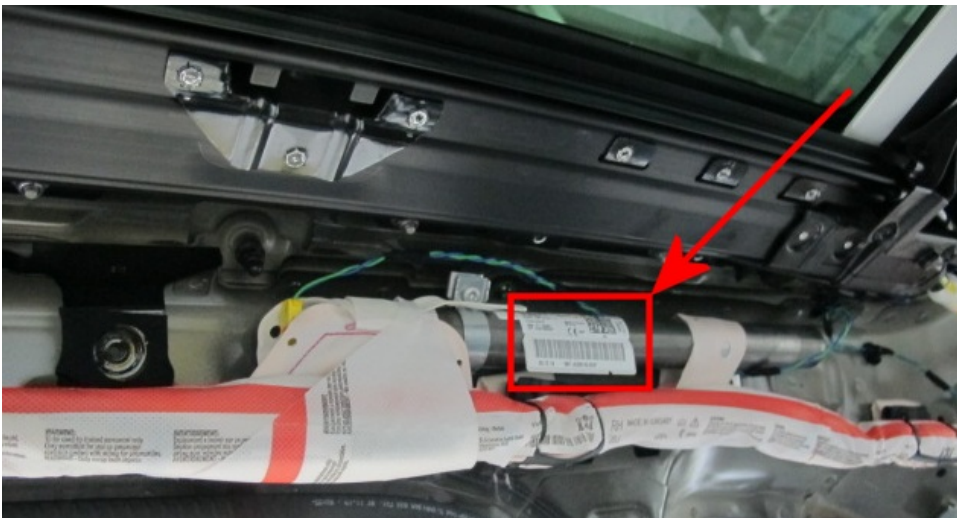
- 1) Remove the airbag fuse - Refer to Rep.Gr 69
- 2) Remove the headlining - Rep.Gr 70
- 3) Referring to Figure 1 - Locate the curtain airbag inflator identification plate

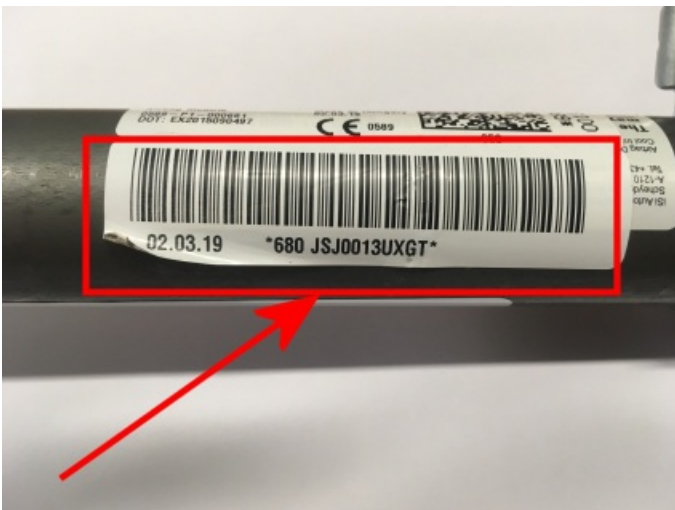
- 4) Take a clear photograph of the right and left hand curtain airbag serial number – see Figure 2 as an example

- Raise a non-technical DISS query, Attach clear photographs of the right and left hand curtain airbag serial number to the DISS query
- **IMPORTANT:** Ensure the photographs are clearly identified as right and left

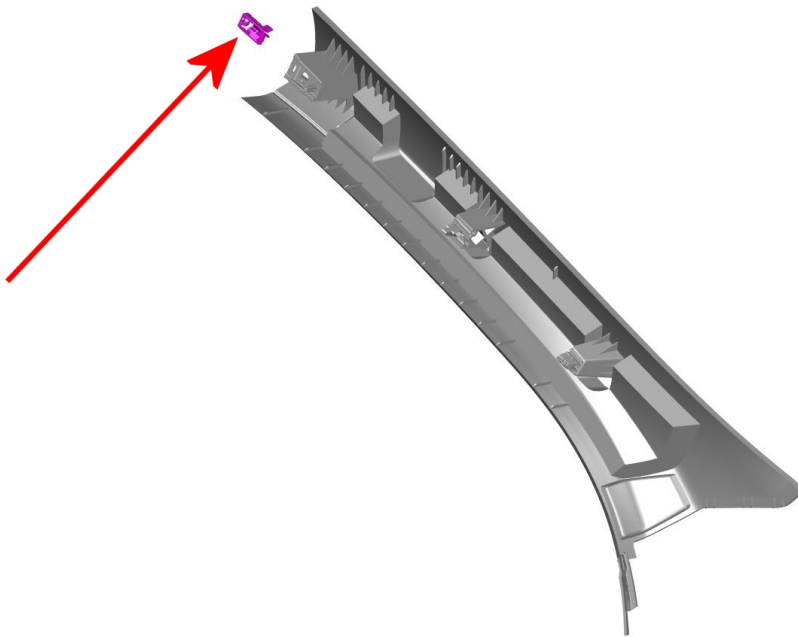
Figure 3

Within the procedure to refit the upper A-post trim there is a single use cap (Figure 3) which must be replaced and not reused. Ensure a new replacement is available prior to starting this procedure.

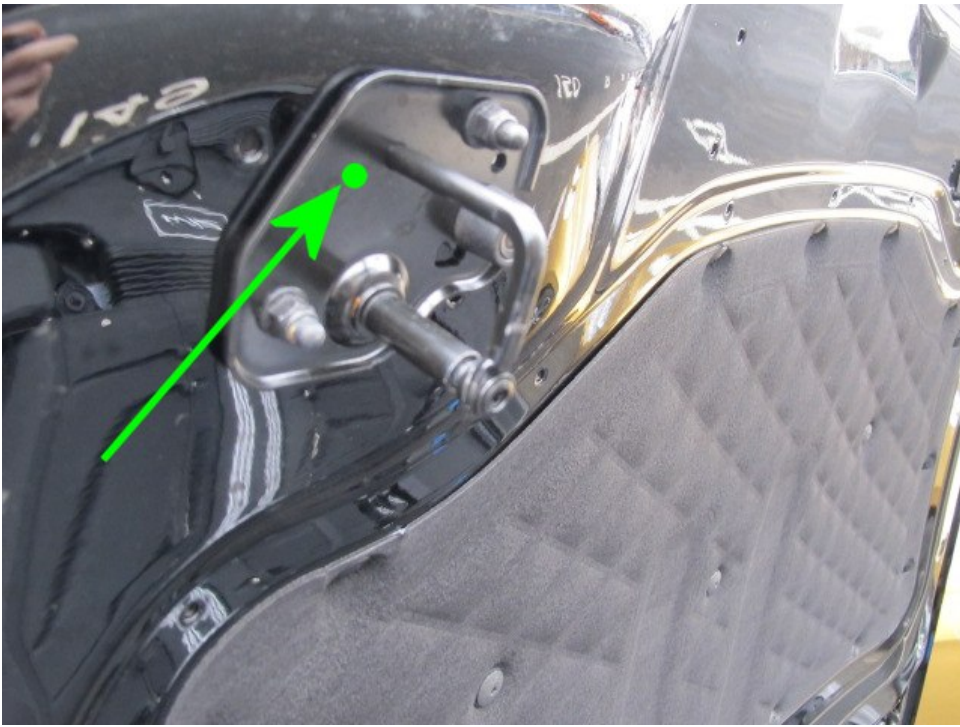
Figure 4

Green campaign competition mark on the right hand bonnet attachment striker (Figure 4)

8) Place a green paint completion mark on the right hand bonnet latch striker (Figure 4)
