GROUP Safety Recall Campaign	MODEL 2013-2014MY Optima (QF) 2.4L/2.0L-T GDI
NUMBER SC187	DATE June 2020

**SUBJECT: LOW-PRESSURE FUEL FEED TUBE INSPECTION
AND REPAIR/REPLACEMENT (SC187)**

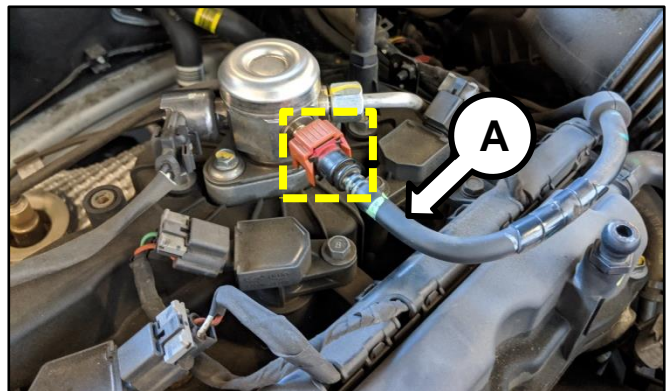
2. Locate the fuel line (A) connector and visually inspect for leak in the outlined area shown.

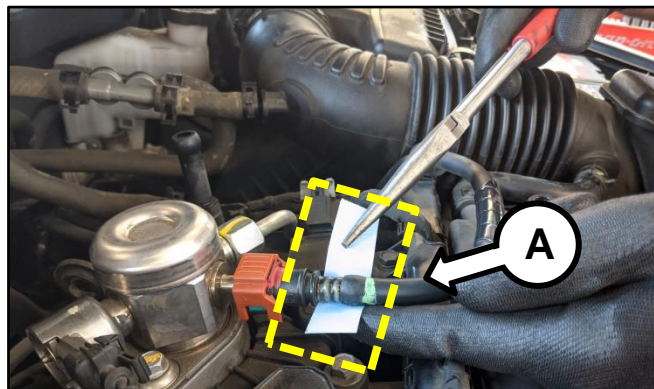
- 3a. Start the engine and allow it to idle.
- 3b. Place the test paper under the fuel line (A) connector area shown and check for moisture on the paper, indicating presence of a leak.
