GROUP  
**Safety Recall Campaign**

MODEL  
**2013-2014MY  
Optima (QF)  
2.4L/2.0L-T GDI**

NUMBER  
**SC187 (Rev 2, 12/09/2020)**

### LOW-PRESSURE FUEL FEED TUBE INSPECTION AND REPAIR/REPLACEMENT (SC187)

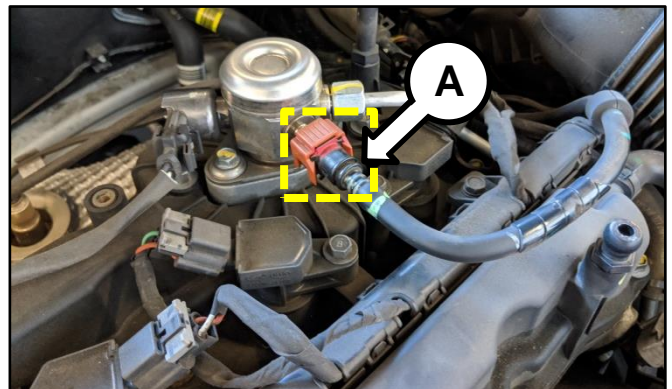
- 2a. Locate the fuel line (A) connector and visually inspect for leak in the outlined area shown.
- 2b. If fuel line IS leaking, refer to page 5 to replace the fuel line.
- 2c. If fuel line is NOT leaking, proceed to step 3 for further inspection.

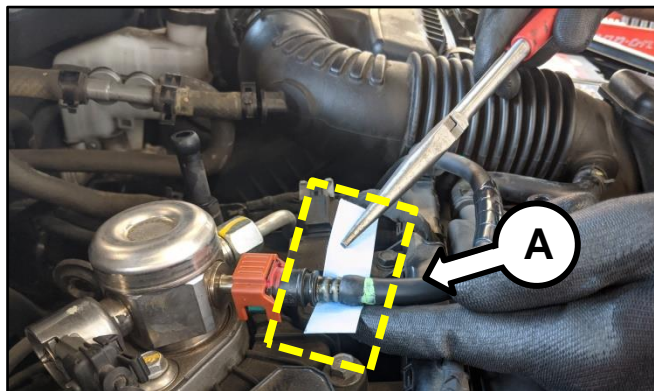
- 3a. Start the engine and allow it to idle.
- 3b. Place the test paper under the fuel line (A) connector area shown and check for moisture on the paper, indicating presence of a leak.
