## **IMPORTANT SAFETY RECALL 20V-103**

# SAFETY NOTICE

# SN681A

SUBJECT: Leveling Sensor Installation

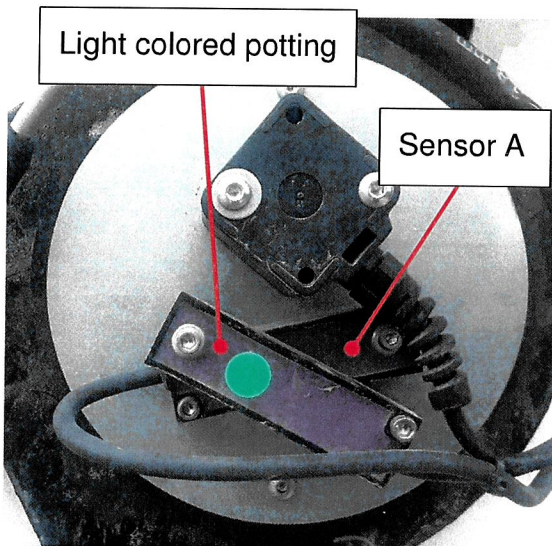
On Terex TM aerial devices, manufactured from February 2011 through April 2020, the basket level limit sensors at the boom tip may have been assembled in the incorrect orientation. The limit sensors prevent the platform from going more than 15 degrees from level if the electrical system malfunctions or there is damage to components. The incorrect mounting of the level sensors may cause an out of level basket to continue moving more than 15 degrees out of level. **If the leveling system malfunctions it may cause the occupants to fall from the platform.**

**Figure 3A**  
This bulletin applies if the light colored potting visible on the top sensor, or sensor labeled A on the bottom

3. If your unit has the light colored potting visible on the top sensor, or the sensor labeled A on the bottom; this bulletin applies. Correct following the instructions in Field Service Kit Z1562. Take a picture before correcting the issue and another picture after correcting the issue. Send both pictures with the completion form including the serial number and date of correction to [utilities.warranty@terex.com](mailto:utilities.warranty@terex.com).
4. If your unit has the light colored potting visible only on the bottom sensor with the wires coming out of the sensors above the mounting screw and with sensor labeled A on top this bulletin does not apply and use can continue without restriction.

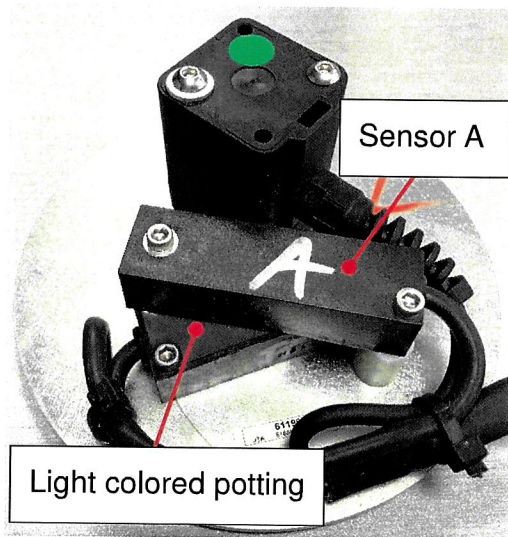
**Figure 3B**  
This bulletin does **NOT** apply if the light colored potting only visible on bottom sensor and sensor labeled A on top

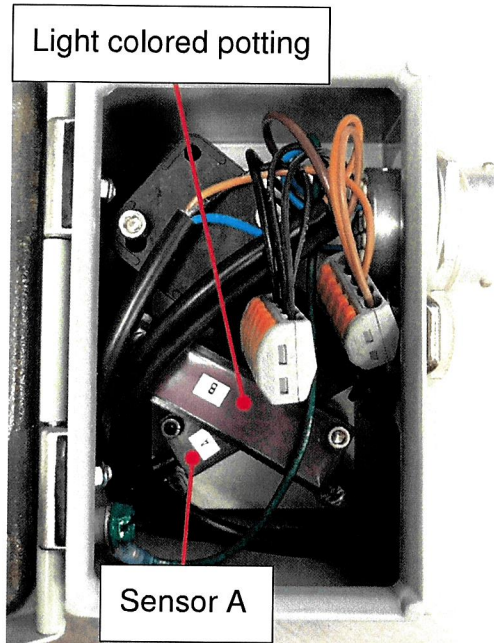
**Figure 4A**

This bulletin applies if the light colored potting visible on the top sensor, or sensor labeled A on the bottom

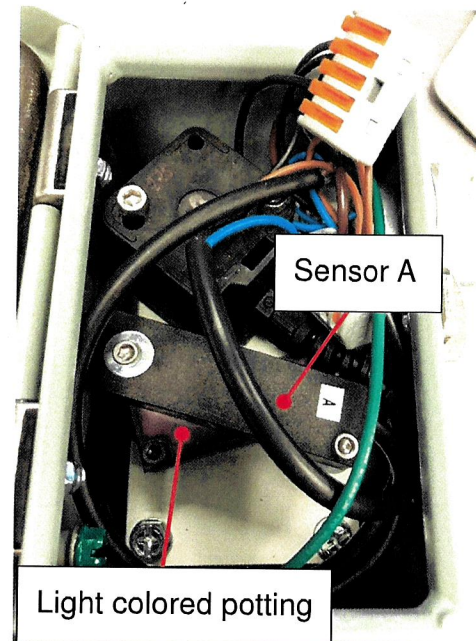
**Figure 4B**

This bulletin does **NOT** apply if the light colored potting only visible on bottom sensor and sensor labeled A on top
