## **IMPORTANT SAFETY RECALL 20V-103**

# SAFETY NOTICE

# SN681A

**SUBJECT:** Leveling Sensor Installation

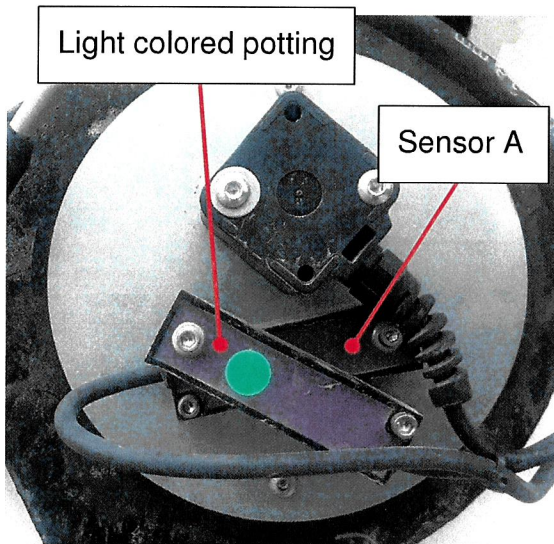
**Figure 3A**  
This bulletin applies if the light colored potting visible on the top sensor, or sensor labeled A on the bottom

The unit noted above had the leveling sensors incorrectly mounted as shown in either Fig. 3A or 4A of the SN681A bulletin. The sensor position has been corrected by following the instructions provided in Field Service Kit Z1562.

3. If your unit has the light colored potting visible on the top sensor, or the sensor labeled A on the bottom; this bulletin applies. Correct following the instructions in Field Service Kit Z1562. Take a picture before correcting the issue and another picture after correcting the issue. Send both pictures with the completion form including the serial number and date of correction to [utilities.warranty@terex.com](mailto:utilities.warranty@terex.com).
4. If your unit has the light colored potting visible only on the bottom sensor with the wires coming out of the sensors above the mounting screw and with sensor labeled A on top this bulletin does not apply and use can continue without restriction.

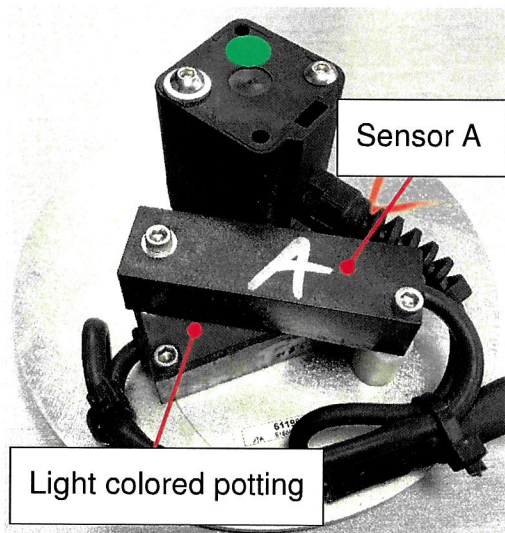
**Figure 3B**  
This bulletin does **NOT** apply if the light colored potting only visible on bottom sensor and sensor labeled A on top

The leveling sensors have been inspected on this unit and are positioned correctly when compared with either Fig. 3B or 4B on the Safety Notice 681A bulletin and **no repair is required**. Please submit a photo of the mounted sensors with this completion form. **\*No reimbursement for only completing this inspection.\***

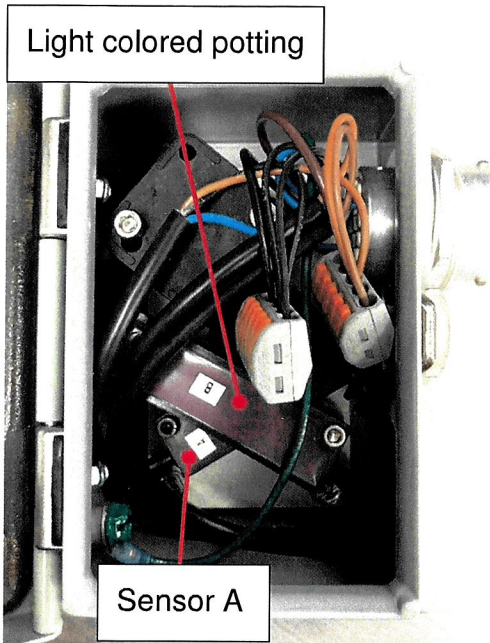
**Figure 4A**

This bulletin applies if the light colored potting visible on the top sensor, or sensor labeled A on the bottom

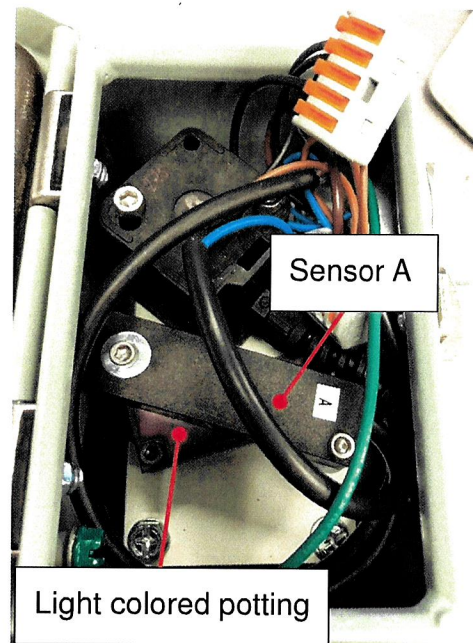
**Figure 4B**

This bulletin does **NOT** apply if the light colored potting only visible on bottom sensor and sensor labeled A on top
