GROUP	NUMBER
RECALL	20-01-030H
DATE	MODEL(S)
JULY, 2020	SONATA (YF)

2013-2014MY SONATA (YF)

FUEL TUBE INSPECTION/REPLACEMENT (RECALL CAMPAIGN 189)

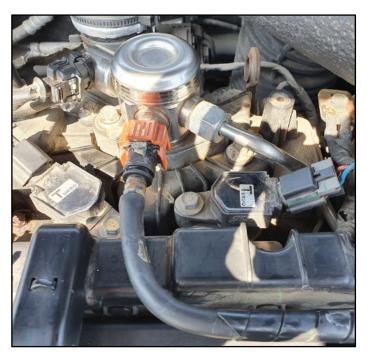
On certain 2013-2014MY Sonata vehicles, the fuel feed line connecting the low pressure fuel pump to the direct injection fuel pump could develop a small crack over time due to ambient heat in the engine compartment. A damaged fuel line could allow fuel to leak, increasing the risk of an engine compartment fire.

This bulletin describes the procedure to inspect the fuel feed line for damage and/or leakage and to replace the fuel tube if necessary or to otherwise improve the connection between the low-pressure fuel tube and fuel pump.

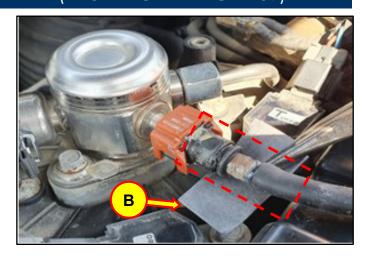
- 3. While the engine is idling:
 - i. Wipe the area around the fuel feed tube connector using the oil test paper (B).
 - ii. Check the area for any indication of fuel leakage or smell.

If the oil test paper appearance does not change and if there is no indication of fuel leakage/smell, proceed to step 4.

If the oil test paper becomes darker or if there is indication of fuel leakage/smell, follow the fuel tube replacement procedure on Page 7.
