Safety Recall Code: 47P8

Electronic Brake Booster Input Rod

March 24, 2020

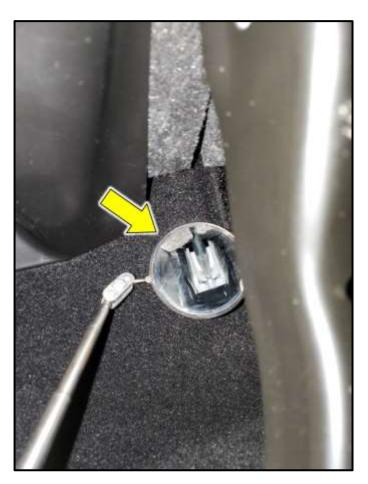
Section B - Brake Booster Push Rod Inspection

Inspect brake booster push rod installation:

Use an inspection mirror to inspect the installation of the brake booster push rod on the back side of the brake pedal.

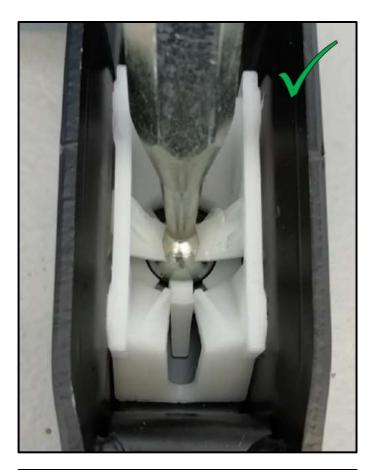
- If the brake booster push rod is installed correctly (as shown) and none of the locking tabs are broken:
 - No further work is required.
 - Proceed to Section E.

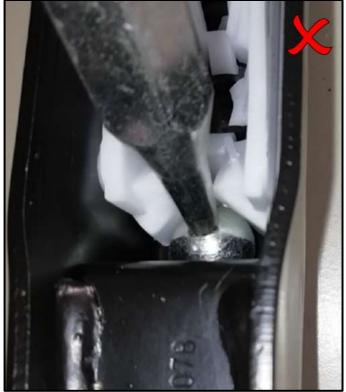
- If the brake booster push rod is installed in the incorrect position (as shown):
 - Take a clear photo of the condition for documentation purposes.
 - The brake booster must be replaced (See Section C).
 - The push rod mount must be replaced (See Section D).
 - After all work is complete, Proceed to Section E.

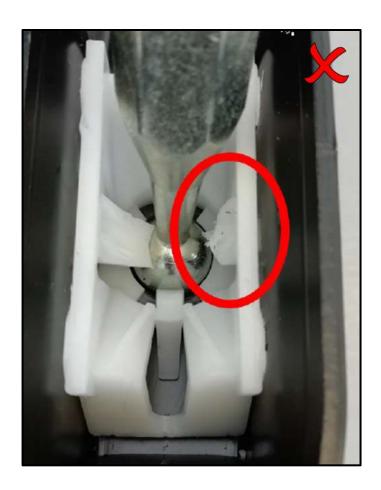
- If the brake booster push rod is installed in the correct position, but <u>any</u> of the brake booster push rod tabs are broken (as shown):
 - Take a clear photo of the condition for documentation purposes.
 - The push rod mount must be replaced.
 - o Proceed to Section D.
 - After all work is complete, Proceed to Section E.
