<b>Topic</b>	Bentayga - Seven Seat - Third Row Safety Belt (RE20/06)
<b>Market area</b>	Bentley: worldwide (2WBE)
<b>Brand</b>	Bentley
<b>Transaction No.</b>	2058805/2
<b>Campaign number</b>	RB48
<b>Note</b>	
<b>Type</b>	Recall Campaign
<b>US code</b>

### Technical background

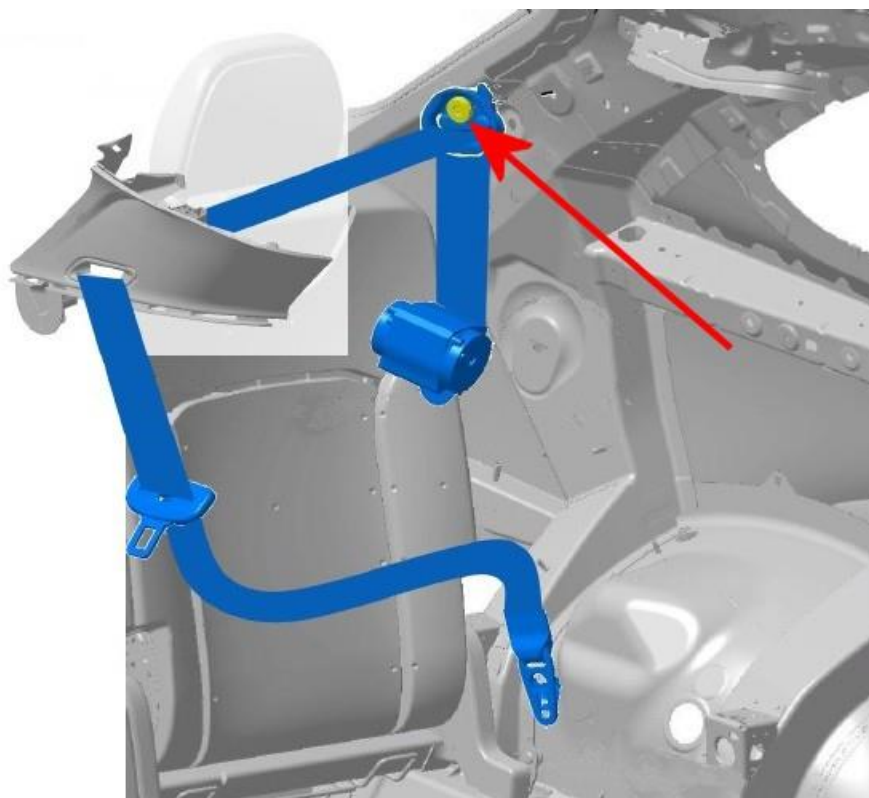
Figure 2.

A change to both D-post castings by the Supplier, has resulted in the recess of the threaded hole used to secure the third row safety belt Pillar Loops. This recess reduces the thread engagement with the current securing bolt – N.989.243.03 – away from design intent.

Remove the Socket Head Bolt securing the Pillar Loop to the D-post, discard the Socket Head Bolt and Retaining clip – figure 2.

Fit new Socket Head Bolt - N.912.382.01 – and new Retaining clip – 36A.853.390, torque tighten the Socket Head Bolt to 40Nm.

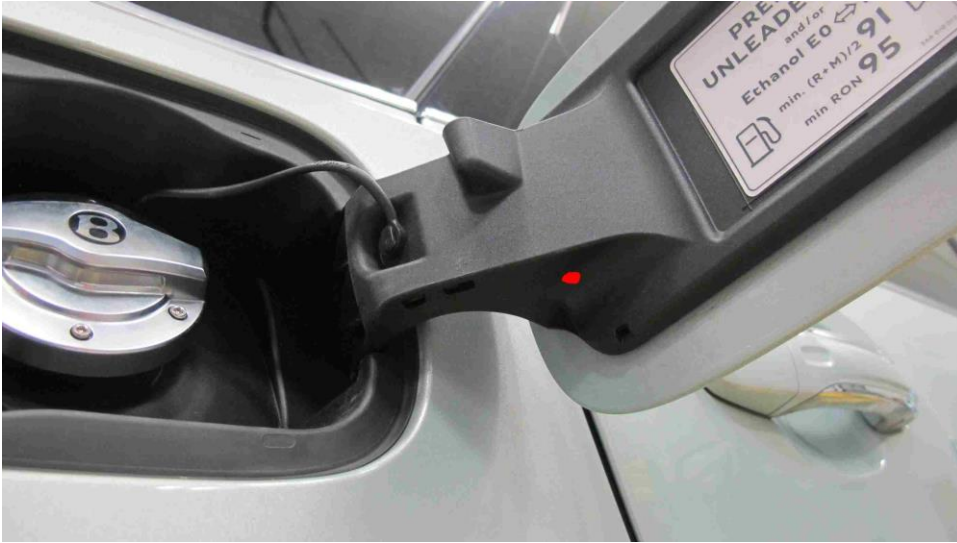
Figure 3

Red Campaign completion mark to the underside of the fuel filler door – Figure 3.
