TO: Mercedes-Benz and Freightliner Dealer Principals, General Managers, Sales Managers, Service Managers, Parts Managers	FROM: Anthony Washington, Department Manager, Regulations and Certifications
RE: <b>Recall Campaign Notification</b> <b>Model 907 (Sprinter)</b> <b>Model Years 2019</b> <b>Tire Running Direction</b>	DATE: April 27, 2020

Campaign No. 2020040014, April 2020

SUBJECT: **Model 907 (Sprinter), Model Year 2019**  
**Tire Running Direction**

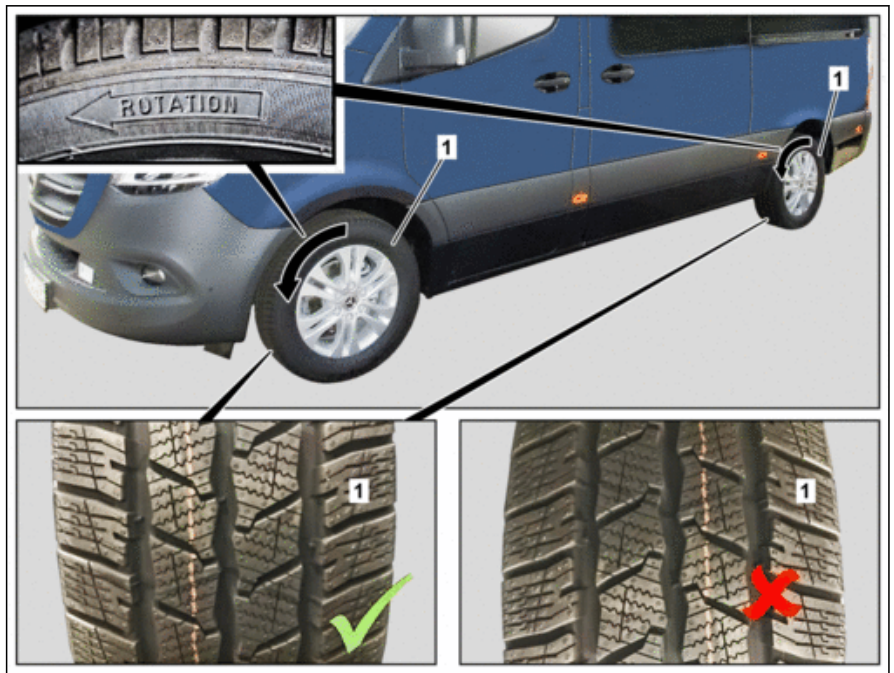
D40.10-A005-76

**Shown on model 907, left side of vehicle**

1 Tires

Only the entry in the "Extended VEGA Application" (EVA) system in the "Current" tab is decisive for authorized Mercedes-Benz service partners. An additional test of the affected vehicles in the workshop information system (WIS) or vehicle list is thereby not necessary.	
2	Check running direction of tires (1) on vehicle.

Pay attention to alignment of tire profiles and running direction arrows. If the running direction is correct on all tires (1), ↓ end the measure. If the running direction is incorrect on one or more tires (1), ↓ Continue with operation step 3.

<p>4</p> <p>AR</p> <p>AR</p>	<p>Correct running direction of affected tires.</p>	<p><b>i</b>  To do so, detach the wheels and rotate between the sides of the vehicle or axles so that the running direction is correct again. Then mount the wheels again.</p> <p>If the tires (1) of the wheels to be replaced on both axles exhibit uneven wear,  ↓  replace the tires (1) of the respective axle.</p> <p>If the running direction of the wheels cannot be corrected by rotation,  ↓  continue with operation step 5.</p>	<p>AR40.10-D-1100TS</p> <p>AR40.10-D-1030TS</p>
<p>5</p> <p>AR</p>	<p>Correct running direction of affected tire (1).</p>	<p>If rotation of the wheels does not provide a remedy.</p> <p><b>i</b>  To do so, remove the tire (1) and mount again with the correct running direction.</p>	<p>AR40.10-D-1030TS</p>
<p>6</p> <p>AR</p>	<p>Lower vehicle.</p>		<p>AR00.60-D-1000-04TS</p>
