SIB 27 01 20

RECALL 20V-185: REPLACING THE FLEX DISC AND INSPECTING THE TRANSFER CASE

F30 (3 Series Sedan)	F31 (3 Series Sports Wagon)	With xDrive and N47T diesel engine
----------------------	-----------------------------	------------------------------------

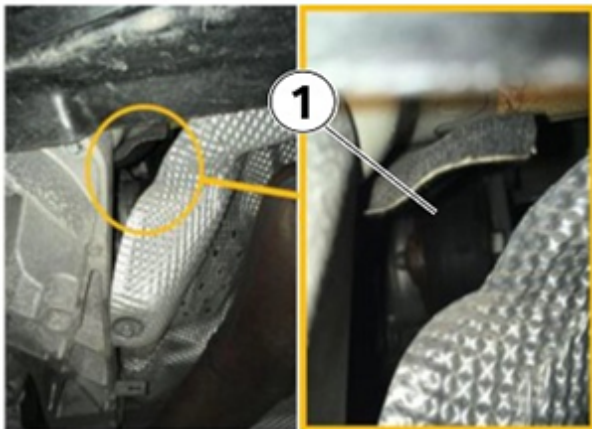
1. Raise the vehicle and determine which style flex disc is installed (1).

No further action is required if a black, corded rubber style (GS105) flex disc is installed (1).

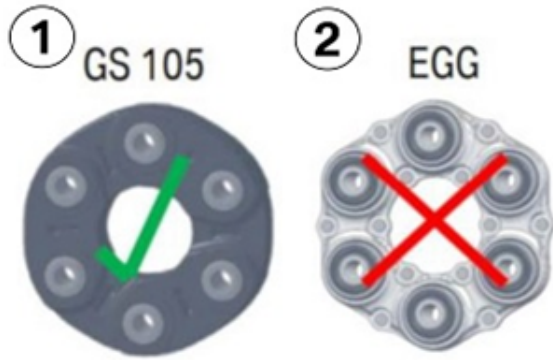
If an aluminum style (EGG) (2) is installed, it will **need** to be replaced and the output flange will need to be inspected.

Continue to Step 2.

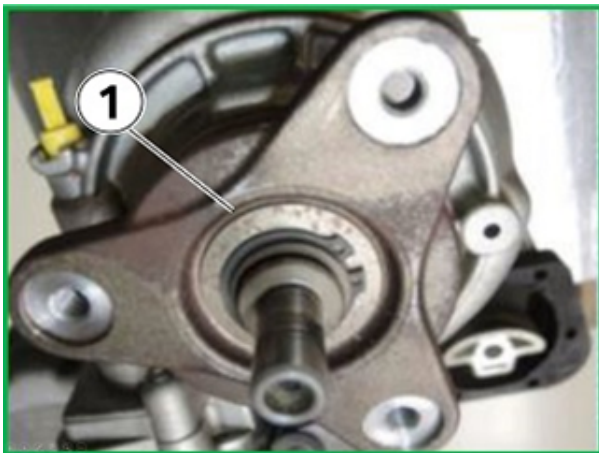
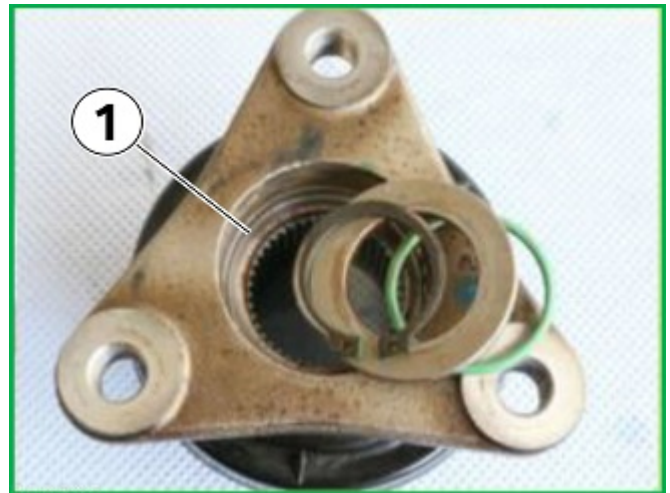
Typical output flanges without friction rust build up (1). No further repair is necessary if there is no friction rust around the splines of the output flange.

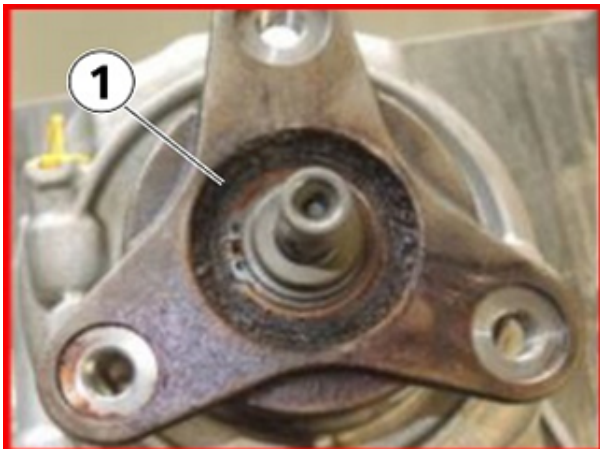
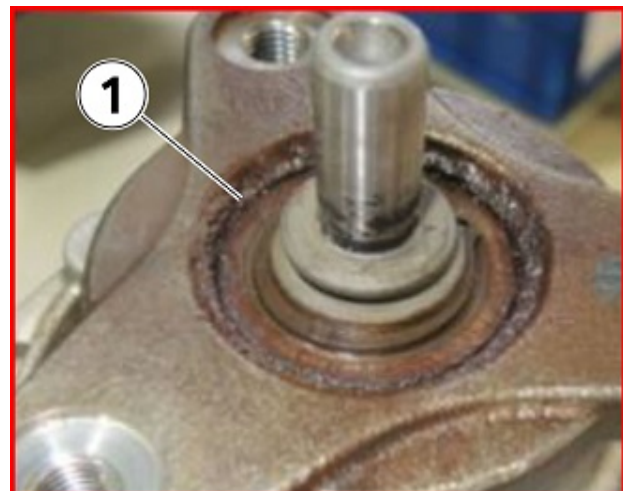
Higher dynamic load on the aluminum flex disc (EGG), which connects the transfer case to the rear driveshaft, can form friction rust on the output flange of the transfer case.

Output flanges with friction rust (1). Flanges with excessive friction rust will require transfer case replacement.

If rust build up cannot be determined by visual inspection, the flange will need to be removed for further diagnosis. Continue to Step 3.

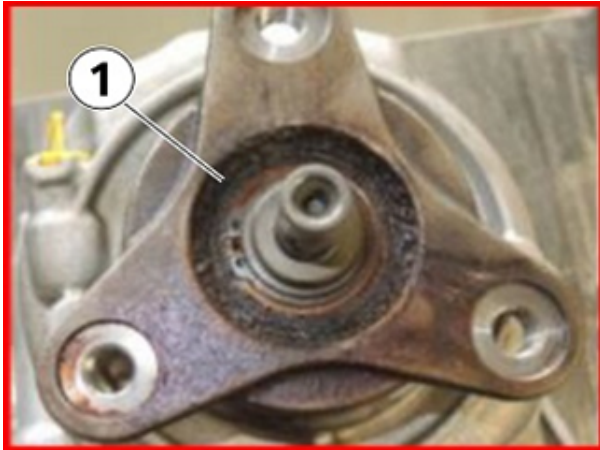
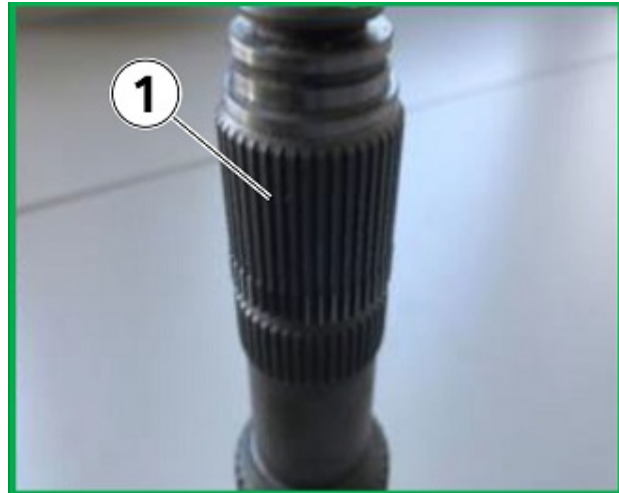
Typical flange and output shaft **without** any friction rust damage (1). Reinstall the flange (with new radial oil seal, O-ring and retaining ring) and reassemble the vehicle with new flex disc.

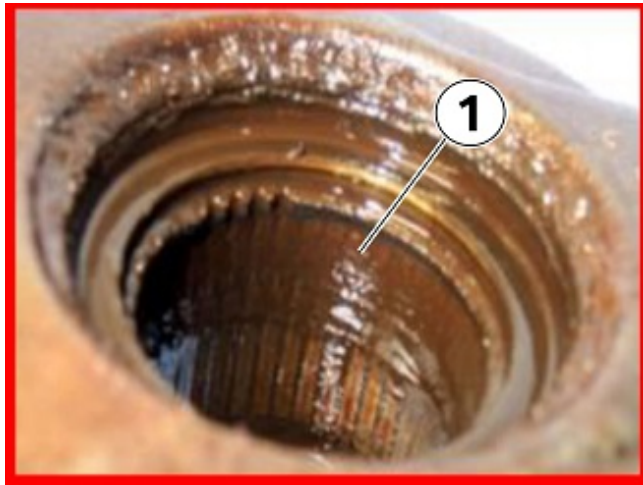
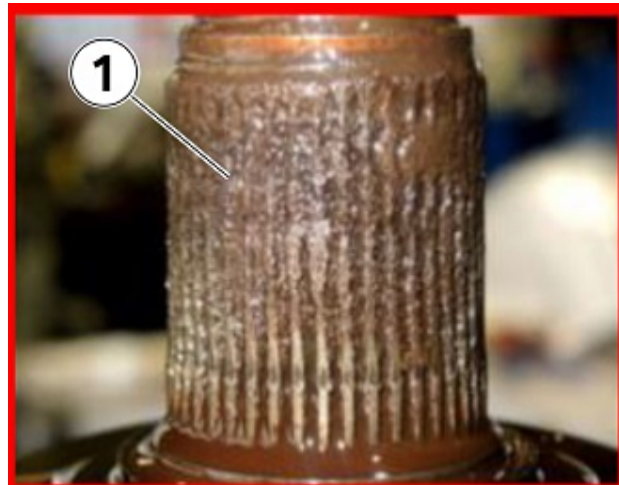
Flange and output shaft **with** friction rust damage (1). The transfer case will need to be replaced (with new flex disc).

NOTE: The transfer case needs to be replaced if either the flange or the output shaft are worn.

Follow Repair Instruction **27 10 020 Installing exchange transfer box (ATC 35L)**.
