SIB 27 01 20

RECALL 20V-185: REPLACING THE FLEX DISC AND INSPECTING THE TRANSFER CASE

F30 (3 Series Sedan)	F31 (3 Series Sports Wagon)	With xDrive and N47T diesel engine
----------------------	-----------------------------	------------------------------------

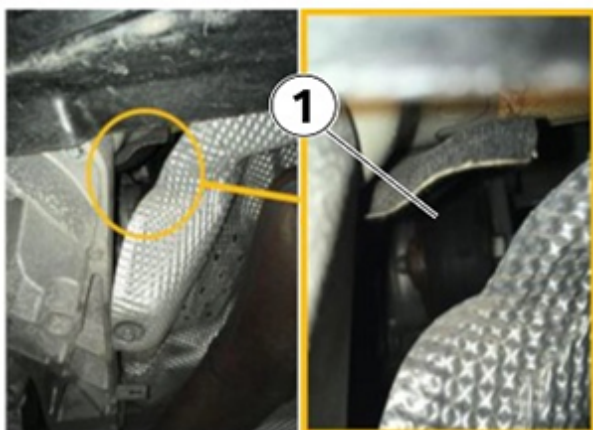
1. Raise the vehicle and determine which style flex disc is installed (1).

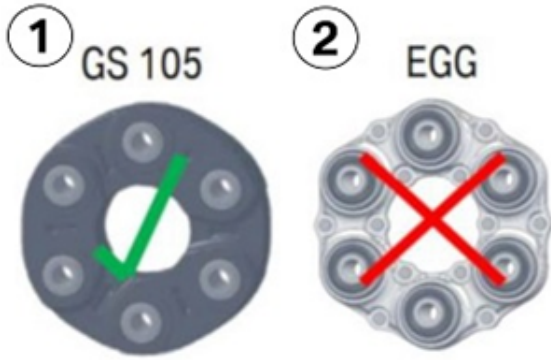
No further action is required if a black, corded rubber style (GS105) flex disc is installed (1).

If an aluminum style **"EGG"** (2) is installed, it **must** be replaced with a **"GS 105"** (1).

The transfer box output flange must then also be inspected for friction rust.

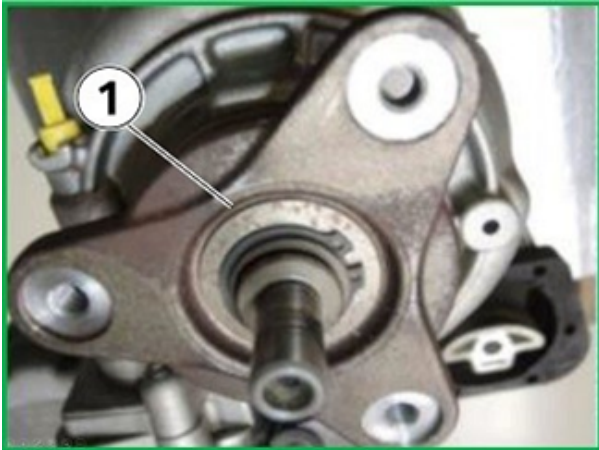
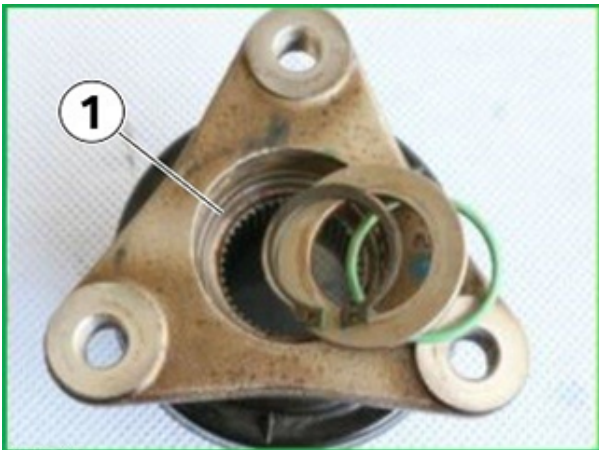
Typical output flanges without friction rust build up (1).

No further repair is necessary if there is no friction rust around the splines of the output flange.

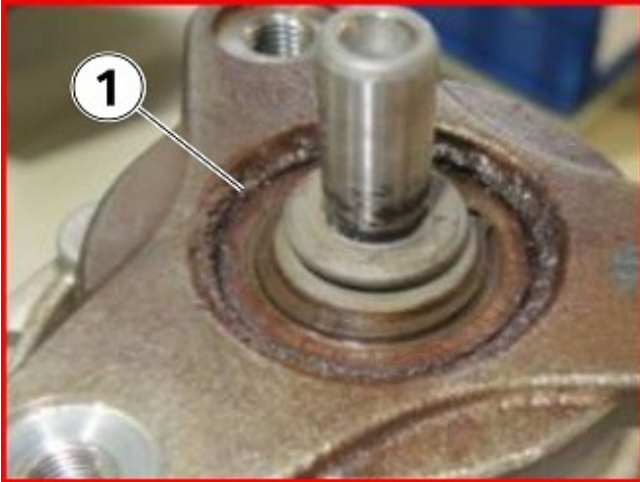
Output flanges with friction rust (1). Flanges with excessive friction rust will require transfer case replacement.

If rust build up cannot be determined by visual inspection, the flange will need to be removed for further diagnosis.

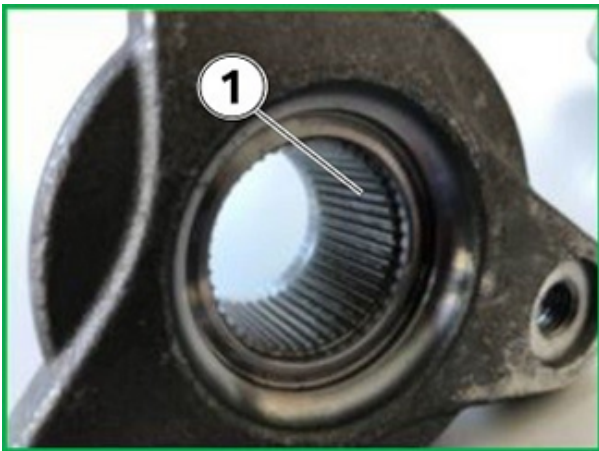
Typical flange and output shaft **without** any friction rust damage (1). Reinstall the flange (with new radial oil seal, O-ring and retaining ring) and reassemble the vehicle with new flex disc.

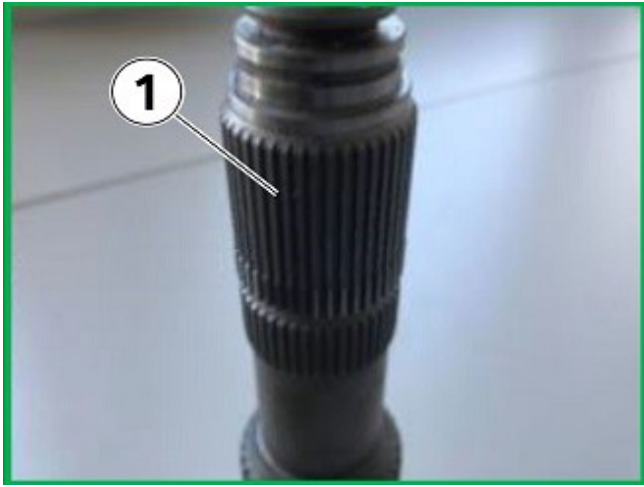
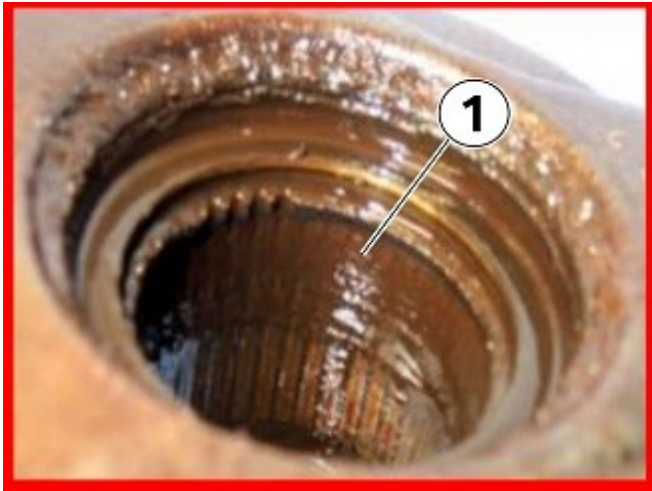
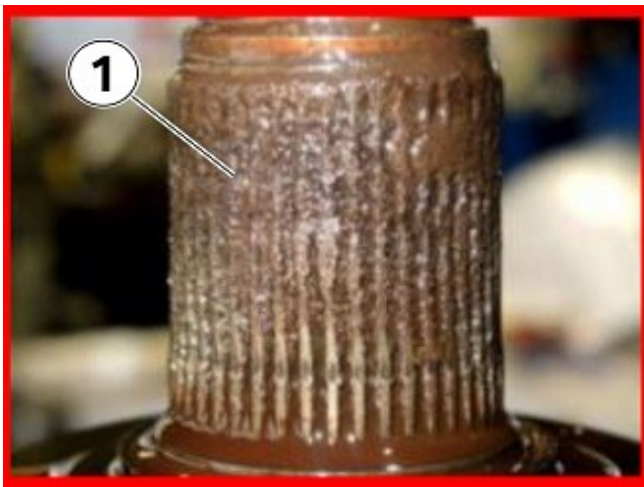
Flange and output shaft **with** friction rust damage (1). The transfer case will need to be replaced (with new flex disc).

NOTE: The transfer case needs to be replaced if either the flange or the output shaft are worn.

Follow Repair Instruction **27 10 020 Installing exchange transfer box (ATC 35L)**.
