April 2020

Dealer Service Instructions for:

# Safety Recall W36 / NHTSA 20V-191 VP4 Radio Software

## 2019 - 2020 (WK) Jeep® Grand Cherokee

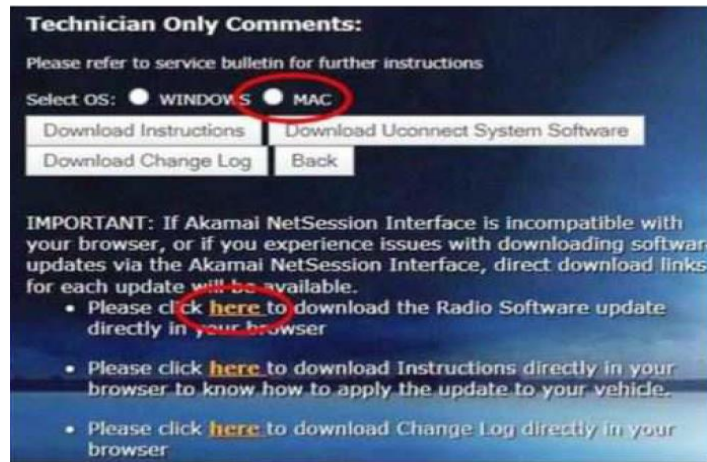
**Figure 3 – Operating System Selection**

10. Enter the VIN into Dealer Update ePortal and select “Go”.
11. Select Software Release ID.
12. Select the “MAC” operating system (OS) only (Figure 3).
