Revision 3 May 2020

Dealer Service Instructions for:

Safety Recall W33 / NHTSA 20V-191 VP4 Radio Software

2019 - 2020 (DF) Ram 3500 10,000 Lb. Cab Chassis

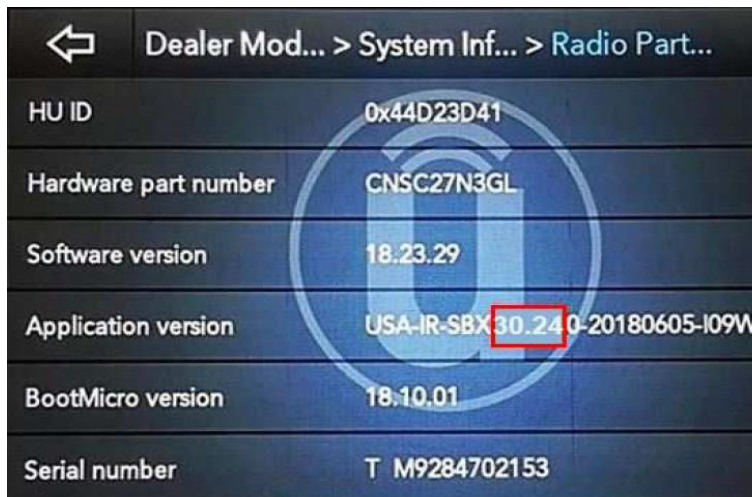
Figure 1 – Application Version Display

1. Turn the ignition to the “RUN” position.
2. Turn the radio to the “ON” position.
3. Press and hold the two lower corners of the radio display screen simultaneously until the “**Dealer Mode**” screen appears, approximately seven seconds, and then release the buttons.
4. Select “**Radio Part Information**”.
5. Is the radio “**Application Version**” **MR27.4, MR28.3, or MR28.32 for 8.4” radio and NR28.1, LR30.21, LR30.22, and LR33.3 for 12” radio?** (Figure 1).

➤ **NO** - The radio software is current. **No further action required.**

➤ **YES** - There is radio software update available. Please continue to section **B. Software Download**

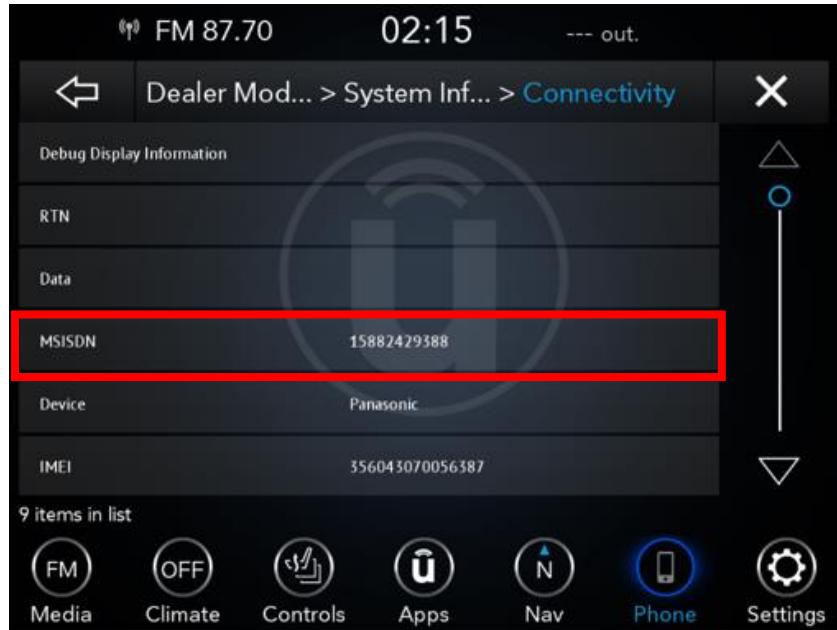
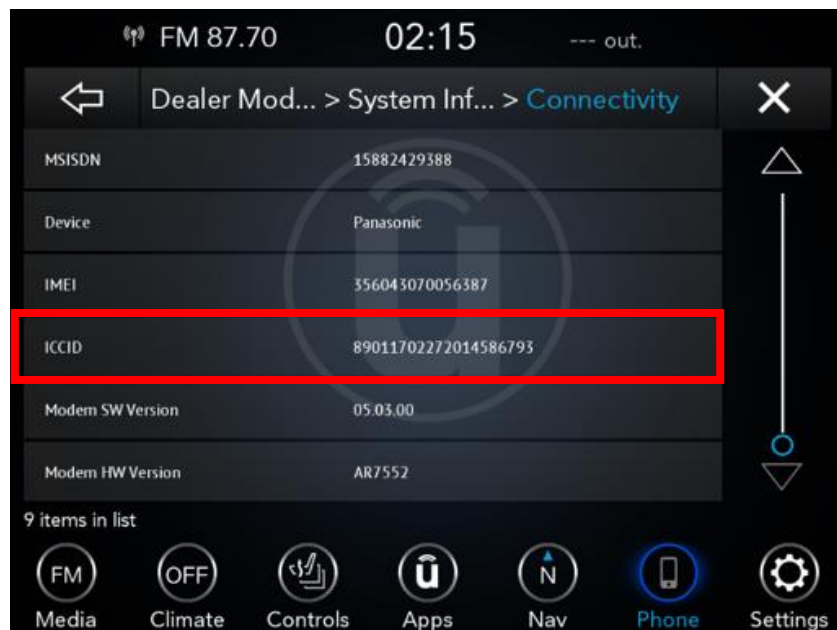
NOTE: Before software reflash, please enter the Dealer Mode ->Connectivity screen verify MSISDN and ICCID numbers. If those 2 fields are blank, do NOT proceed with the software reflash process, order a replacement. Replace radio under warranty, use Inspect LOP to close recall (Figure 2 and 3).

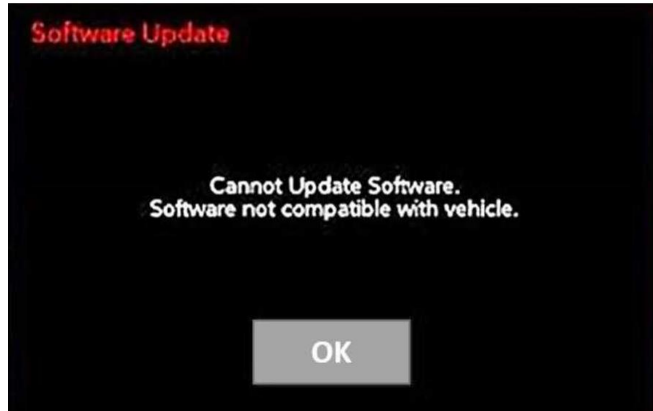
Figure 8 – Software Not Compatible

- 7. If the screen displays “Cannot Update Software” the USB flash drive was not set up correctly. Use a top name brand USB and create a new flash drive and start the update again (Figure 8).

NOTE: If you receive an Error 01 message, verify the USB was created properly. If error persists reformat the drive and begin again.

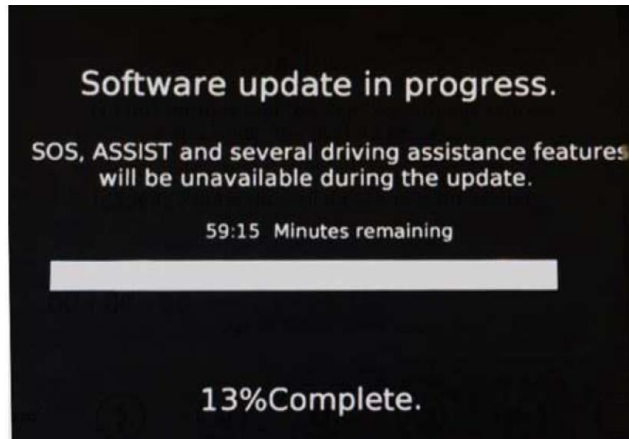
Figure 11 – Software Update Progress

- The radio will reboot and the update will begin. The update should only take 20 minutes, the timer on the screen may display the incorrect time remaining (Figure 11).

Note: If the radio update fails along the way you may receive an Error message on the screen; DO NOT remove the USB at this time. The radio will roll back to the previous software level and attempt the radio update up to three times. Please allow up to 15 minutes for the rollback to occur before the update retries.
