April 2020

Dealer Service Instructions for:

Safety Recall W37 / NHTSA 20V-191 VP4 Radio Software

2019 - 2020 (RU) Chrysler Pacifica

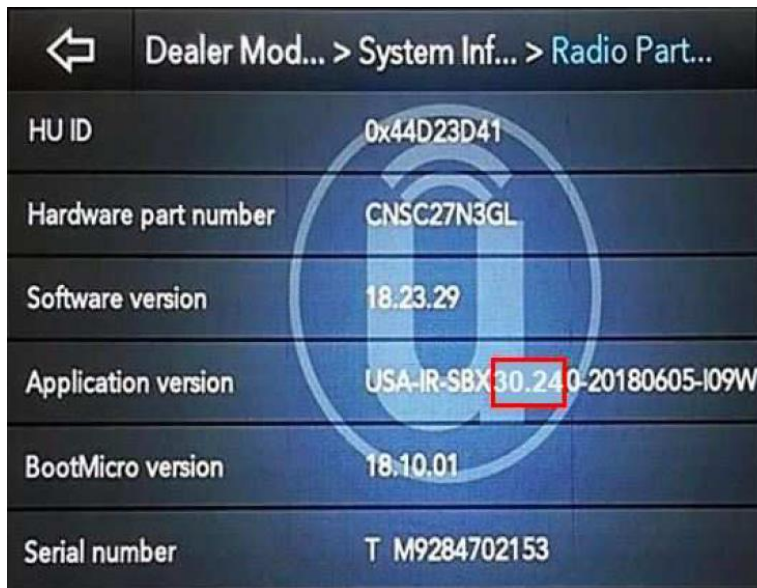
Figure 1 – Application Version Display

1. Turn the ignition to the “RUN” position.
2. Turn the radio to the “ON” position.
3. Press and hold the two lower corners of the radio display screen simultaneously until the “**Dealer Mode**” screen appears, approximately seven seconds, and then release the buttons.
4. Select “**Radio Part Information**”.
5. Is the radio “Application Version” **JR34.1** or higher? (Figure 1).
 - **Yes** - The radio software is current. **No further action required.**
 - **No** - **There is** radio software update available. Please continue to section **B. Software Download**

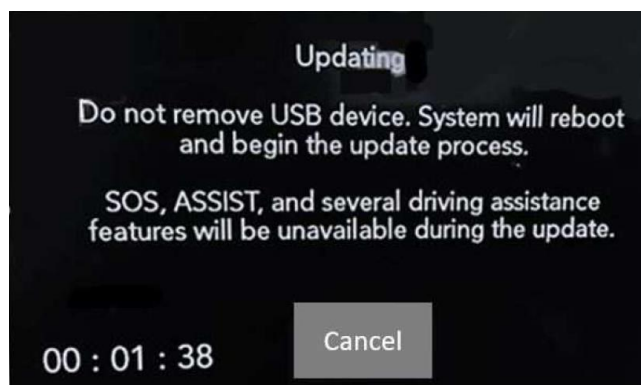
Figure 7 – Updating Screen

- 9. Updating screen will be displayed (Figure 7).

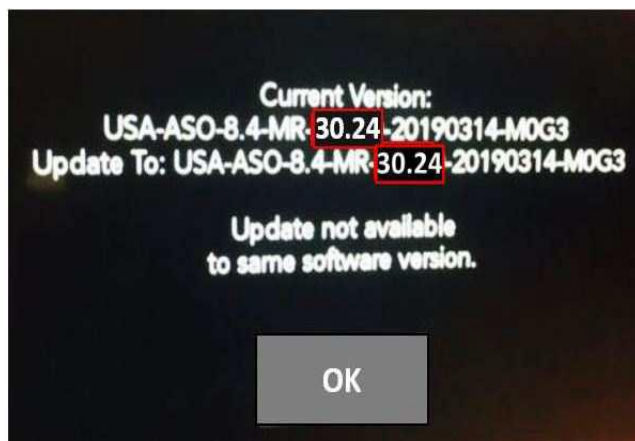
Figure 9 – Software Updated Screen

- After the update has completed, the radio will shut down. With the USB flash drive still inserted in the USB port. If the radio has been updated correctly, the screen will be displayed. Press “OK” and remove the USB flash drive (Figure 9).
