Revision 1 May 2020

Dealer Service Instructions for:

Safety Recall W34 / NHTSA 20V-191 VP4 Radio Software

2020 (KL) Jeep Cherokee

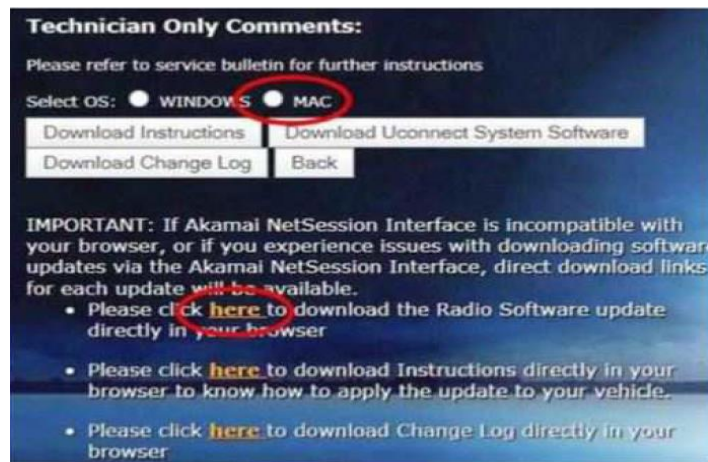
Figure 3 – Operating System Selection

10. Enter the VIN into Dealer Update ePortal and select “Go”.
11. Select Software Release ID.
12. Select the “MAC” operating system (OS) only (Figure 3).

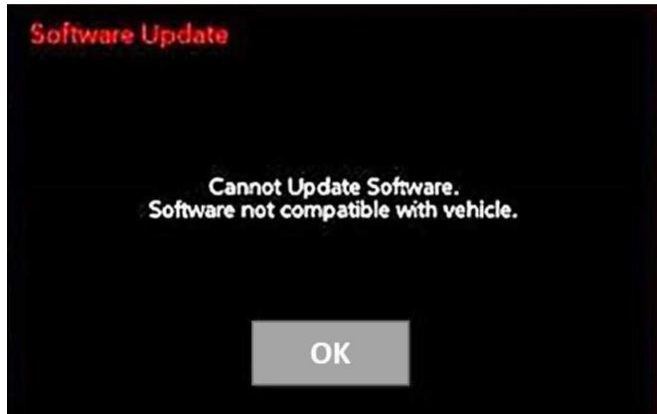
Figure 5 – Software Not Compatible

- 7. If the screen displays “**Cannot Update Software**” the USB flash drive was not set up correctly. Use a top name brand USB and create a new flash drive and start the update again.
(Figure 5)

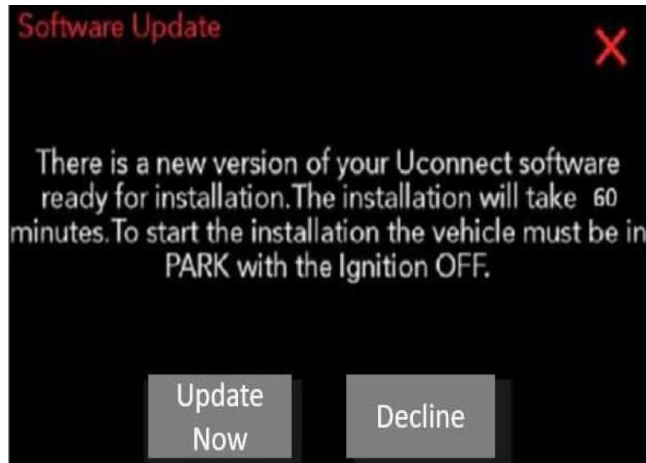
Figure 6 – Software Selection

- 8. Select the ‘**Update Now**’ button (Figure 6).

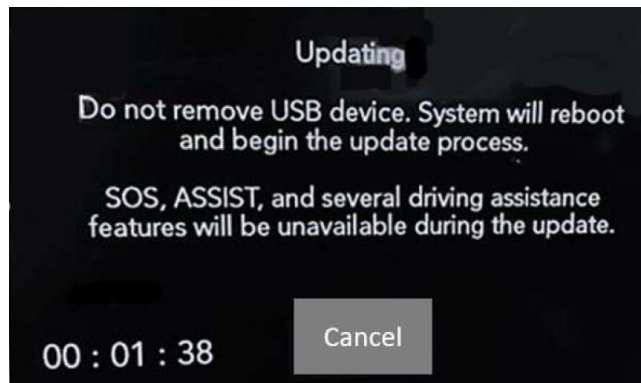
Figure 7 – Updating Screen

- 9. Updating screen will be displayed (Figure 7).
