Revision 2 May 2020

Dealer Service Instructions for:

Safety Recall W33 / NHTSA 20V-191 VP4 Radio Software

VP4 Radio Software

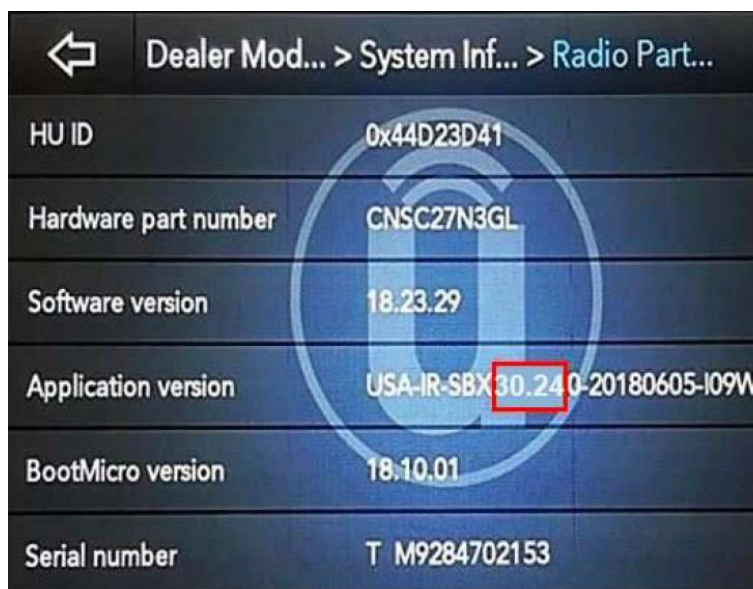
Figure 1 – Application Version Display

1. Turn the ignition to the “RUN” position.
2. Turn the radio to the “ON” position.
3. Press and hold the two lower corners of the radio display screen simultaneously until the “**Dealer Mode**” screen appears, approximately seven seconds, and then release the buttons
4. Select “**Radio Part Information**”.
5. Is the radio “**Application Version**” **KR20.16** or lower or **LR34.2** or higher? (Figure 1).
 - **Yes** - The radio software is current. **No further action required.**

- **No** - There is radio software update available. Please continue with section **B. Software Download**

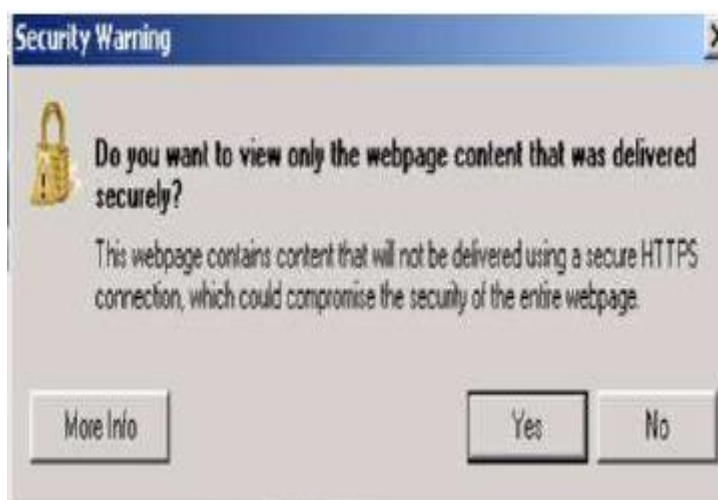
Figure 2 – Security Warning

NOTE: If a security message appears ‘Do you want to view only the web page content that was delivered securely?’ select “NO” and continue (Figure 2).

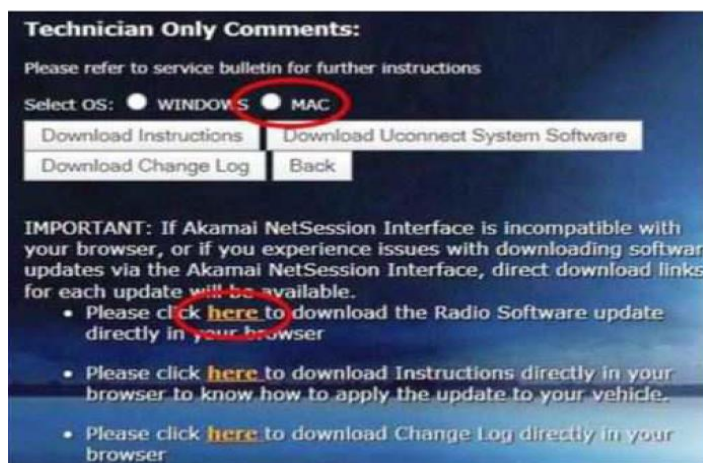
Figure 3 – Operating System Selection

10. Enter the VIN into Dealer Update ePortal and select “Go”.
11. Select Software Release ID.
12. Select the “MAC” operating system (OS) only (Figure 3).

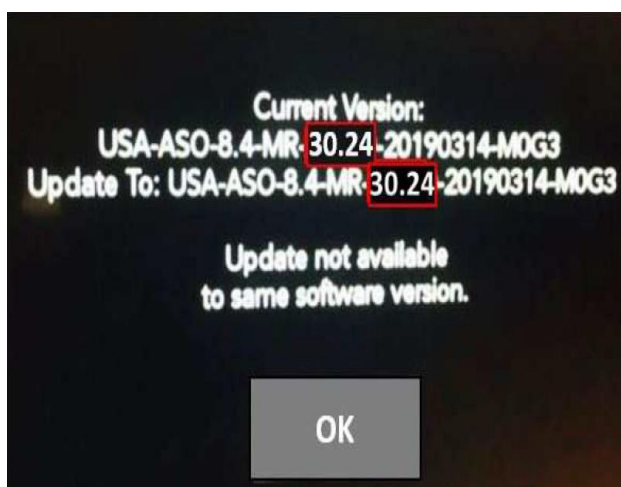
Figure 4 – Update Screen

2. Remove all devices (SD, USB, and AUX) from the media hub.
3. Insert the USB flash drive containing the downloaded software into the vehicle USB port.
4. Turn the ignition to the “ON” position.
5. Turn the radio to the “ON” position.
6. If the current version” and “Update To” are the same Press “OK” and remove the USB flash drive (Figure 4).

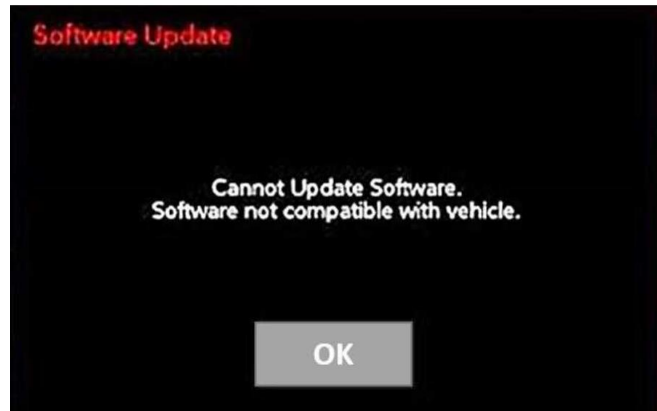
**Figure 5 – Software Not Compatible**

7. If the screen displays “**Cannot Update Software**” the USB flash drive was not set up correctly. Use a top name brand USB and create a new flash drive and start the update again (Figure 5).

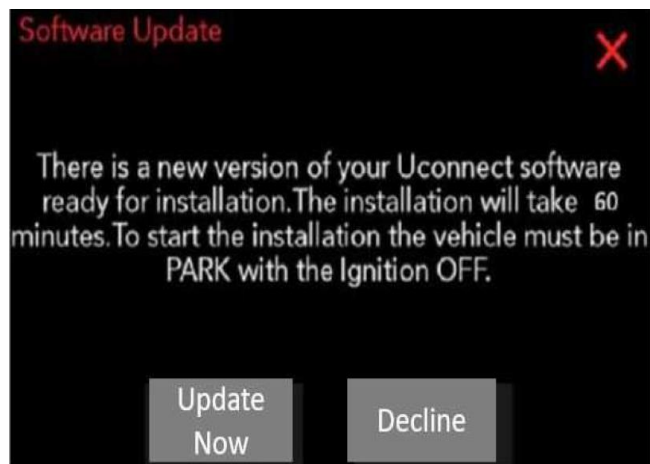
**Figure 6 – Software Selection**

8. Select the ‘**Update Now**’ button (Figure 6).

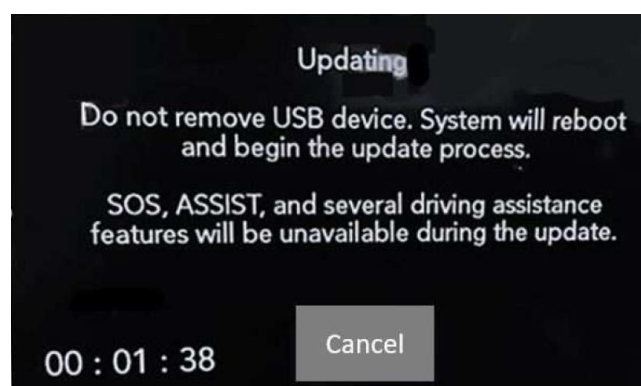
**Figure 7 – Updating Screen**

9. Updating screen will be displayed (Figure 7).
