Revision 1 May 2020

Dealer Service Instructions for:

Safety Recall W35 / NHTSA 20V-191 VP4 Radio Software

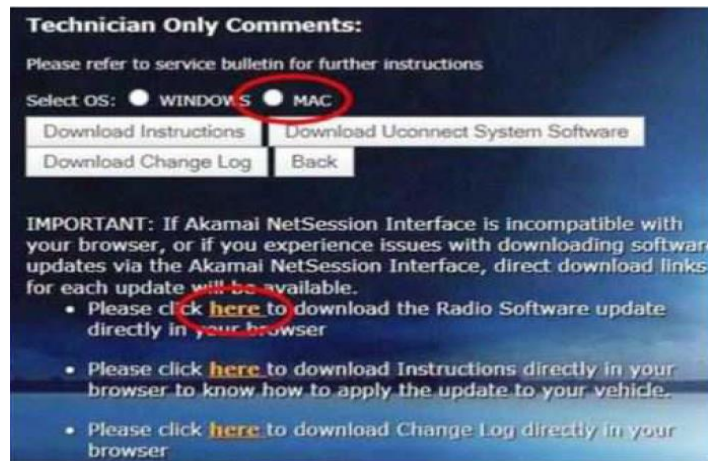
Figure 3 – Operating System Selection

10. Enter the VIN into Dealer Update ePortal and select “Go”.
11. Select Software Release ID.
12. Select the “MAC” operating system (OS) only (Figure 3).

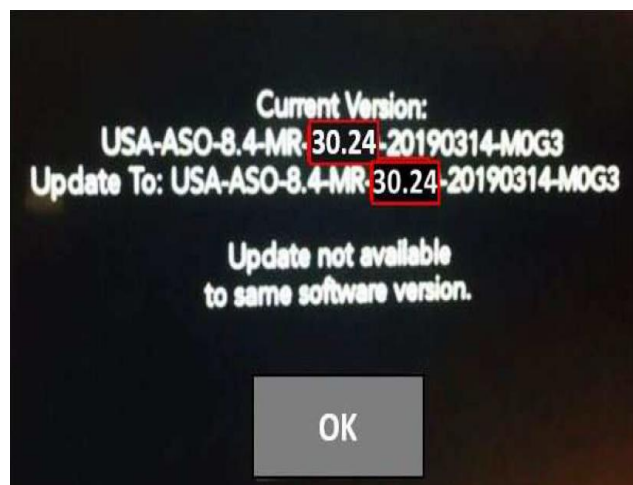
Figure 4 – Update Screen

2. Remove all devices (SD, USB, and AUX) from the media hub.
3. Insert the USB flash drive containing the downloaded software into the vehicle USB port.
4. Turn the ignition to the “ON” position.
5. Turn the radio to the “ON” position.
6. If the current version” and “Update To” are the same Press “OK” and remove the USB flash drive (Figure 4).

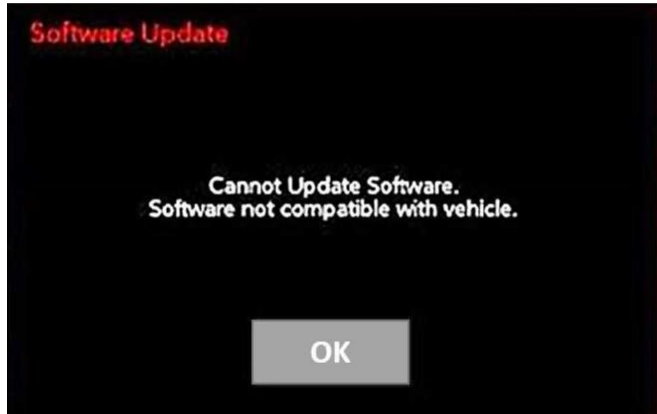
Figure 5 – Software Not Compatible

- 7. If the screen displays “**Cannot Update Software**” the USB flash drive was not set up correctly. Use a top name brand USB and create a new flash drive and start the update again (Figure 5).

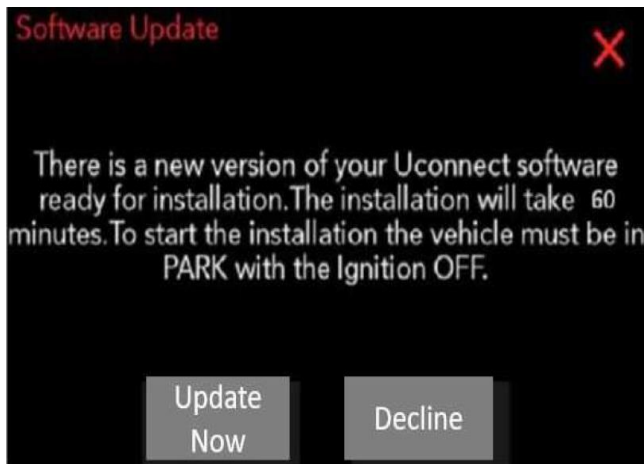
Figure 6 – Software Selection

- 8. Select the ‘**Update Now**’ button (Figure 6).

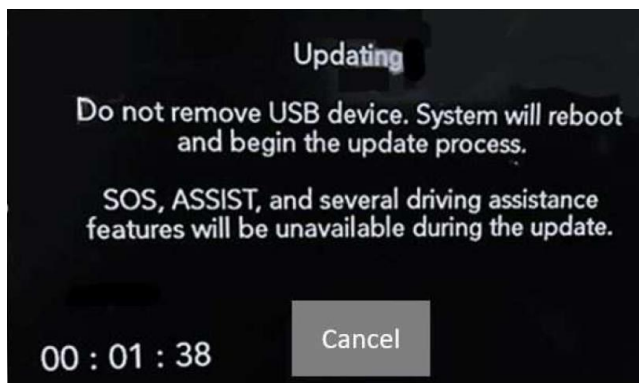
Figure 7 – Updating Screen

- 9. Updating screen will be displayed (Figure 7).
