Revision 2 May 2020

Dealer Service Instructions for:

Safety Recall W34 / NHTSA 20V-191 VP4 Radio Software

2020 (KL) Jeep Cherokee

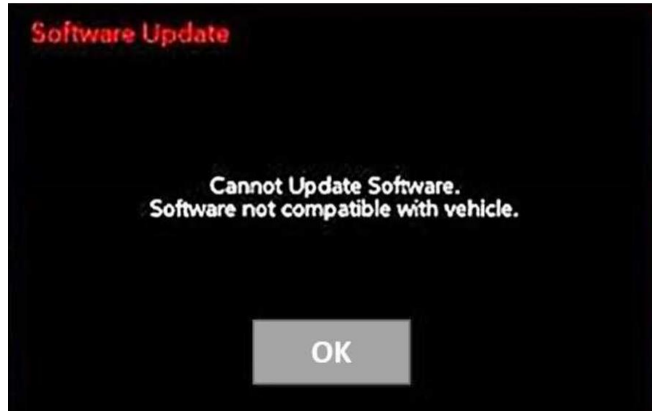
Figure 8 – Software Not Compatible

- 7. If the screen displays “Cannot Update Software” the USB flash drive was not set up correctly. Use a top name brand USB and create a new flash drive and start the update again (Figure 8).

NOTE: If you receive an Error 01 message, verify the USB was created properly. If error persists reformat the drive and begin again.
