April 2020

Dealer Service Instructions for:

Safety Recall W31 / NHTSA 20V-191 VP4 Radio Software

2019 (LA) Dodge Challenger

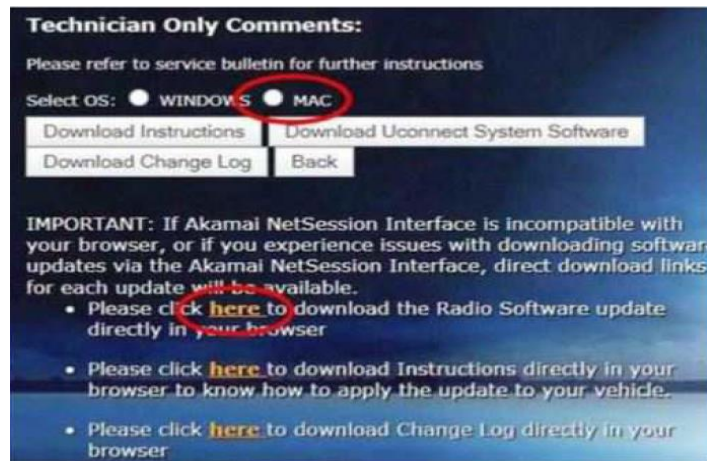
Figure 3 – Operating System Selection

10. Enter the VIN into Dealer Update ePortal and select “Go”.
11. Select Software Release ID.
12. Select the “MAC” operating system (OS) only (Figure 3).

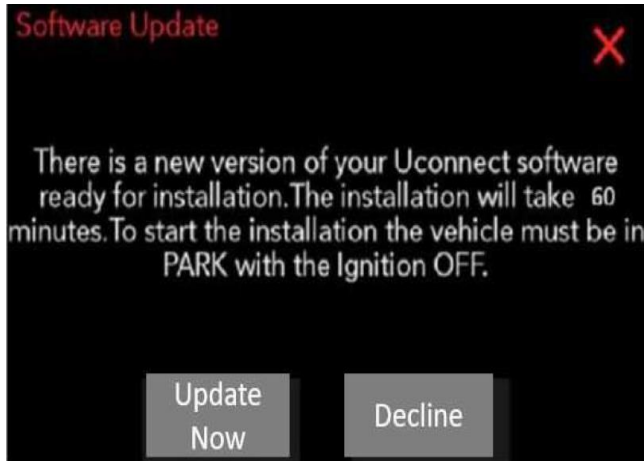
Figure 6 – Software Selection

- 8. Select the ‘**Update Now**’ button (Figure 6).

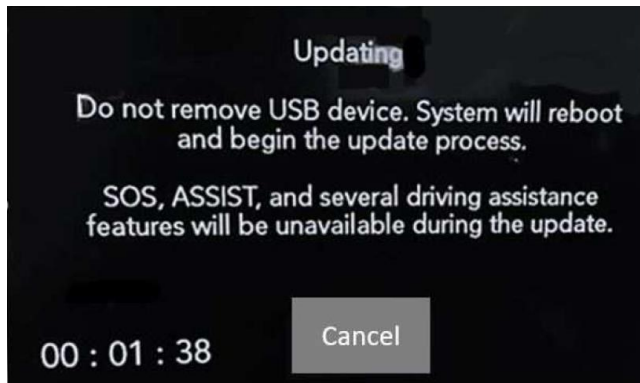
Figure 7 – Updating Screen

- 9. Updating screen will be displayed (Figure 7).
