Dealer Service Instructions for:

Safety Recall W30 / NHTSA 20V-191 VP4 Radio Software

Remedy Available

2019 - 2020 (WD) Dodge Durango

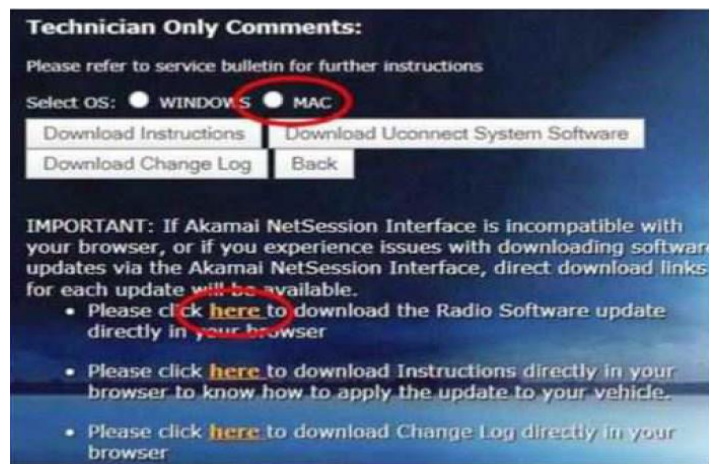
Figure 3 – Operating System Selection

12. Select the “MAC” operating system (OS) only (Figure 3).

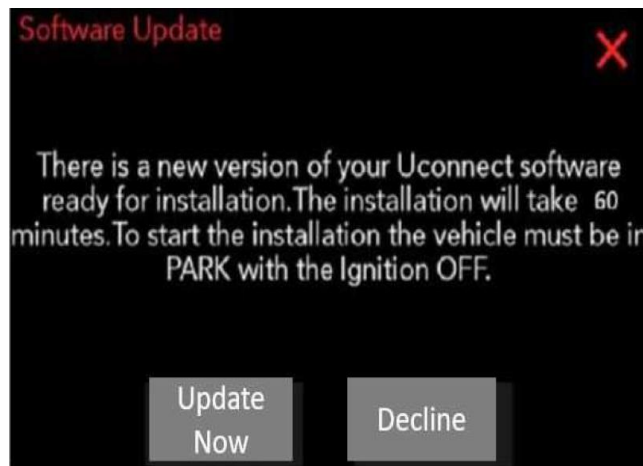
Figure 6 – Software Selection

- Select the ‘**Update Now**’ button (Figure 6).

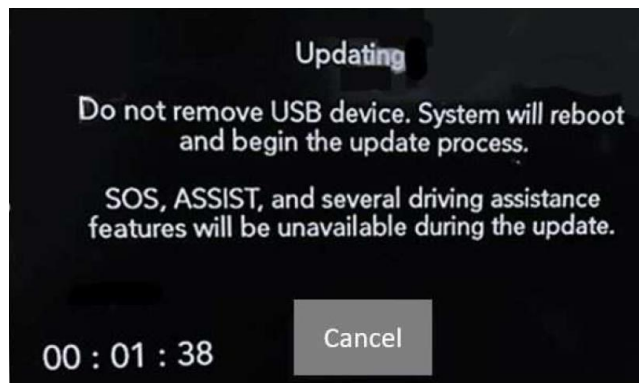
Figure 7 – Updating Screen

NOTE: Do not turn off the ignition until the two-minute timer has expired (Figure 7).

- The ignition must be turned to the off position **before** the two-minute timer has expired, or the update may be canceled (Figure 7).
