Revision 2 May 2020

Dealer Service Instructions for:

Safety Recall W32 / NHTSA 20V-191 VP4 Radio Software

2019 - 2020 (DF) Ram 3500 10,000 Lb. Cab Chassis

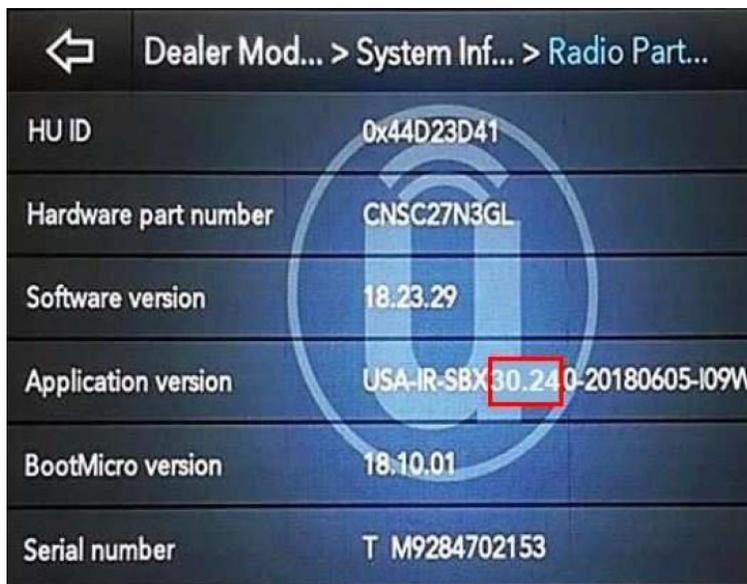
Figure 1 – Application Version Display

1. Turn the ignition to the “RUN” position.
2. Turn the radio to the “ON” position.
3. Press and hold the two lower corners of the radio display screen simultaneously until the “**Dealer Mode**” screen appears, approximately seven seconds, and then release the buttons.
4. Select “**Radio Part Information**”.
5. Is the radio “**Application Version**” **IR22.6** or lower or **JR30.24** or higher? (Figure 1).
 - **Yes** - The radio software is current. **No further action required.**

- **No** - There is radio software update available. Please continue to section **B. Software Download**

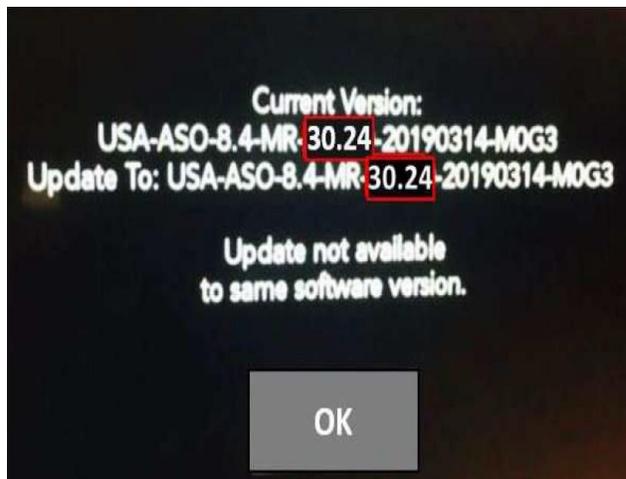
Figure 4 – Update Screen

2. Remove all devices (SD, USB, and AUX) from the media hub.
3. Insert the USB flash drive containing the downloaded software into the vehicle USB port.
4. Turn the ignition to the “ON” position.
5. Turn the radio to the “ON” position.
6. If the current version” and “Update To” are the same Press “OK” and remove the USB flash drive (Figure 4).

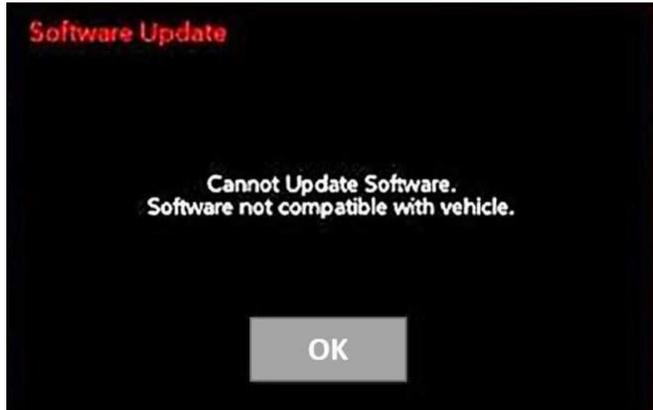
Figure 5 – Software Not Compatible

- 7. If the screen displays “**Cannot Update Software**” the USB flash drive was not set up correctly. Use a top name brand USB and create a new flash drive and start the update again (Figure 5).
