Revision 1 April 2020

Dealer Service Instructions for:

# Safety Recall W33 / NHTSA 20V-191 VP4 Radio Software

**2019 - 2020 (DF) Ram 3500 10,000 Lb. Cab Chassis**

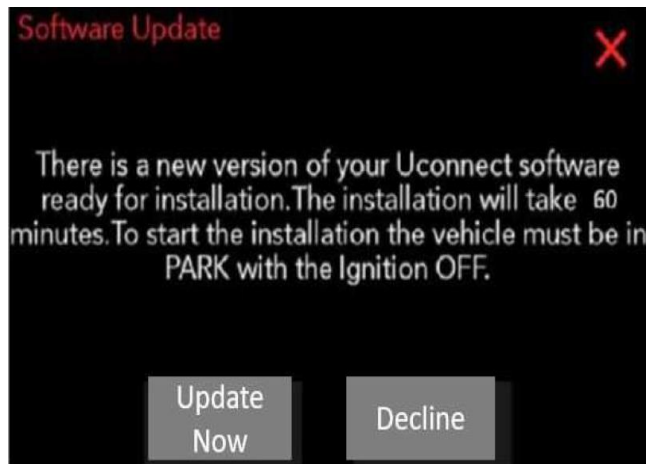
Figure 6 – Software Selection

- 8. Select the ‘Update Now’ button (Figure 6).

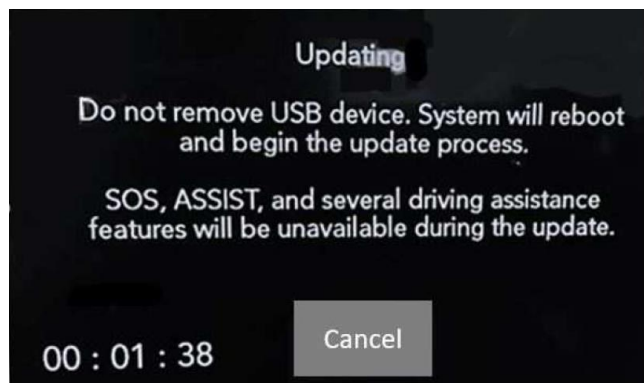
Figure 7 – Updating Screen

- 9. Updating screen will be displayed (Figure 7).

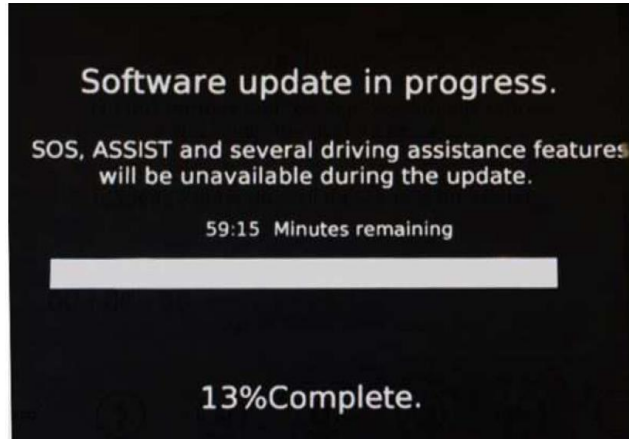
**Figure 8 – Software Update Progress**

- The radio will reboot and the update will begin. The update should only take 20 minutes, the timer on the screen may display the incorrect time remaining (Figure 8).

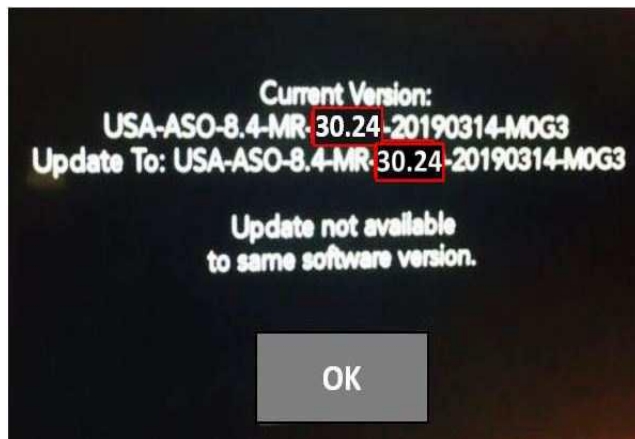
**Figure 8 – Software Updated Screen**

- After the update has completed, the radio will shut down. With the USB flash drive still inserted in the USB port. If the radio has been updated correctly, the screen will be displayed. Press “OK” and remove the USB flash drive (Figure 9).
