April 2020

Dealer Service Instructions for:

Safety Recall W32 / NHTSA 20V-191 VP4 Radio Software

2019 - 2020 (DF) Ram 3500 10,000 Lb. Cab Chassis

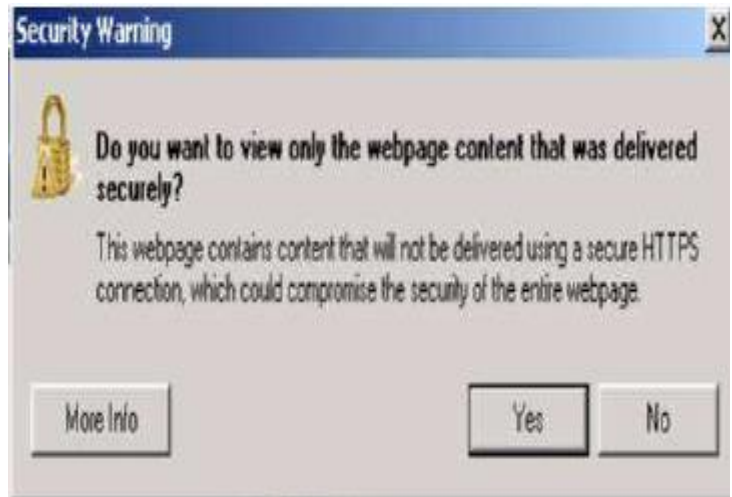
Figure 2 – Security Warning

NOTE: If a security message appears ‘Do you want to view only the web page content that was delivered securely?’ select “NO” and continue (Figure 2).

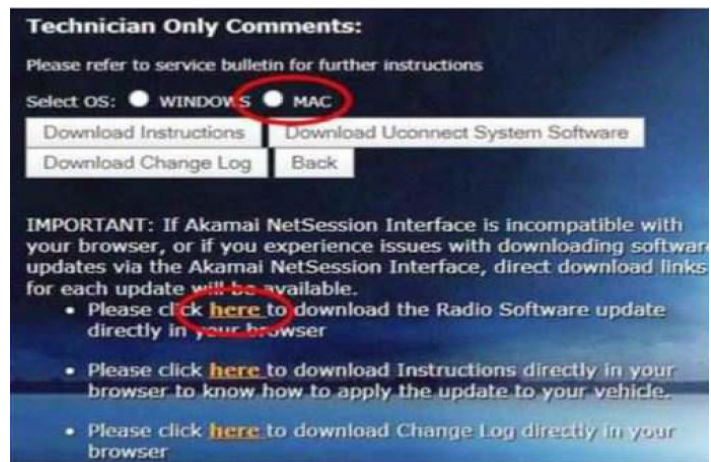
Figure 3 – Operating System Selection

10. Enter the VIN into Dealer Update ePortal and select “Go”.
11. Select Software Release ID.
12. Select the “MAC” operating system (OS) only (Figure 3).
13. Select the download directly to your browser.
14. Select the downloaded file and extract the file to the jump drive record the campaign number on the jump drive.
15. Safely remove the jump drive from your computer.

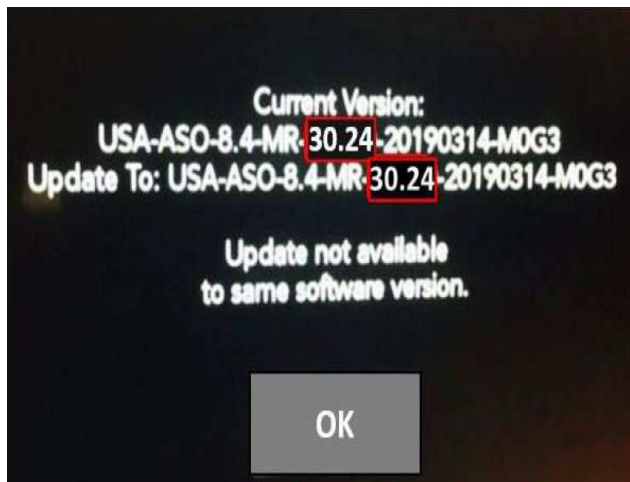
Figure 4 – Update Screen

2. Remove all devices (SD, USB, and AUX) from the media hub.
3. Insert the USB flash drive containing the downloaded software into the vehicle USB port.
4. Turn the ignition to the “RUN” position.
5. Turn the radio to the “ON” position.
6. Current Version” and “Update To” will be the same Press “OK” and remove the USB flash drive (Figure 4).

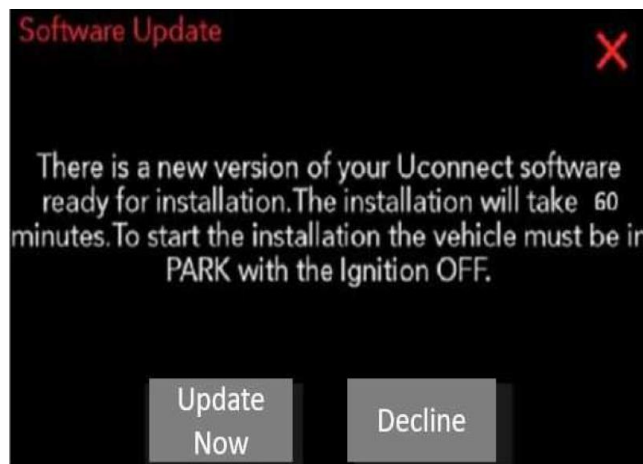
Figure 6 – Software Selection

- 8. Select the ‘**Update Now**’ button (Figure 6).

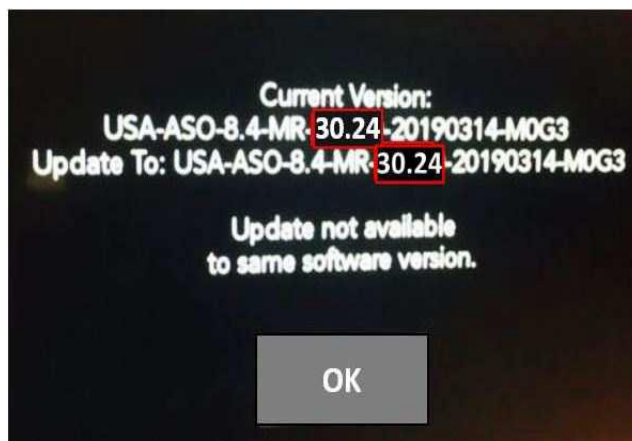
Figure 8 – Software Updated Screen

- After the update has completed, the radio will shut down. With the USB flash drive still inserted in the USB port, turn the ignition back to the run position. If the radio has been updated correctly, the screen will be displayed. Press “OK” and remove the USB flash drive (Figure 8).
