Revision 2 May 2020

Dealer Service Instructions for:

# Safety Recall W35 / NHTSA 20V-191 VP4 Radio Software

## Remedy Available

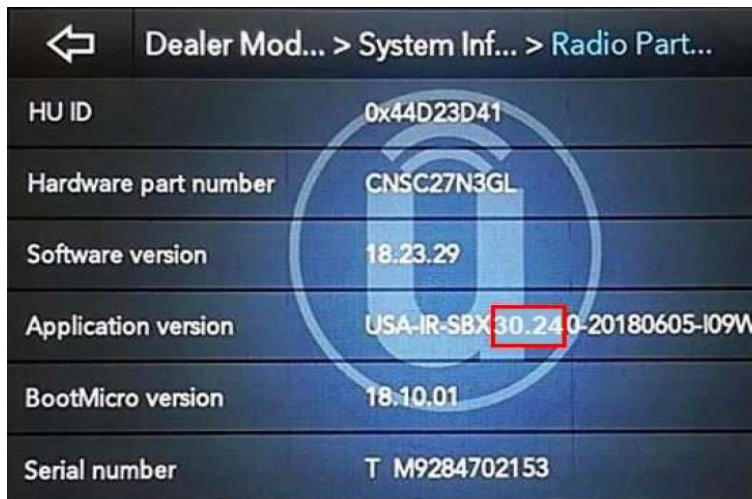
**Figure 1 – Application Version Display**

1. Turn the ignition to the “RUN” position.
2. Turn the radio to the “ON” position.
3. Press and hold the two lower corners of the radio display screen simultaneously until the “**Dealer Mode**” screen appears, approximately seven seconds, and then release the buttons.
4. Select “**Radio Part Information**”.
5. Is the radio “**Application Version**” **MR27.4, MR28.3, or MR28.32 for 8.4” radio and NR28.1, LR30.21, LR30.22, and LR33.3 for 12” radio?** (Figure 1).

➤ **NO** - The radio software is current. **No further action required.**

➤ **YES** - There is radio software update available. Please continue to section **B. Software Download**

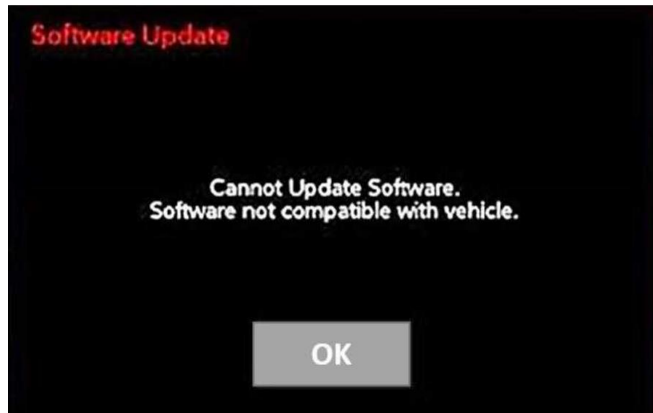
**Figure 8 – Software Not Compatible**

- If the screen displays “**Cannot Update Software**” the USB flash drive was not set up correctly. Use a top name brand USB and create a new flash drive and start the update again (Figure 8).

**NOTE: If you receive an Error 01 message, verify the USB was created properly. If error persists reformat the drive and begin again.**
