Revision 1 April 2020

Dealer Service Instructions for:

Safety Recall W30 / NHTSA 20V-191 VP4 Radio Software

2019 - 2020 (WD) Dodge Durango

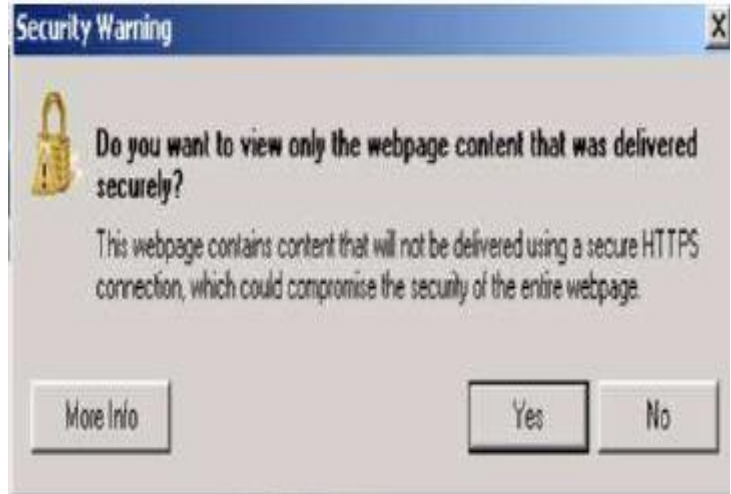
Figure 2 – Security Warning

NOTE: If a security message appears ‘Do you want to view only the web page content that was delivered securely?’ select “NO” and continue (Figure 2).

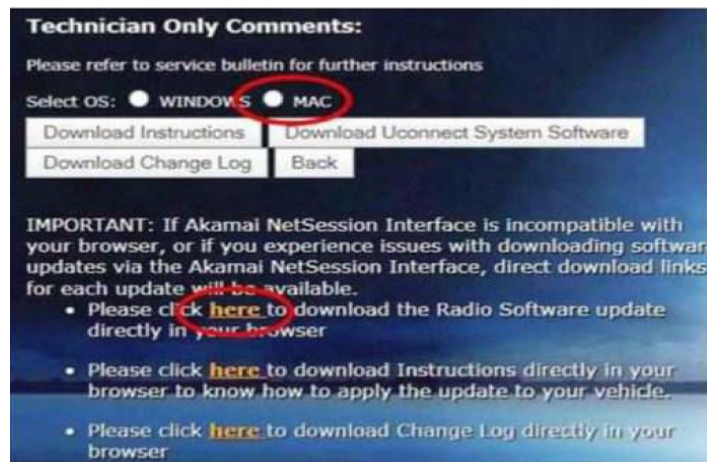
Figure 3 – Operating System Selection

10. Enter the VIN into Dealer Update ePortal and select “Go”.
11. Select Software Release ID.
12. Select the “MAC” operating system (OS) only (Figure 3).

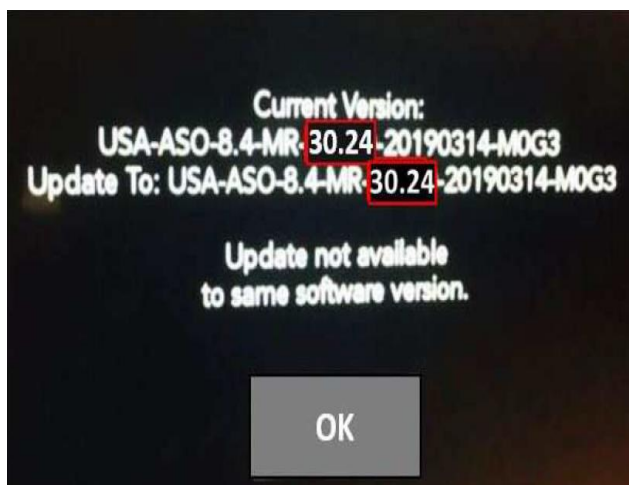
Figure 4 – Update Screen

2. Remove all devices (SD, USB, and AUX) from the media hub.
3. Insert the USB flash drive containing the downloaded software into the vehicle USB port.
4. Turn the ignition to the “ON” position.
5. Turn the radio to the “ON” position.
6. If the current version” and “Update To” are the same Press “OK” and remove the USB flash drive (Figure 4).

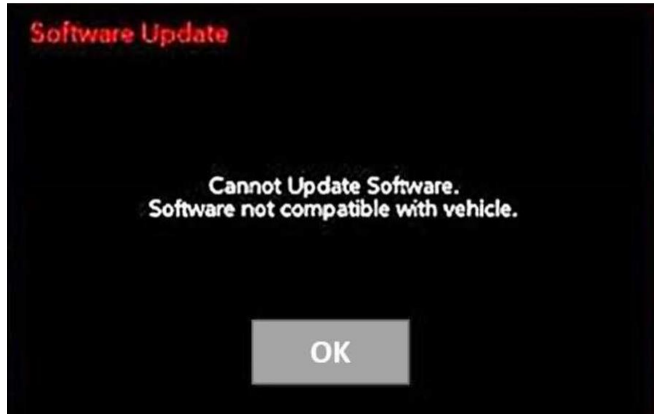
Figure 5 – Software Not Compatible

- 7. If the screen displays “**Cannot Update Software**” the USB flash drive was not set up correctly. Use a top name brand USB and create a new flash drive and start the update again (Figure 5).

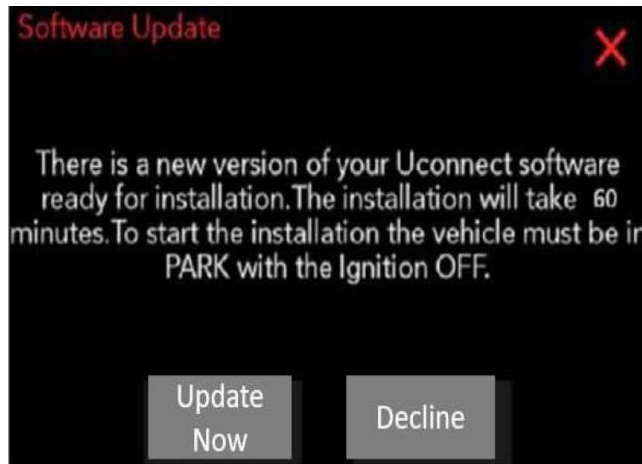
Figure 6 – Software Selection

- 8. Select the ‘**Update Now**’ button (Figure 6).

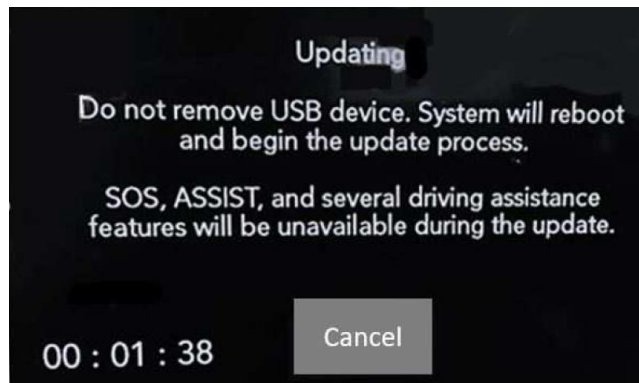
Figure 7 – Updating Screen

- 9. **Updating screen will be displayed (Figure 7).**

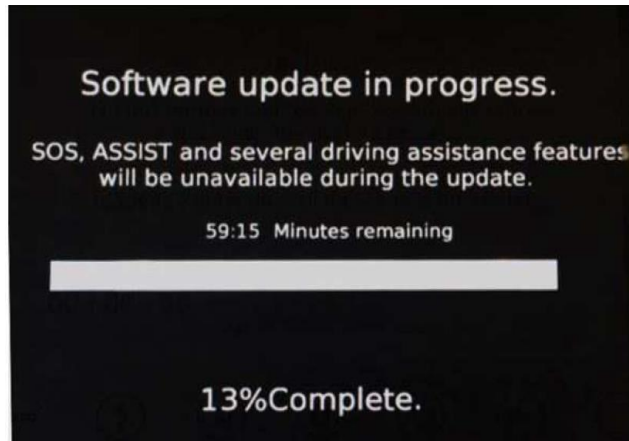
Figure 8 – Software Update Progress

- 10. The radio will reboot and the update will begin. The update should only take 20 minutes, the timer on the screen may display the incorrect time remaining (Figure 8).

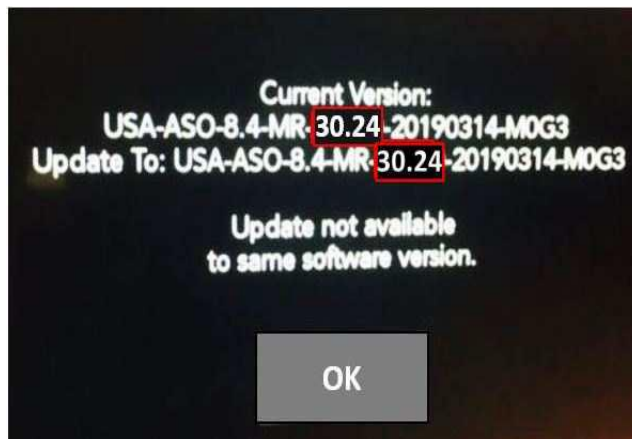
Figure 9 – Software Updated Screen

- 11. After the update has completed, the radio will shut down. With the USB flash drive still inserted in the USB port. If the radio has been updated correctly, the screen will be displayed. Press “OK” and remove the USB flash drive (Figure 9).
