Revision 3 May 2020

# Safety Recall W30 / NHTSA 20V-191 VP4 Radio Software

**2019 - 2020 (WD) Dodge Durango**

*NOTE: This recall applies only to the above vehicles equipped with an 8.4" radio display (Sales Code RFL).*

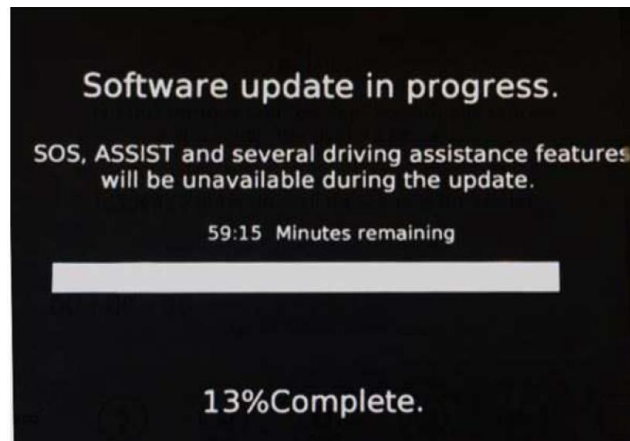
Figure 11 – Software Update Progress

10. The radio will reboot and the update will begin. The update should only take 20 minutes, the timer on the screen may display the incorrect time remaining (Figure 11).

**Note: If the radio update fails along the way you may receive an Error message on the screen; DO NOT remove the USB at this time. The radio will roll back to the previous software level and attempt the radio update up to three times. Please allow up to 15 minutes for the rollback to occur before the update retries.**
