Safety Recall W33 / NHTSA 20V-191 VP4 Radio Software

2019 - 2020 (DF) Ram 3500 10,000 Lb. Cab Chassis

2019 - 2020 (DJ) Ram 2500 Pickup

2019 - 2020 (DT) Ram 1500 Pickup

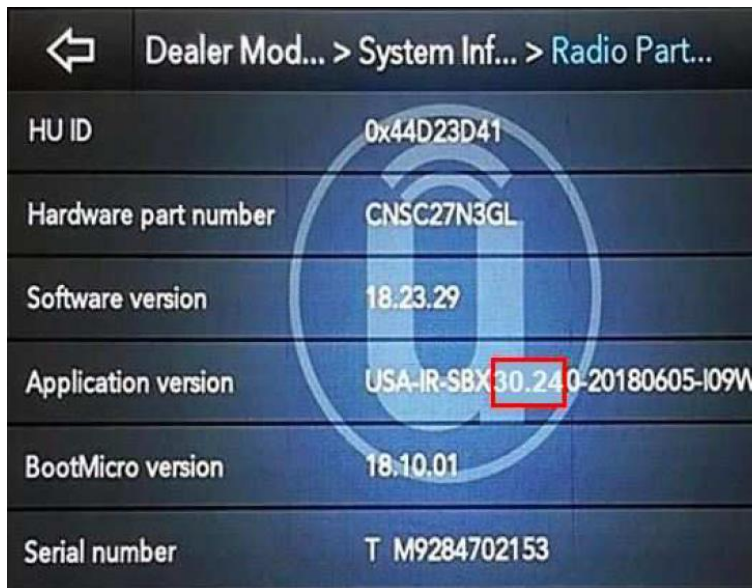
Figure 1 – Application Version Display

1. Turn the ignition to the “RUN” position.
2. Turn the radio to the “ON” position.
3. Press and hold the two lower corners of the radio display screen simultaneously until the “**Dealer Mode**” screen appears, approximately seven seconds, and then release the buttons
4. Select “**Radio Part Information**”.
5. Is the radio “**Application Version**” **LR34.2** or higher? (Figure 1).
 - **Yes** - The radio software is current. **No further action required.**
 - **No** - **There is** radio software update available. Please continue with section **B. Software Download**

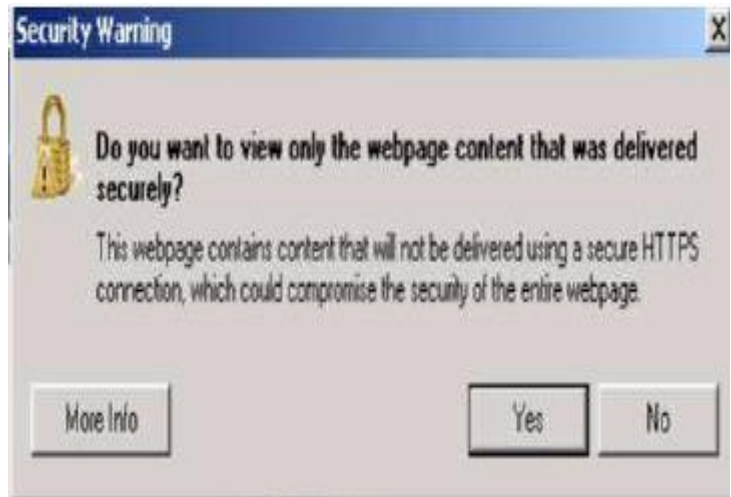
Figure 2 – Security Warning

NOTE: If a security message appears ‘Do you want to view only the web page content that was delivered securely?’ select “NO” and continue (Figure 2).

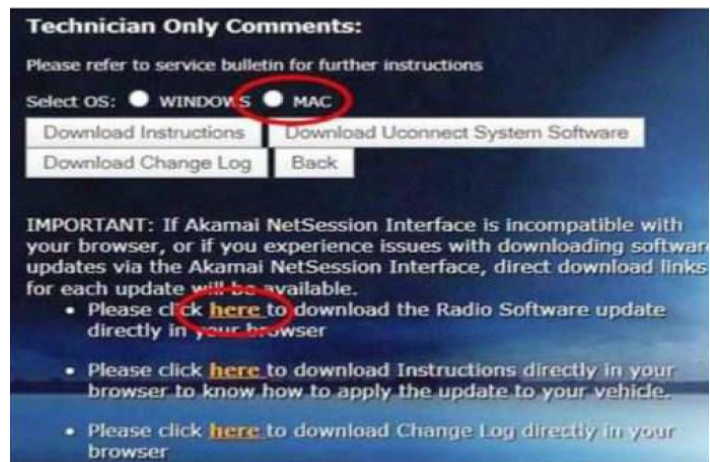
Figure 3 – Operating System Selection

10. Enter the VIN into Dealer Update ePortal and select “Go”.
11. Select Software Release ID.
12. Select the “MAC” operating system (OS) only (Figure 3).
13. Select the download directly to your browser.
14. Select the downloaded file and extract the file to the jump drive record the campaign number on the jump drive.
15. Safely remove the jump drive from your computer.

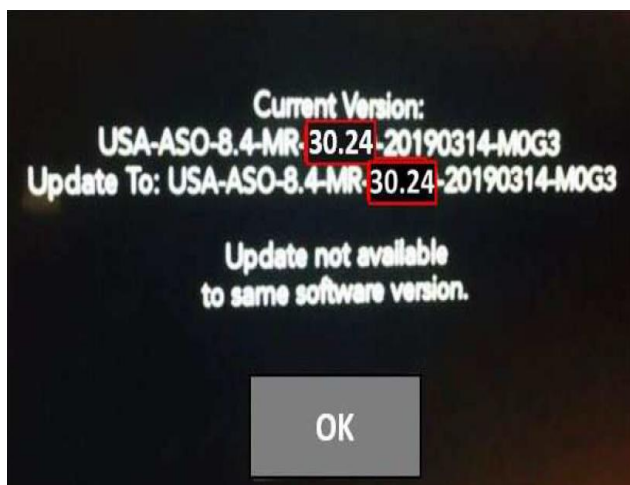
Figure 4 – Update Screen

2. Remove all devices (SD, USB, and AUX) from the media hub.
3. Insert the USB flash drive containing the downloaded software into the vehicle USB port.
4. Turn the ignition to the “RUN” position.
5. Turn the radio to the “ON” position.
6. Current Version” and “Update To” will be the same Press “OK” and remove the USB flash drive (Figure 4).

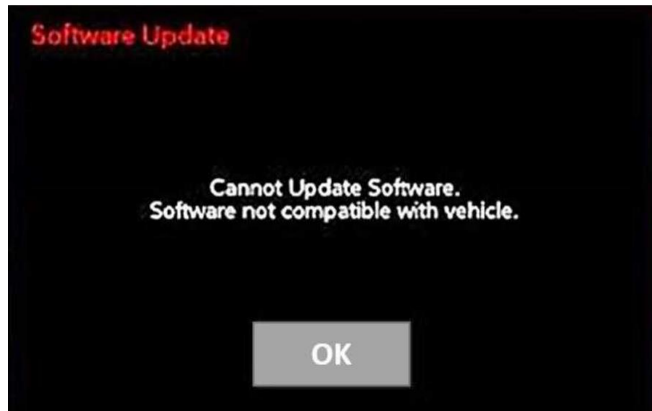
Figure 5 – Software Not Compatible

7. If the screen displays “**Cannot Update Software**” the USB flash drive was not set up correctly. Use a top name brand USB and create a new flash drive and start the update again (Figure 5).

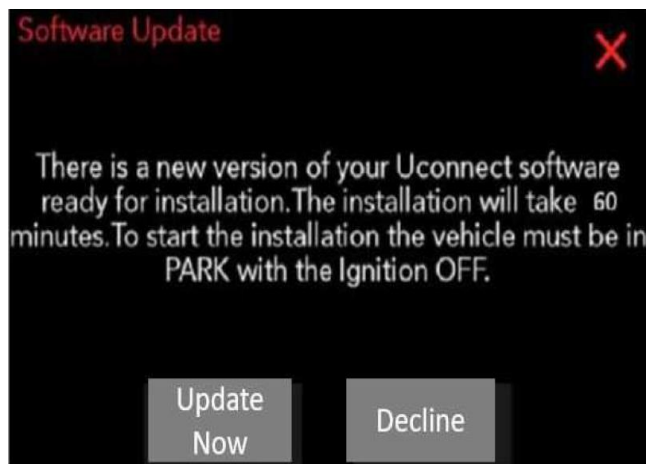
Figure 6 – Software Selection

8. Select the ‘**Update Now**’ button (Figure 6).

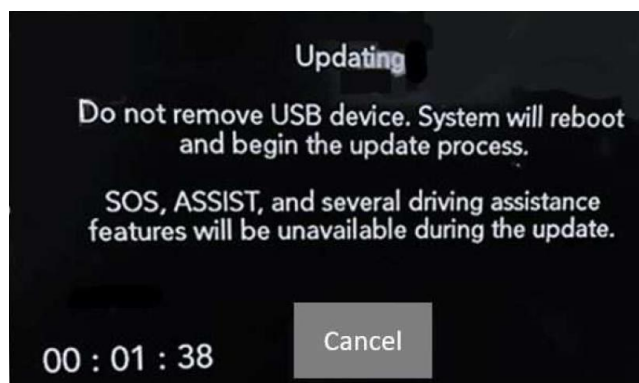
Figure 7 – Updating Screen

NOTE: Do not turn off the ignition until the two-minute timer has expired (Figure 7).

9. The ignition must be turned to the off position **before** the two-minute timer has expired, or the update may be canceled (Figure 7).

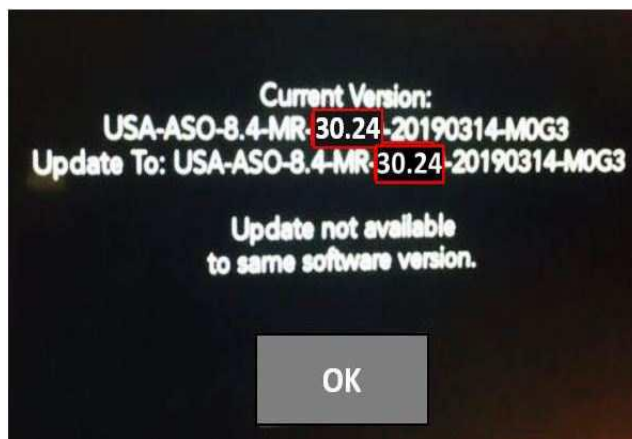
Figure 8 – Software Updated Screen

- After the update has completed, the radio will shut down. With the USB flash drive still inserted in the USB port, turn the ignition back to the run position. If the radio has been updated correctly, the screen will be displayed. Press “OK” and remove the USB flash drive (Figure 8).
