Revision 3 May 2020

Dealer Service Instructions for:

Safety Recall W32 / NHTSA 20V-191 VP4 Radio Software

VP4 Radio Software

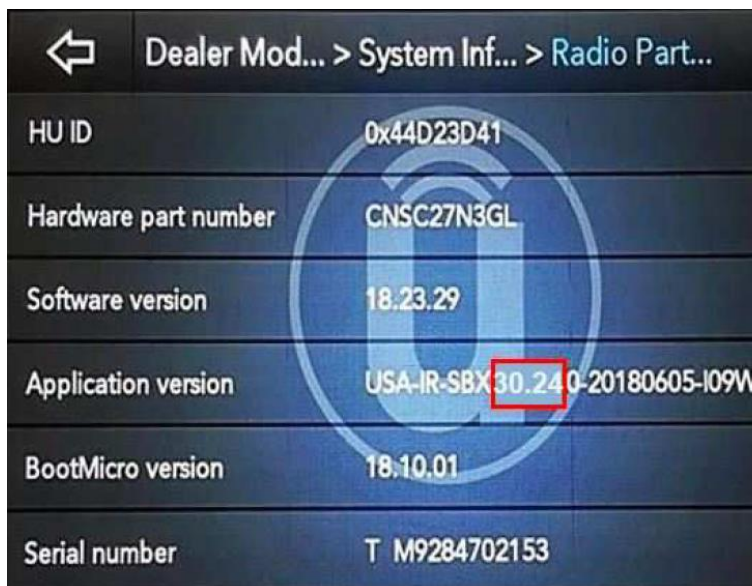
Figure 1 – Application Version Display

1. Turn the ignition to the “RUN” position.
2. Turn the radio to the “ON” position.
3. Press and hold the two lower corners of the radio display screen simultaneously until the “**Dealer Mode**” screen appears, approximately seven seconds, and then release the buttons.
4. Select “**Radio Part Information**”.
5. Is the radio “**Application Version**” **MR27.4, MR28.3, or MR28.32 for 8.4” radio and NR28.1, LR30.21, LR30.22, and LR33.3 for 12” radio?** (Figure 1).

➤ **NO** - The radio software is current. **No further action required.**

➤ **YES** - **There is** radio software update available. Please continue to section **B. Software Download**

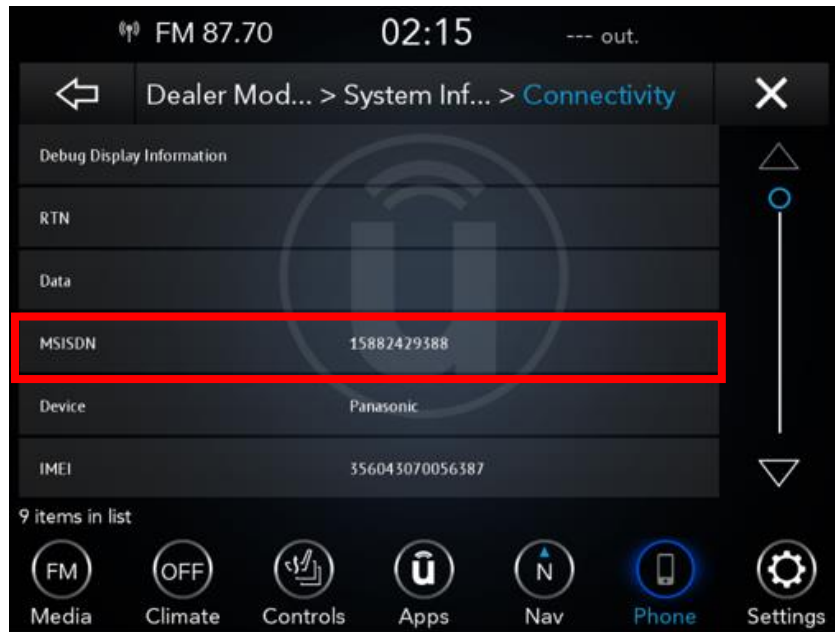
Figure 2 – MSISDN Information

NOTE: Before software reflash, please enter the Dealer Mode ->Connectivity screen verify MSISDN and ICCID numbers. If those 2 fields are blank, do NOT proceed with the software reflash process, order a replacement. Replace radio under warranty, use Inspect LOP to close recall (Figure 2 and 3).
