BULLETIN NUMBER:
CB20-H-001A

IMPORTANT SAFETY RECALL

BRAKE LINE CLIP INSPECTION AND INSTALLATION – 20V-193

- 2019MY Isuzu N-Gas Vehicles Produced Between July 8 and July 12, 2019

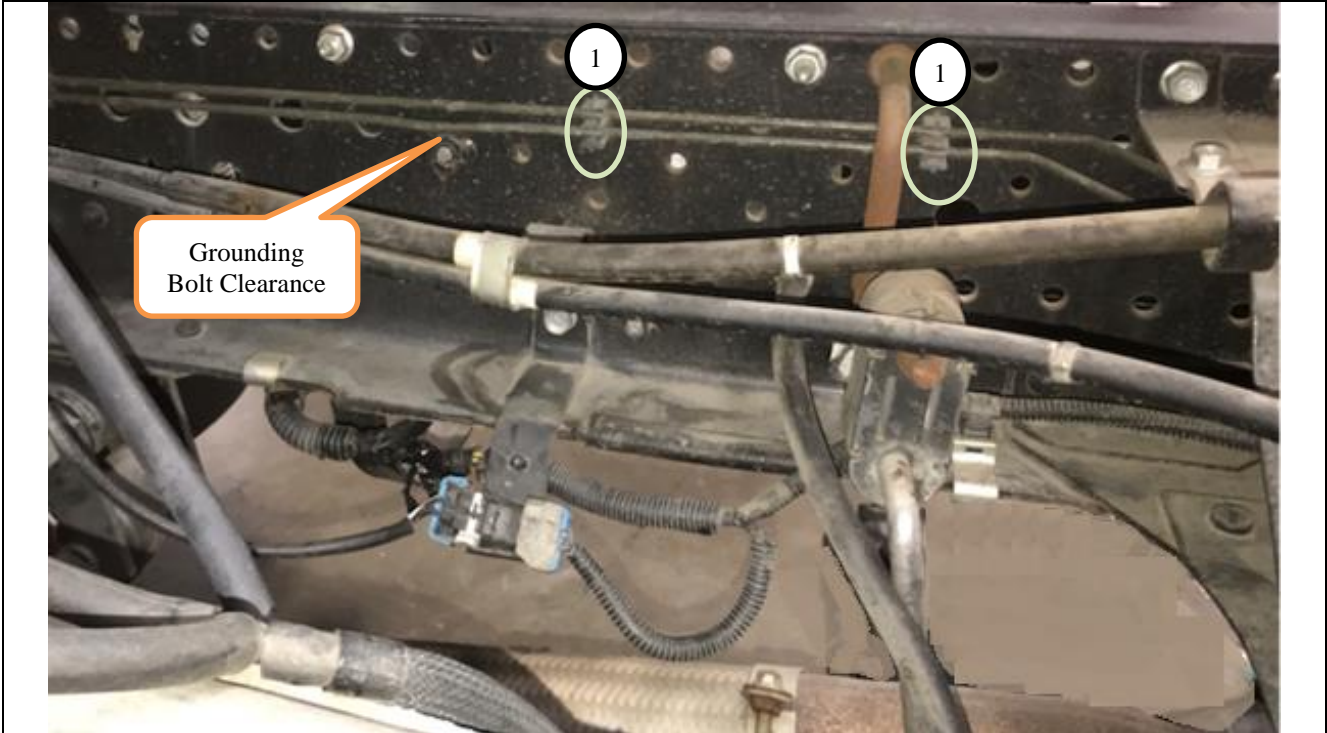
1. Shift vehicle to park, turn off engine, set parking brake, and block rear wheels.
2. Inspect the two (2) brake pipe clips on the inside of the Right Hand Frame Channel as shown in Figure 1 for proper placement.
 - If the brake pipe clips are in the correct locations (see Figure 1), skip to “Applying the Campaign Label”.
 - If the brake pipe clips are **NOT** in the correct location (see Figure 2), the brake line must be replaced. Proceed to Step 3.

Figure 1 – 1-Pipe Clip Correct Location

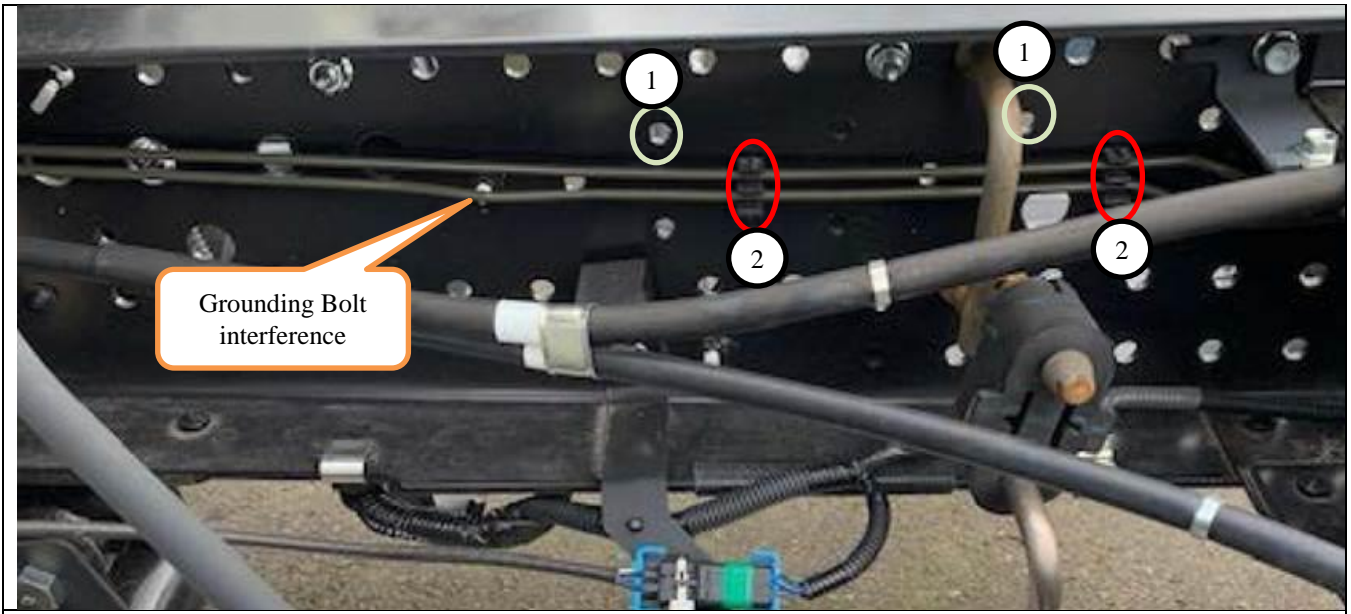
Isuzu Motors Limited has decided that a defect, which relates to motor vehicle safety, exists in certain 2019MY Isuzu N-Gas vehicles produced between July 8 and July 12, 2019. In some of the affected vehicles, the brake line clip(s) for the rear driver side brake line (which is routed inside the passenger side frame rail) may have been incorrectly installed, potentially allowing the brake line to make contact with a grounding bolt. Repeated contact with the bolt could compromise the rear driver side brake line, leading to a loss of brake fluid and resulting in a drop in the hydraulic brake pressure and a reduction or loss of the rear driver side braking performance. All of the remaining brakes (front, passenger side rear and parking brake) will continue to operate normally. If the rear driver side brake fails, the braking performance of the vehicle can be reduced, increasing the risk of a crash.

Figure 2 – 1-Correct Location
2- Pipe Clip INCORRECT Location

Dealers will inspect the brake line mounting clips to determine if they were installed correctly. If the clips are not installed correctly, the brake line will be replaced. This service will be performed **free of charge**.

13. Remove the 8 plastic clips securing the brake lines to the frame one at a time. The clips may be broken when removing them. Replace each clip with the same type of new clip as each old one is removed. Ensure that each new clip is installed in the correct location with the correct (original) orientation. Ensure that any pipe clips that were originally installed in an incorrect location are newly installed in the proper location. (See Figures 1, 2, and 9.)

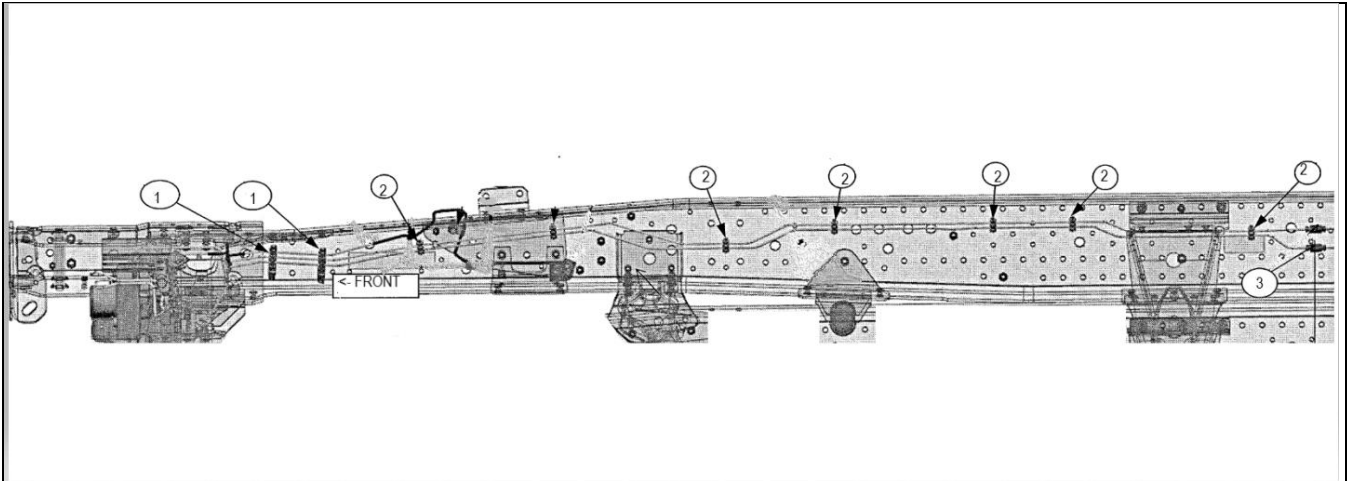
Figure 9

- 1- Large (White) Pipe Clip
- 2- Small (Gray or Black) Pipe Clip
- 3- Brake Pipe Union Joint

11. Make note of the type and location of each of the 8 plastic clips securing the brake lines. Use a paint pen or chalk to draw a circle around the correction hole for each clip hole on the outside of the frame. (See Figure 9.) Ensure that the **correct holes** for both of the two improperly installed clips shown in Figure 2 are marked.
