BULLETIN NUMBER:
CB20-N-001A

IMPORTANT SAFETY RECALL

HARNES INSPECTION AND CLIP INSTALLATION – 20V-195
(Transport Canada 2020-143)

- 2018-2020MY Isuzu FTR Vehicles Produced Between February 6, 2018 and February 5, 2020 (Canada Produced Between February 19, 2018 and December 4, 2019)

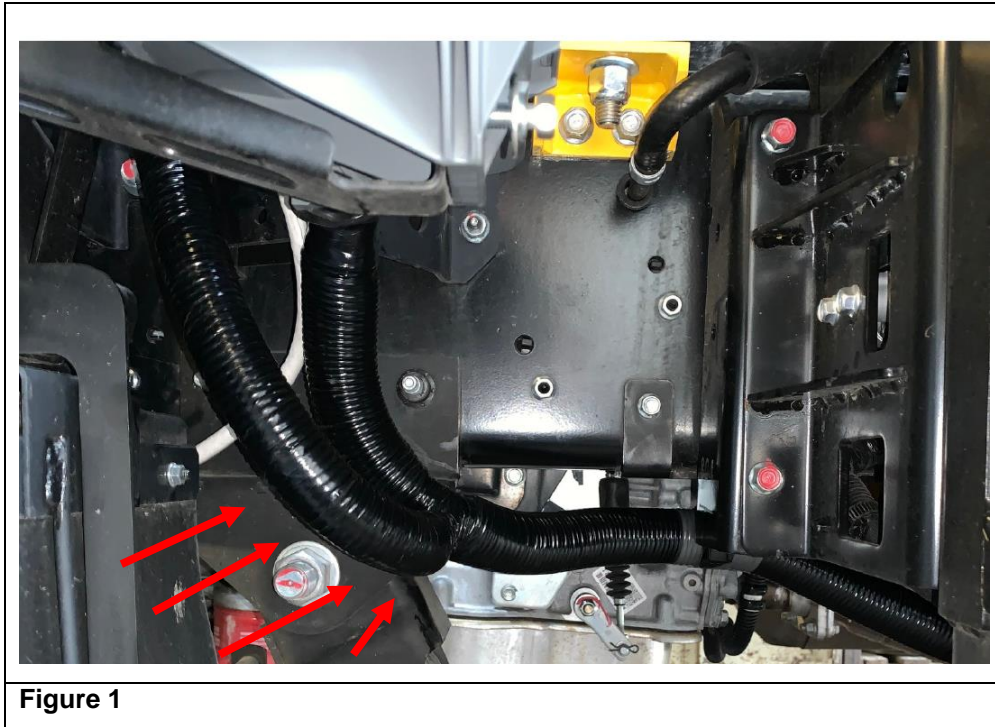
Figure 1

1. Place the vehicle in park, apply the parking brake, turn the engine off and block the rear tires.
2. Disconnect the negative (-) battery cable.
3. Inspect the Harness for contact with the Left Front Leaf Spring's, Rear Hanger Bracket.

- a. If there is any damage to the harness or wires, take a photo of the damage and email it to isuzuta@icta-us.com. Then call the Isuzu Technical Assistance Line at 1-877-478-9828, Prompt 3 for further instructions. Document the TAL case number on the repair order. This will be required for claim submission. After the harness has been repaired or replaced per the instructions from the Isuzu Technical Assistance Line, continue to Step 4.
 - b. If the harness is not contacting the spring hanger and/or there is no sign of harness damage continue to Step 4.
4. Familiarize yourself with the parts of the Harness Hardware Kit shown in Figure 2.
