# Product Safety Recall

## N202303150 Chassis Harness Improperly Routed

Release Date: May 2020

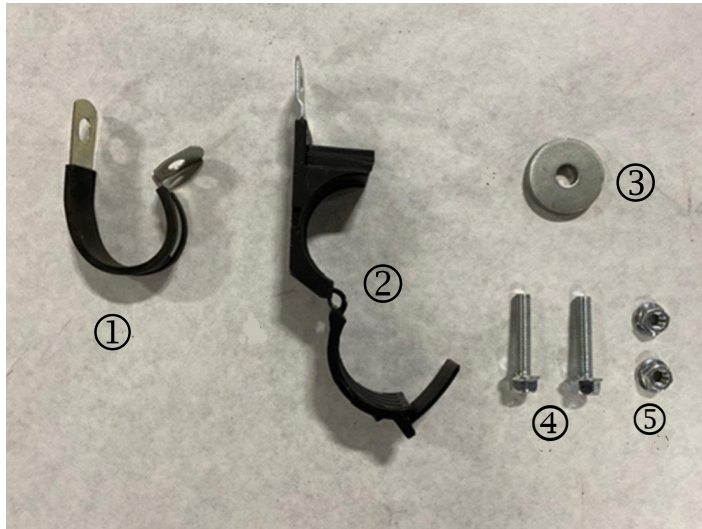
5600808

3. Inspect the Harness for contact with the Left Front, Rear Leaf Spring Hanger Bracket. Figure 1 indicates where the harness may contact the Bracket.
  - 3.1. If the harness is not contacting the spring hanger and/or there is no sign of harness damage continue to Step 4.
