TO: Mercedes-Benz Dealer Principals, General Managers, Sales Managers, Service Managers, Parts Managers	FROM: Gregory Gunther, Department Manager, Vehicle Compliance and Analysis, Engineering Services
RE: Recall Campaign Launch Notification Check Left Front Seatbelt MY20 238(E-Class)	Date: May 15, 2020

Campaign No. 2020050001, May 2020

SUBJECT: **Model E-Class (C238 platform) vehicles**
Model Year 2020
Seatbelt Routing of Left Front Seat

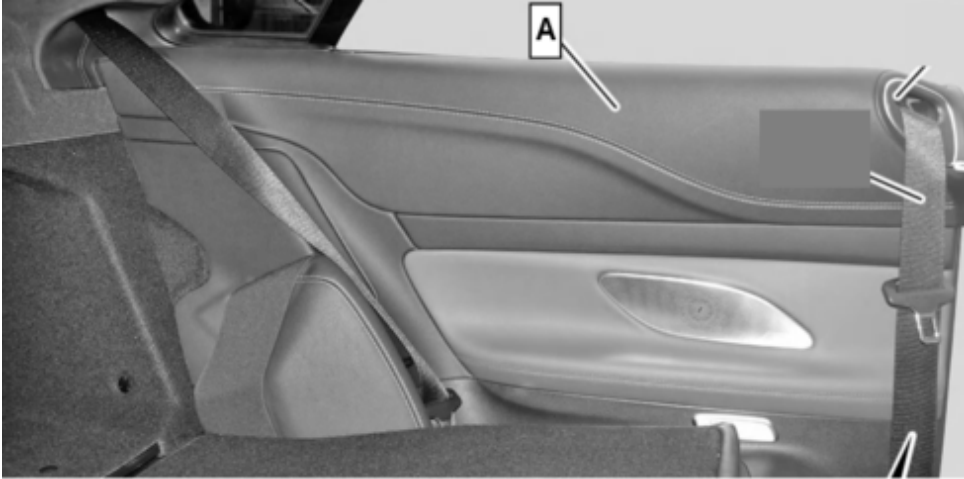
Figure 1

1. Remove upper trim (A, Figure 1) on the **left** in the rear (AR68.30-P-4783LWO)

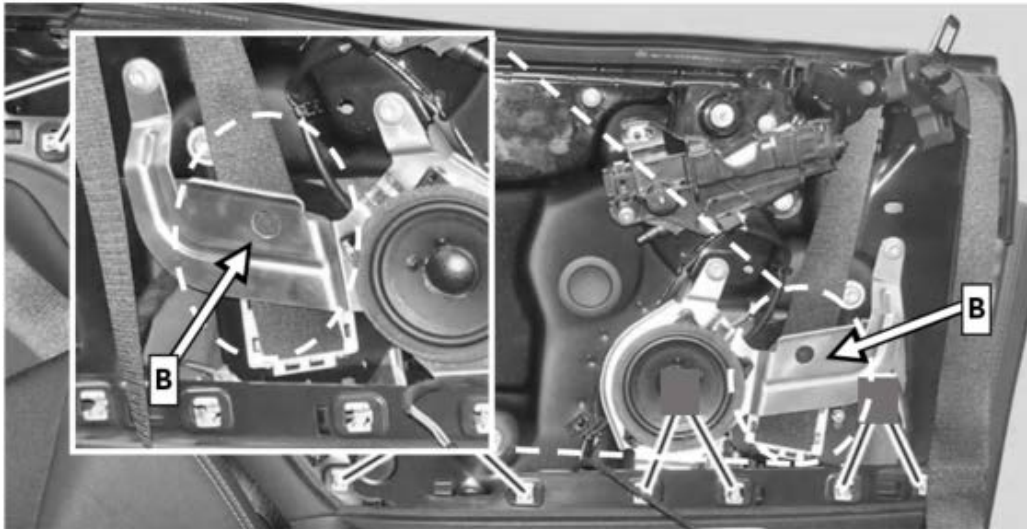
Figure 2

2. Check seat belt strap for **left front** seat belt for correct routing and damage.

- i A correctly routed seat belt strap **must be routed under** the speaker bracket (B, Figure 2).
- i An undamaged seat belt strap **must not be chafed** (damaged) by the panel edge.

- a. Seat belt strap is routed **incorrectly** and undamaged: Carry out **work procedure A**.
- b. Seat belt strap is routed **incorrectly** and **damaged**: Carry out **work procedure B**.
- c. Seat belt strap is routed **correctly and undamaged**: **End measure**.
