SAFETY RECALL

**CONVENTIONAL BATTERY TERMINAL
EXTENSION**

CAMPAIGN NO: AAHT0

SUBJECT VEHICLES: Certain 2020MY-2021MY Conventional trucks equipped with a J08 engine

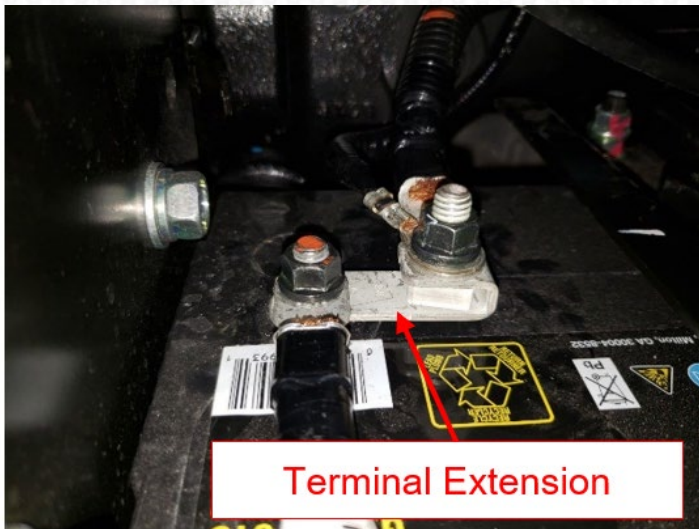
2. Inspect the negative battery terminal on the inner most battery for the presence of a terminal extension. If a terminal extension is present as shown in the photograph below, no repair is necessary, proceed to Final Inspection.

If a terminal extension is not present, continue to step 3.

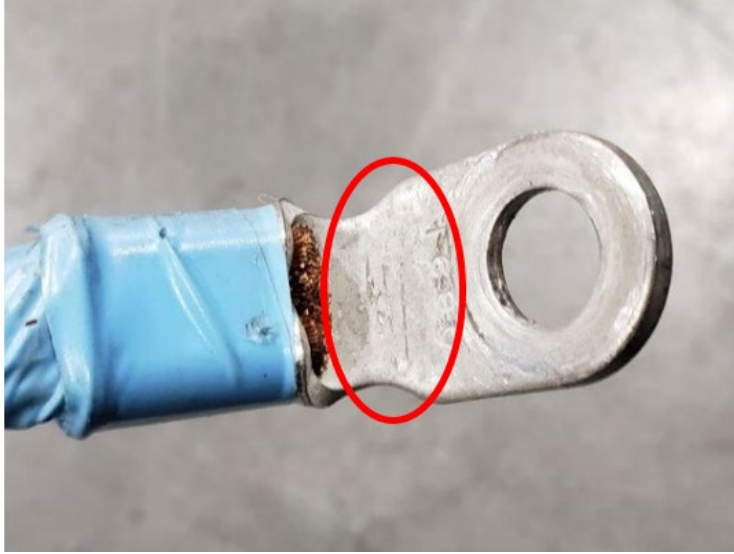
6. Clean the battery ground cable. Inspect both terminal ends of the battery ground cable for cracking in the area circled in the photograph below. If cracking is found, discard and replace using a new 82124-EW140 Wire, Engine No. 4. Proceed to step 7.

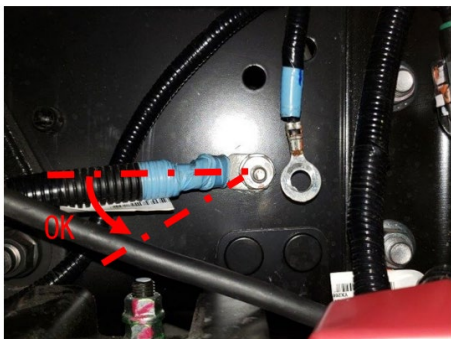
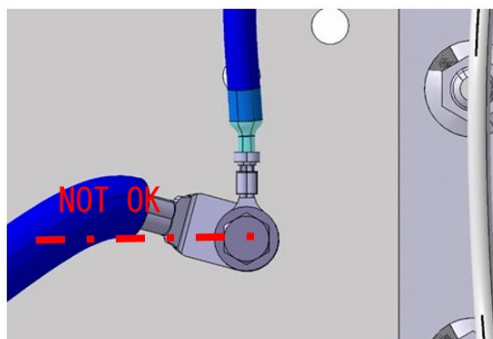
It is very important that the battery ground cable is positioned close to horizontal, and no more than 30 degrees downward from the horizontal position. Do not allow the cable to angle upwards when tightening. Tighten the bolt to the specified torque. See the photograph below, at left, which shows the battery ground cable positioned horizontally. See the illustration, at right, shows the battery cable positioned incorrectly, above the horizontal.

9. For 2021 Model Year Vehicles, Go ahead to Step 10. Attach the battery ground cable to the frame rail using the bolt removed in step 5.

Specified Torque: 38 lb-ft (51.5Nm)

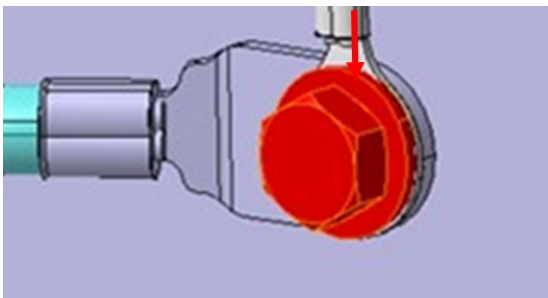
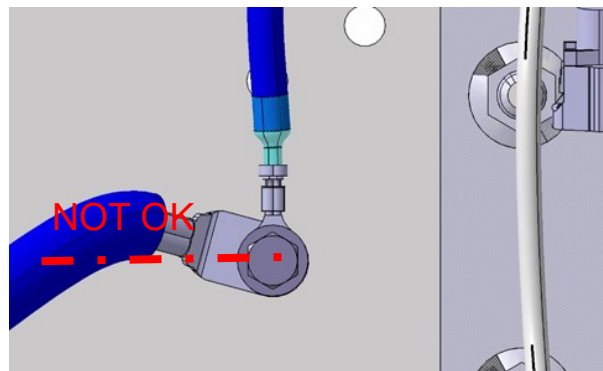
It is very important that the battery ground cable is positioned close to horizontal, and no more than 30 degrees downward from the horizontal position. Do not allow the cable to angle upwards when tightening. Tighten the bolt to the specified torque. See the illustrations below. The first illustration, at left, shows the battery ground cable positioned horizontally. The second illustration, at right, shows the battery cable positioned incorrectly, above the horizontal. **Remember**, on 2021 Model Year Vehicles this bolt is used to secure both the **battery** ground cable connection as well as the **body** ground cable connection

10. For 2020 Model Year Vehicles, Go back to Step 9. Attach the battery ground cable along with the smaller cab harness ground to the frame rail using the bolt removed in step 5.

Specified Torque: 38 lb-ft (51.5Nm)
