ALA4 - Replacing the Fuel Supply Line in the Engine Compartment (Delivery Stop / Recall Campaign)

Vehicle Type: Cayenne Turbo (9YA) / Cayenne Turbo Coupé (9YB) / Cayenne Turbo

Model Year: As of 2019 up to 2020

Subject: Fuel supply line in the engine compartment

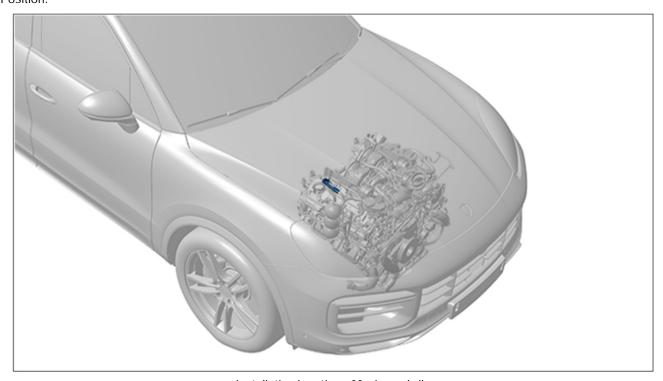
Information: Due to a weakness in the quick connector component on the fuel supply line, the leak-tightness

of the quick connector may not be guaranteed at very high engine compartment temperatures

As a result, fuel may leak from the quick connector on the fuel supply line, which can be perceived as an

Installation location of fuel supply line

Replace fuel supply line in the engine compartment.
