## IMPORTANT SAFETY RECALL

NHTSA Safety Recall  
No. 20V-301

# Customer Service Notice

## Class III Receiver Hitch Inspection and Placard Installation

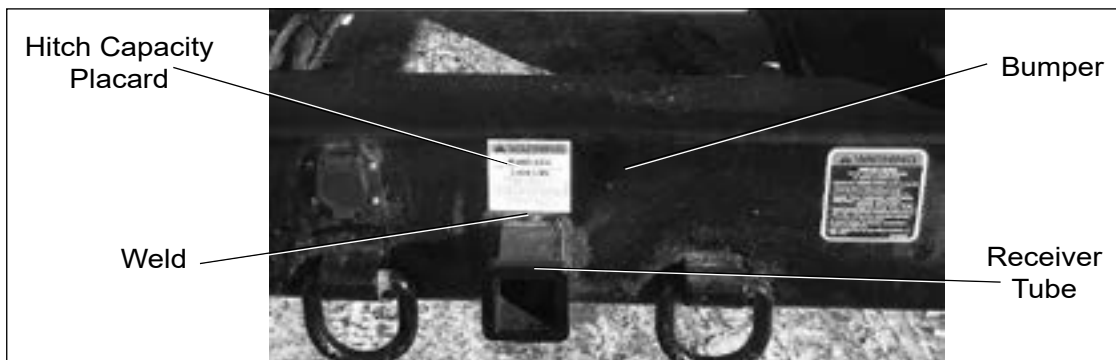
**Figure 1 — Inspection Area**

1. Position the unit on a level surface. Apply the parking brake and chock the wheels. Turn off the engine and remove the key from the ignition.
2. Look at the rear of the vehicle where the receiver tube is welded to the bumper (refer to Figure 1). If there is any dirt or debris on the weld area around the tube, clean this area with soap and water or other suitable cleaning solution to ensure that any potential defects will be visible.

3. Inspect the weld region all around the base of the receiver tube for any cracks.
  - If no cracks are present, proceed to the Placard Installation Procedure.

1. Position the unit on a level surface. Apply the parking brake and chock the wheels. Turn off the engine and remove the key from the ignition.
2. Remove the hitch capacity placard if it is installed close to the weld at the base of the receiver tube (refer to Figure 1).

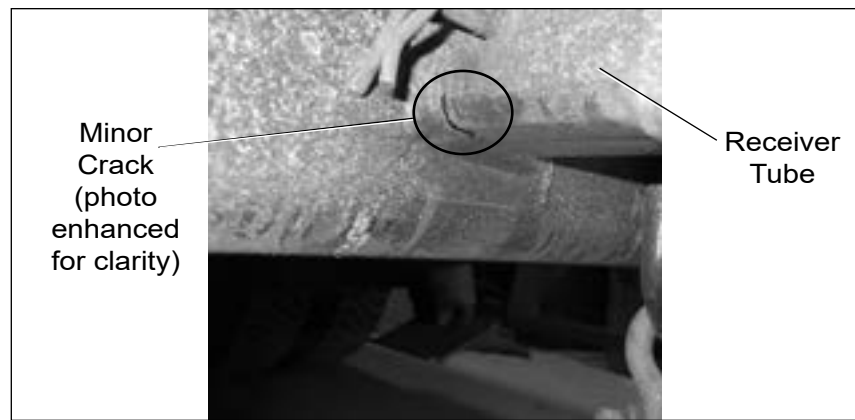
**Figure 2 — Minor Crack Example**

- If there are minor cracks, defined as cracks present only in the corner(s) or in the corner(s) and extending across no more than one full side, and the cracks have not opened up to produce a gap (refer to Figure 2), proceed to the Receiver Tube Repair Procedure.

3. Clean the area all around the base of the receiver tube and the adjoining weld to remove all paint, rust, oil, etc.
4. Inspect for visible cracking in the weld and the parent material of the receiver tube and bumper. Use dye penetrant if necessary to determine the extent of the crack(s). Use a felt-tip marker to mark the extent of the crack(s) such that the marking will remain visible after grinding off the weld.

5. Grind to remove any cracked fillet weld, continuing 1" beyond each end of each crack.
6. If crack(s) exist in the parent material, proceed to step 7. If no cracks exist in the parent material, proceed to step 8.

7. Evaluate each crack in the parent material and repair if possible, using the following procedure.
  - a. Stop drill an  $\frac{1}{8}$ " diameter hole at both ends of each crack. If the crack is in a double-walled receiver tube, stop drill only through the outer tube.

- b. Grind along the crack in a vee shape until the crack is no longer visible or the groove reaches a  $\frac{1}{8}$ " maximum depth from the surface. Do not grind deeper than  $\frac{1}{8}$ "

- If the crack is no longer visible after grinding the vee groove as described, continue this repair procedure.
  - c. Grind to continue the vee groove at the same depth to 1" length beyond the stop drilled hole at each end.

- d. Weld to fill the vee groove and drilled holes slightly above the surface.
  - e. Inspect the completed weld for any defects and make any corrections necessary.

8. Replace each fillet weld removed in step 5 using the following procedure.
  - a. Apply a fillet weld of the size specified on the bumper weldment print.

- b. Inspect the completed weld for any defects and make any corrections necessary.
  - c. Sand to remove any spatter and roughness.
9. Apply primer paint and finish paint to the repaired areas.

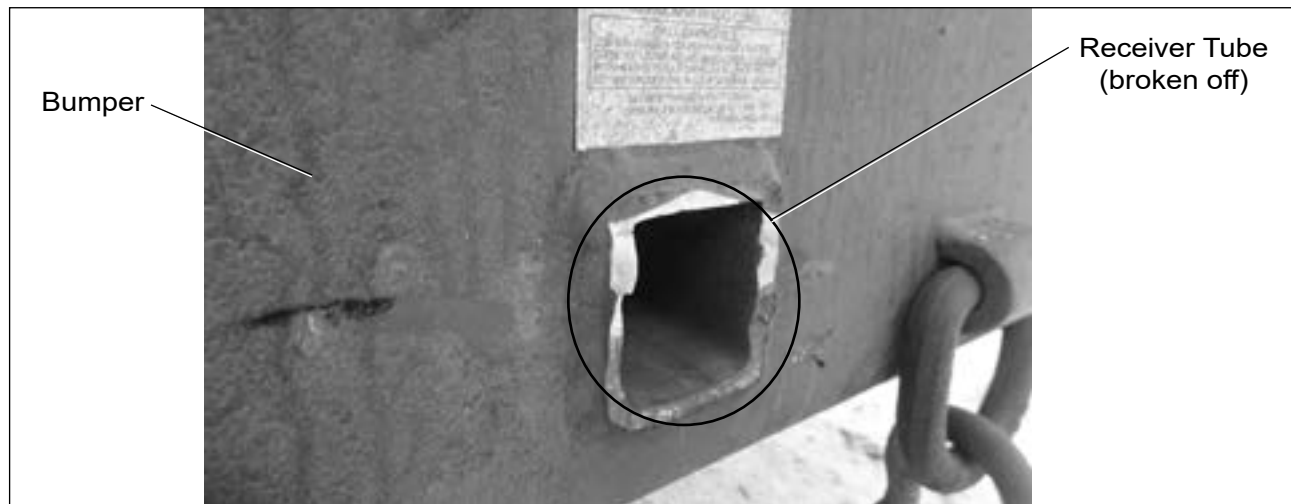
**Figure 3 — Structural Failure Example**

- If there are major cracks, defined as cracks extending across two or more full sides or cracks that have opened up to produce a gap, or if there is structural failure (refer to Figure 3), proceed as determined below.

- If the customer or the customer's warranty provider performed the inspection procedure, call 1-877-GO ALTEC (1-877-462-5832) and press 4 for Technical Support to request a repair recommendation.

- o If the recommendation is to install a replacement receiver tube in the existing bumper weldment, proceed according to instructions provided by Technical Support.

- o If the recommendation is to replace the bumper weldment, proceed to the Bumper Replacement Procedure.
    - If Altec Service performed the inspection procedure, contact Service Engineering to request a repair recommendation.
