FMVSS Noncompliance Recall

N202305070 Warning Lamp May Not Indicate ABS Malfunction - US Only

Release Date: July 2020

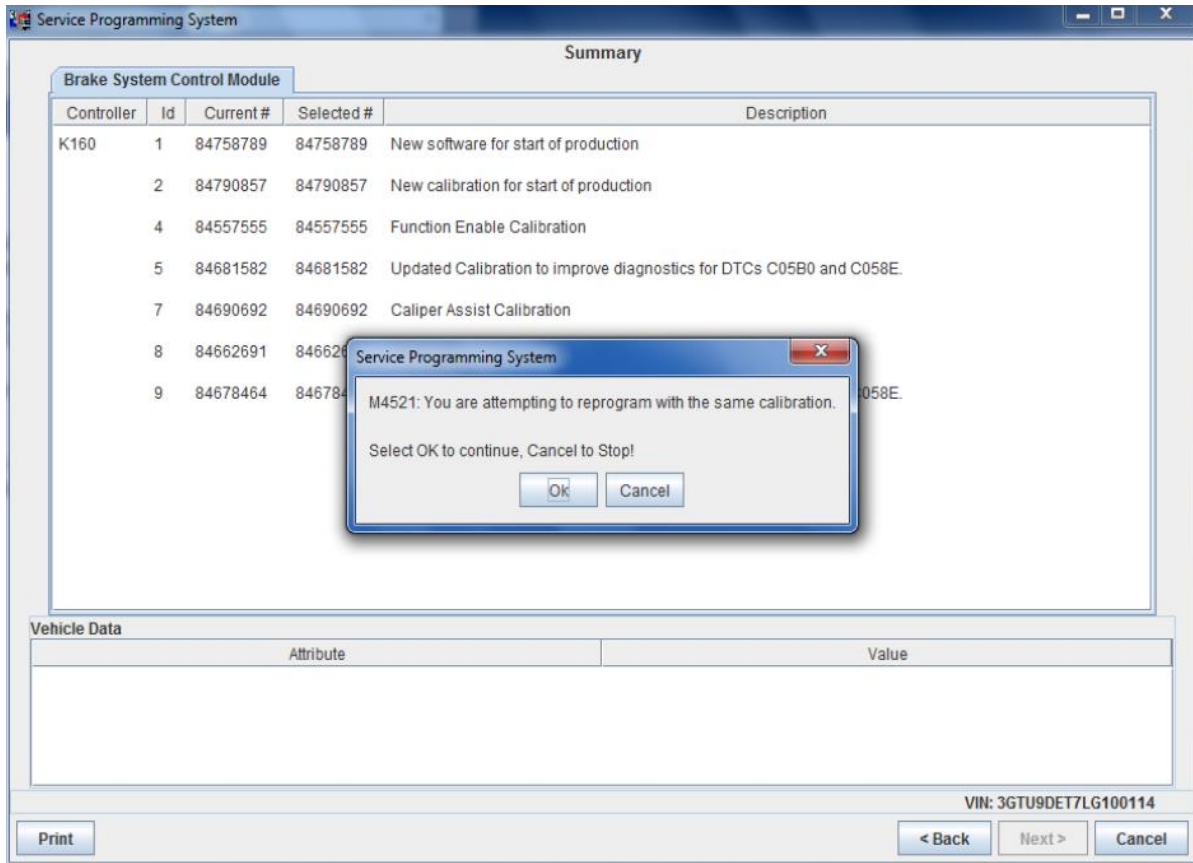
5431207

Important: TIS2WEB screen shown. Techline Connect screen is similar and will be included in the near future.

Important: If the Same Calibration/Software Warning is noted on the SPS screen, select OK and follow screen instructions. After a successful programming event, the WCC is located in the Service Programming System dialogue box of the SPS Summary screen. No further action is required. Refer to the Warranty section of the bulletin.

1. Reprogram the Body Control Module. Refer to *K9 Body Control Module: Programming and Setup* in SI.

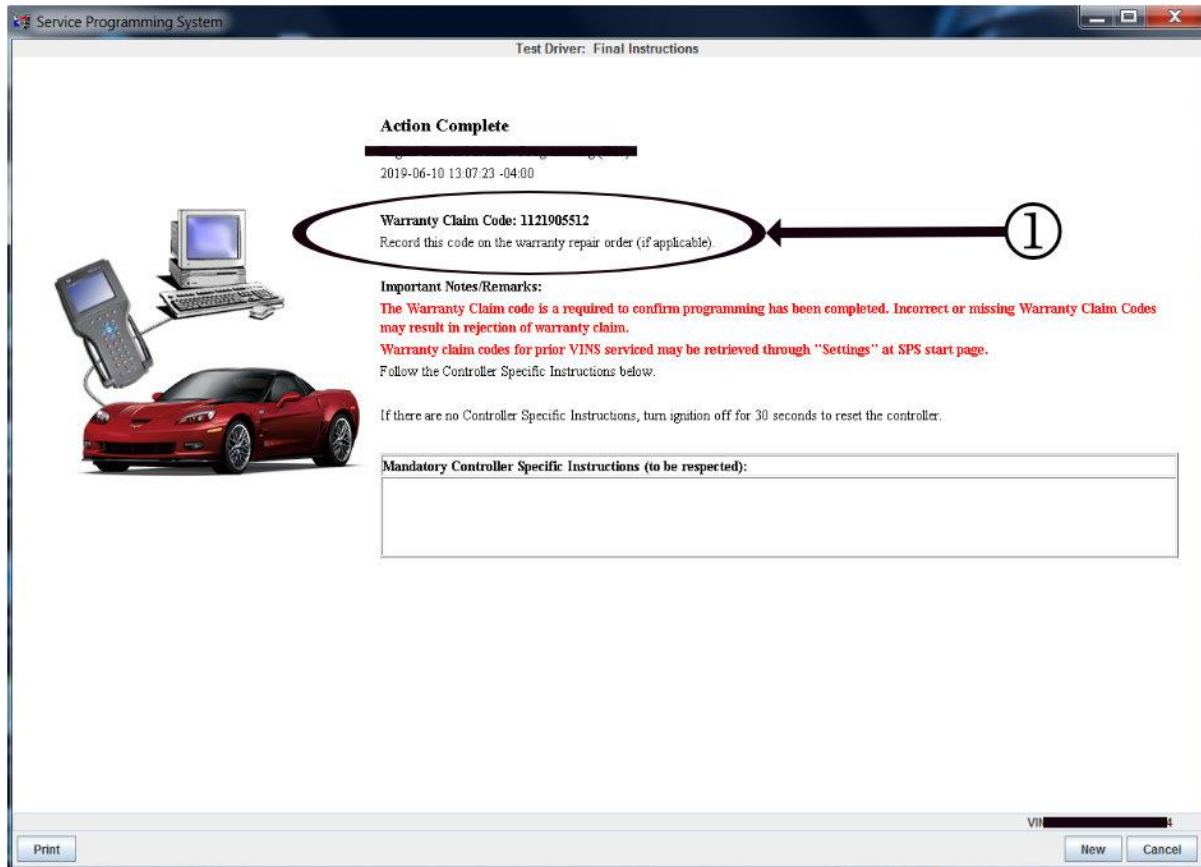
5431209

Important: TIS2WEB screen shown. Techline Connect screen is similar and will be included soon.

Important: To avoid warranty transaction rejections, you **MUST** record the warranty claim code provided on the SPS Warranty Claim Code (WCC) screen on the job card. Refer to callout 1 above for the location of the WCC on the SPS screen.

2. Record SPS Warranty Claim Code on job card for warranty transaction submission.
