# FMVSS Noncompliance Recall

## N202305070 Warning Lamp May Not Indicate ABS Malfunction - US Only

Release Date: May 2020

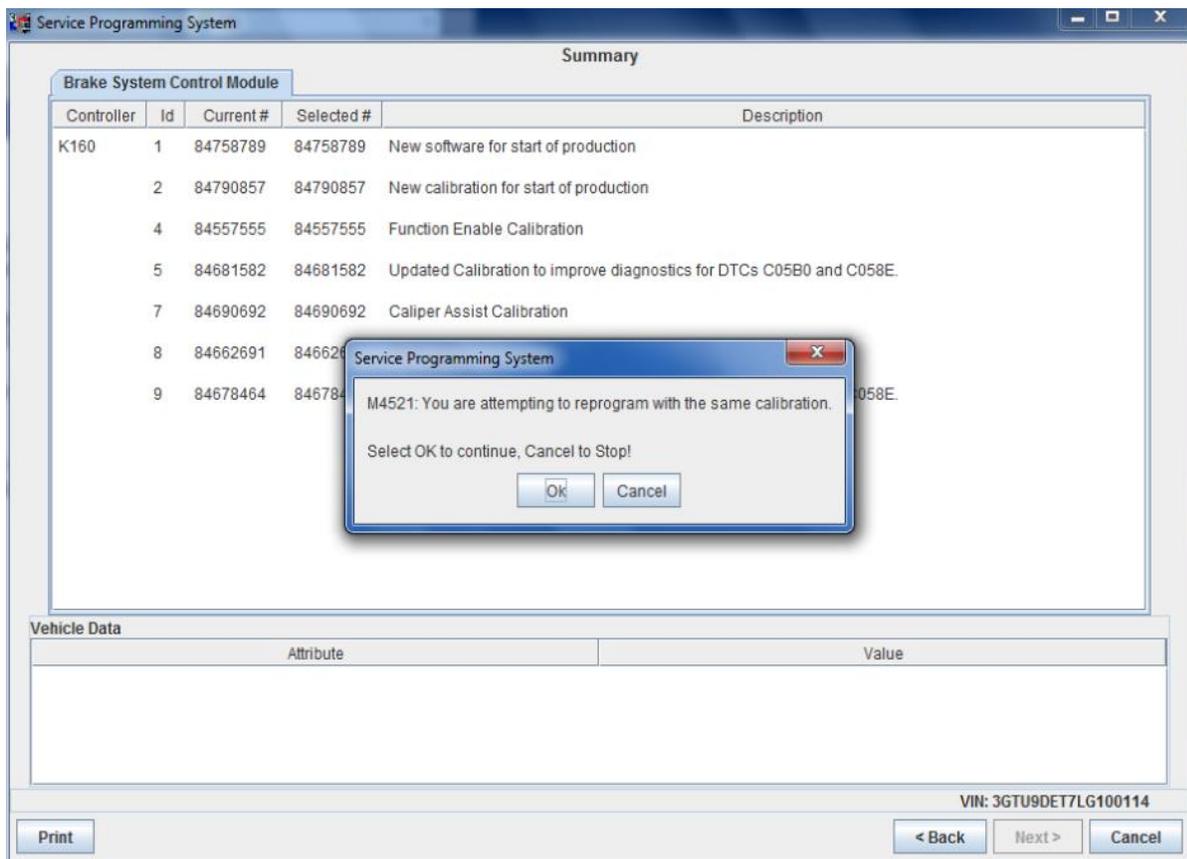
5431207

**Important:** If the Same Calibration/Software Warning is noted on the SPS screen, select OK and follow screen instructions. After a successful programming event, the WCC is located in the Service Programming System dialogue box of the SPS Summary screen. No further action is required. Refer to the Warranty section of the bulletin.

1. Reprogram the Body Control Module. Refer to *K9 Body Control Module: Programming and Setup* in SI.

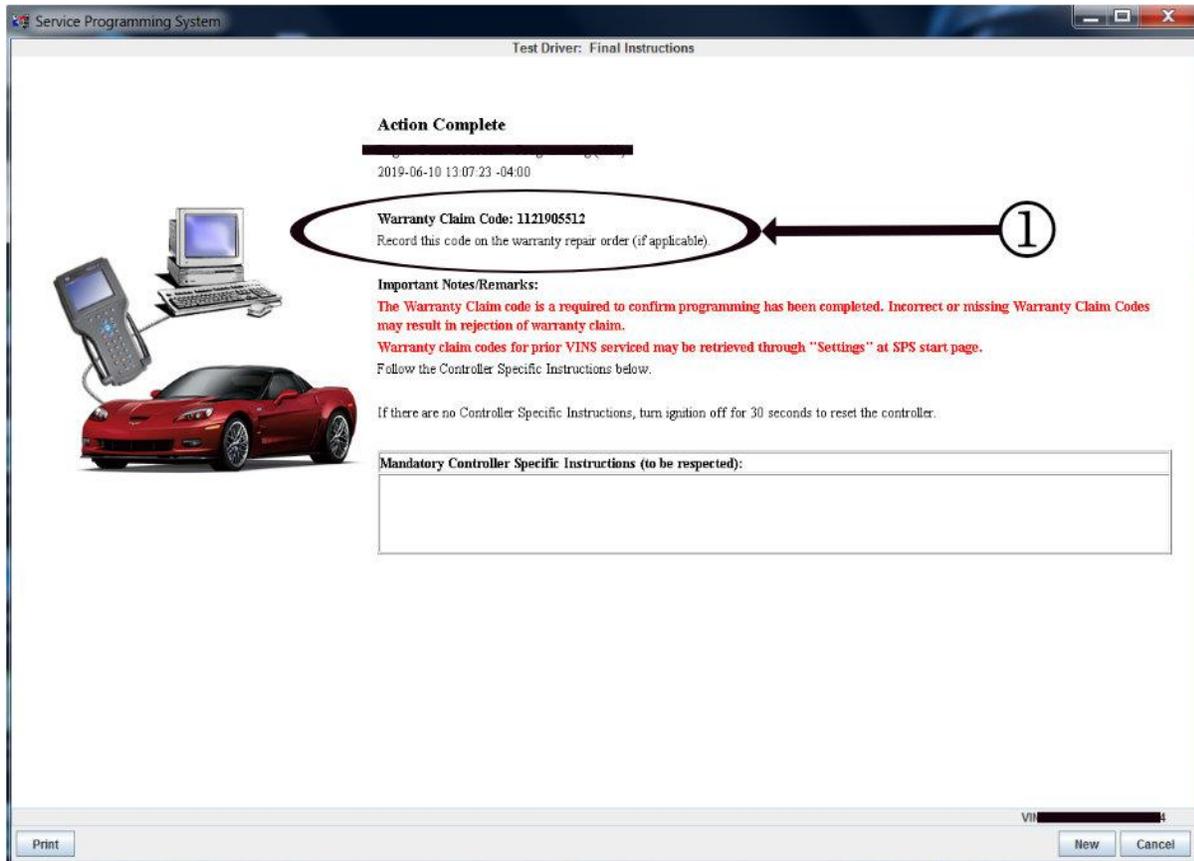
5431209

**Important:** To avoid warranty transaction rejections, you **MUST** record the warranty claim code provided on the SPS Warranty Claim Code (WCC) screen on the job card. Refer to callout 1 above for the location of the WCC on the SPS screen.

2. Record SPS Warranty Claim Code on job card for warranty transaction submission.
