Dealer Service Instructions for:

Safety Recall W46 / NHTSA 20V-334 12-Volt Isolator Post Connection (Interim Repair)

2017-2020 (RU) Chrysler Pacifica PHEV

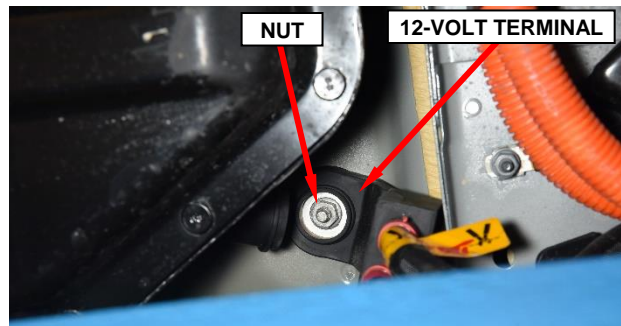
Figure 23 – 12-Volt Cable Terminal

7. Loosen the nut and remove the 12-volt terminal and nut assembly from the isolator post (Figure 23).

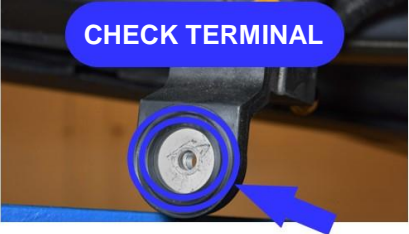
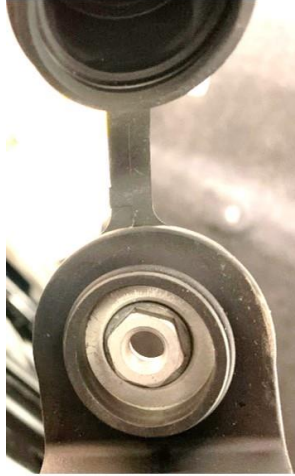
Figure 25 – Inspect Terminal for Corrosion or Moisture

8. Inspect for corrosion or moisture on the terminal (Figure 25).

Acceptable

- Free from Dirt, Debris, or Lime
- Plating is Not Discolored or Tarnished
- Plating is Free from Oxidized or Corrosion
- No signs of moisture

Not Acceptable

- Signs of Dirt, Debris, or Lime
- Plating is Discolored or Tarnished
- Plating is Oxidized or Signs of Corrosion
- Signs of moisture

17. Were any signs of corrosion or moisture detected (Figure 25) on either the lower or upper 12-volt cable terminals in **Step 8** or **Step 16**?
 - **YES:** Reassemble the vehicle then follow **Section C** for holding the vehicle until final remedy is available.
 - **NO:** Reassemble the vehicle then return the vehicle to the customer.

56. Were any signs of corrosion and/or moisture detected (Figure 25) on either the lower or upper 12-volt cable terminals in **Step 8** and/or **Step 16**?
- **YES:** Continue with **Section C** for holding the vehicle until final remedy.
 - **NO:** Return the vehicle to the customer and advise the customer to not park these vehicles inside of buildings or structures and avoid parking near other vehicles. In addition, keep liquids out of the backseat area, including but not limited to beverages, wet items, umbrellas, or bottled liquids that may leak.

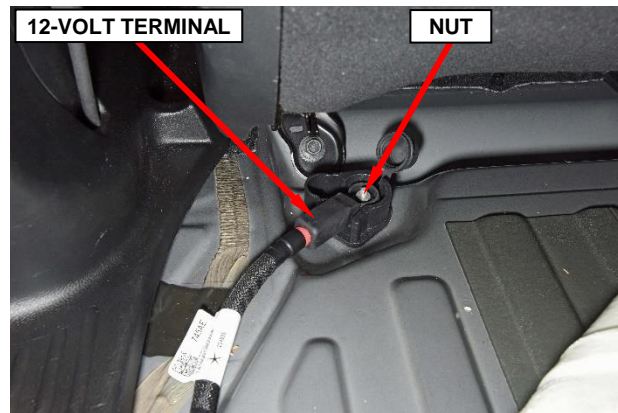
**Figure 29 – 12-Volt Cable Terminal**

14. Remove the nut from the 12-volt terminal isolator post (Figure 29).
15. Remove the 12-volt terminal from the isolator post (Figure 29).
16. Inspect for corrosion or moisture on the terminal same as was done in **Step 8** (Figure 25).

18. Install the 12-volt terminal to the isolator post (Figure 29).
19. Install the nut to the 12-volt terminal isolator post and tighten the nut to 23 N·m (17 ft. lbs.) (Figure 29).
20. Install the dust cover to the 12-volt cable terminal (Figure 28).

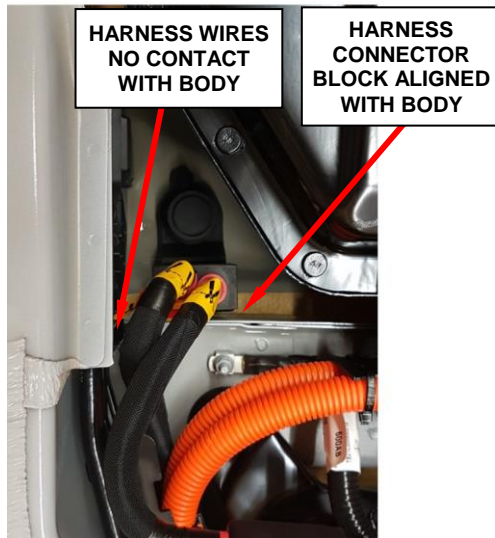
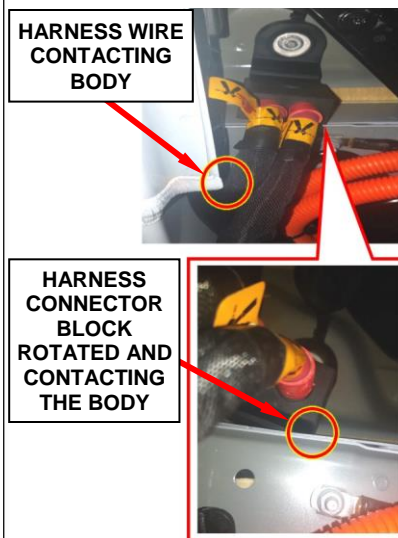
Figure 30 – Inspect Terminal for Proper Alignment after Tightening

NOTE: The 12-volt terminal may rotate during tightening. Ensure the cable stays stationary during tightening and is properly aligned when fully tightened. Connector should not be visibly rotated and cables should not be touching any metal surfaces after the terminal nut has been tightened to the proper torque specification (Figure 30).

Acceptable

- Harness wire is NOT contacting the body
- Harness connector block is aligned with body NOT rotated or contacting the body

Not Acceptable

- Harness wire is contacting the body
- Harness connector block is rotated and contacting the body
