DOC #	PROCESS NAME	PAGE	REVISION	STATION	BY	DATE
Recall 20V335	FCCC Electrical Wire Routing Rubbing Frame	1 OF 2		SER	C.Ward	6/9/2020

The purpose of Recall 20V335 is on certain vehicles, inspection and/or relocation of power cables for proper routing and clearance is necessary to avoid chaffing of power cables which increases the potential for fire to occur.

Vehicles Affected: 2014-2019 ARBOC Spirit of Liberty and Spirit of America Units on Freightliner (FCCC) Chassis

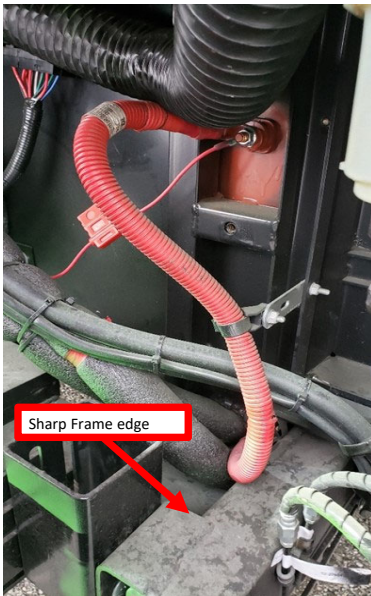
Photo 1 - Correct Routing - Tight and pulled away from sharp frame edge

3A. If the unit is wired correctly (photo 1), please add an inspection mark to the firewall and submit warranty documentation including notation that NO further changes were required.

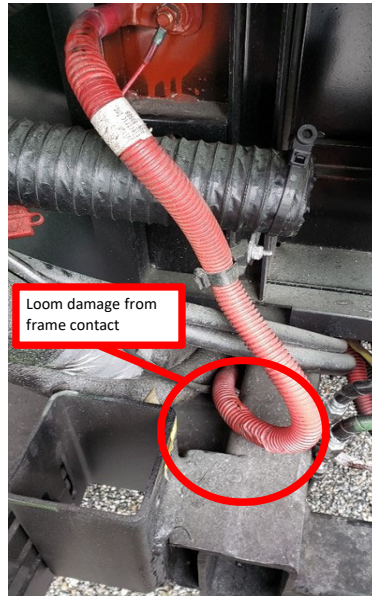
Complaint: Area #1: FCCC Power Cable rubbing against FCCC forward frame

Cause: Incorrect routing from FCCC

Photo 2 - Incorrect Routing - Loose and making contact with sharp edge frame

3B. If the unit is wired incorrectly (photo 2), please continue to the repair section for re-wiring instructions. When completed, please submit warranty documentation of repairs completed.

1. Disconnect batteries
2. Remove/Discard P-Clamp
3. Pull Cable upwards to create maximum separation from frame and add a P-Clamp. NOTE: Excess cable should be above the P-Clamp as shown in Photo 1.
4. Re-connect batteries
5. Add witness mark for repairs completed.

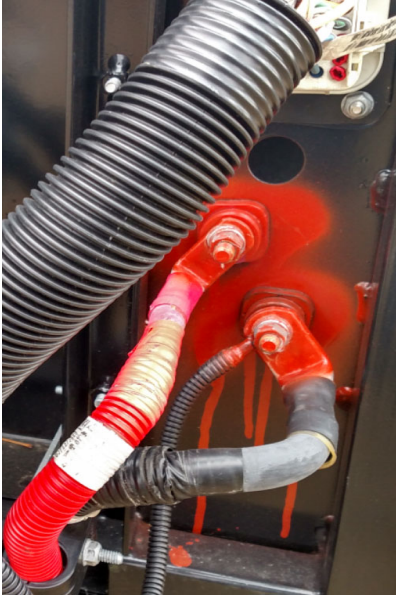
Photo 3 - Correct Routing - Adequate spacing between positive and ground terminals

3A. If the unit is wired correctly (photo 3), please add an inspection mark to the firewall and submit warranty documentation including notation that NO further changes were required.

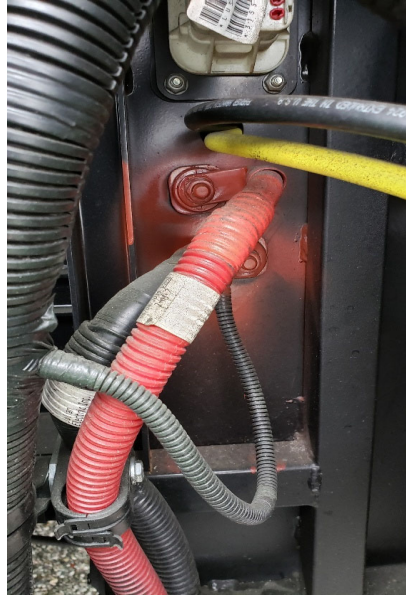
Area #2: FCCC Positive Cable making contact with Ground Cable

Photo 4 - Incorrect Routing - Cables routed over each other and/or making contact with each other

3B. If the unit is wired incorrectly (photo 4), please continue to the repair section for re-wiring instructions. When completed, please submit warranty documentation of repairs completed.

1. Disconnect batteries
2. Loosen positive and ground connections
3. Re-route cables to create maximum separation from each other.
4. Re-tighten lug connections (Torque = 45 ft/lbs)
5. Re-spray connections with di-electric spray
6. Re-connect batteries
7. Add witness mark for repairs completed.
