## Thor Motor Coach Technical Service Bulletin

Recall #	<b>20V-339 / 2020-260</b>		
Description/Title:	LCI Frameless Windows		
Affected Product Line(s):	Certain model year 2020/2021 Ace, Axis, Compass, Delano, Four Winds, Gemini, Hurricane, Outlaw, Vegas, and Windsport motorhomes		
Service Campaign # :	<b>RC000192</b>	Released Date:	7/10/2020
Codes:	<b>Inspect Only: TMCRC80489Y</b>  <b>Inspect with Repair: TMCRC80489V</b> <i>Photos Required for Repair pre-authorization requests</i>	Document Date:	7/10/2020
Time Allowed:	<b>Inspect Only: 0.5 per VIN</b>  <b>Inspect with Repair: 0.8 (+ 0.3 for each additional window)</b>	Document Revision:	<b>A</b>

# 3000 SERIES WINDOW VENT BONDING INSPECTION

TSB Number:	TSB 15-002-19
Product:	3000 Series Windows (EPW, FV, FVD, FVSE, SEFV, SESV, SV, SVD, SVSE, VEPW)
Date:	March 6, 2020

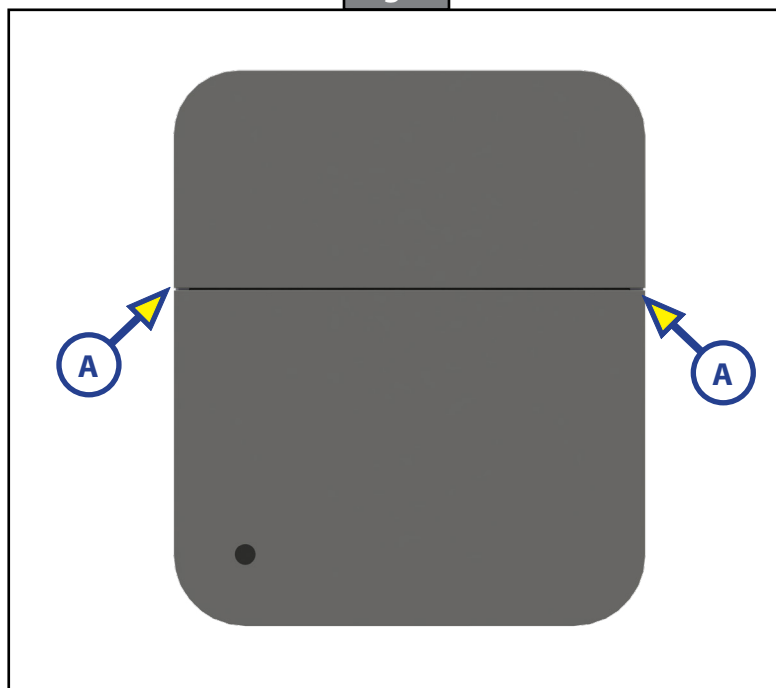
Fig. 5

1. Make sure the unit is on a level, flat surface then chock the wheels.
2. Inspect the frameless window for proper adhesive bond where the glass meets the hinge frame (Fig. 5A).

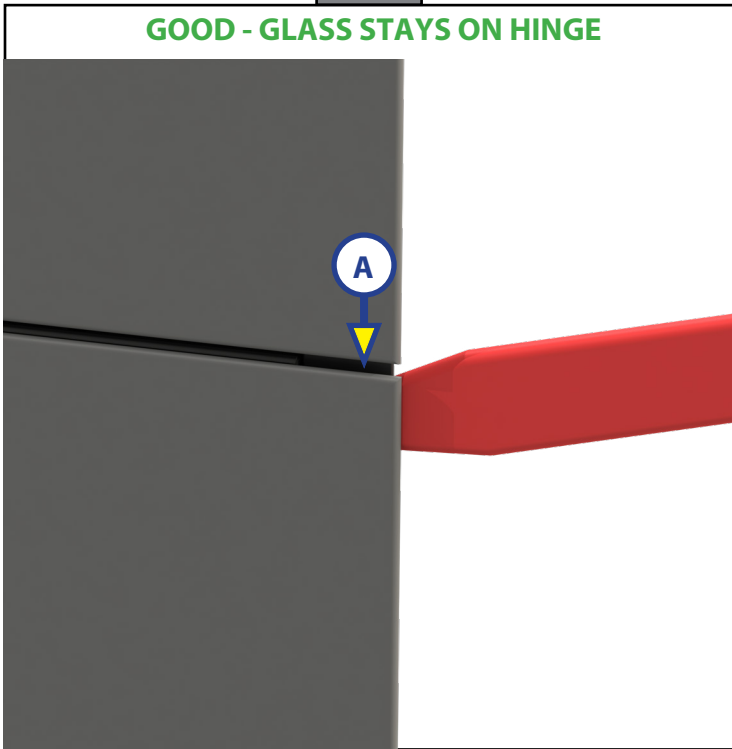
Fig. 6

4. If the glass does not separate from the hinge (Fig. 6A), it is a good bond. **DO NOT REPLACE** the vent. If the glass is not adhering to the vent (Fig. 7A), the glass **DOES NEED TO BE REPLACED**.

**GOOD - GLASS STAYS ON HINGE**

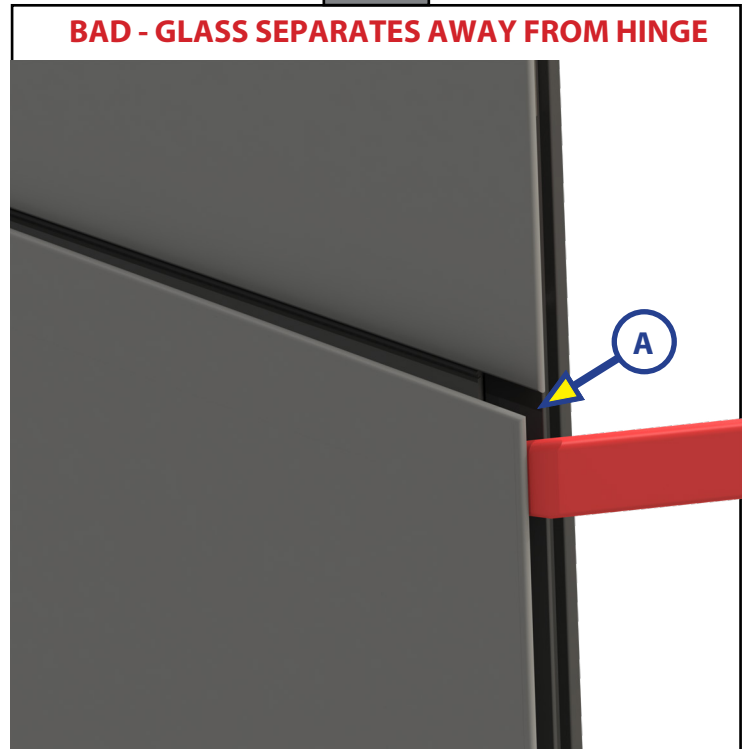
Fig. 7

**BAD - GLASS SEPARATES AWAY FROM HINGE**

**Replacement of glass: 0.3 hour per window**
