Title: Telma Mounting Hardware Inspection

Date: July 7, 2020

Vehicles: *KME Custom Chassis' that have a Telma retarder.*

Issue: Incorrect Mounting Hardware may have been used.

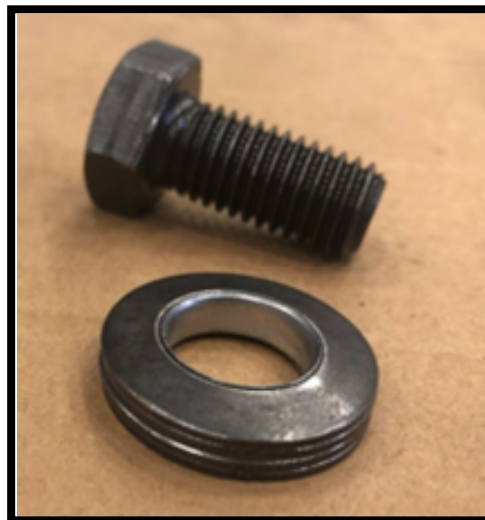
Figure 2 Attaching Hardware

4. Locate the mounting brackets on the left side of the retarder.
5. Verify that the hardware is correct. Ensure that each bolt has a washer. See Figure 2.

10. Verify that the hardware is correct. Ensure that each bolt has a washer. See Figure 2.

- (8) M14 x 2 x 35 mm GR 8.8 bolts
- (8) Trep-style spring washers.

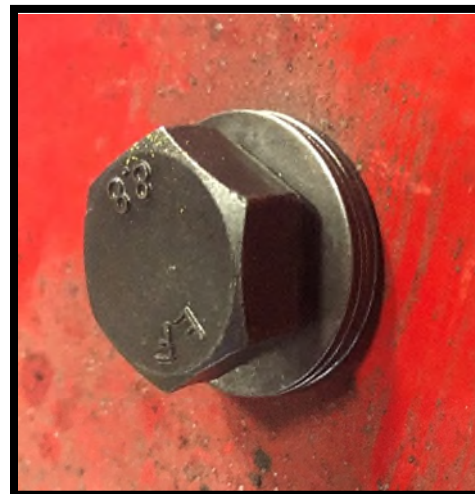
Figure 3 Bolt and Washer Correctly Attached and Torqued

(M14 x 2 x 35mm GR 8.8 Bolt with a trap-style spring washers)
6. Visually check that the attaching hardware is tight. Ensure that bolts and washers are flat against the bracket with no gaps or cracks. See Figure 3.
7. Verify that each bolt is torqued to 65 ft-lbs.

11. Visually check that the attaching hardware is tight. Ensure that bolts and washers are flat against the bracket with no gaps or cracks. See Figure 3.

Replace any bolt that is out of torque or not torqued to 65 ft-lbs.
