**R20AW**

**IMPORTANT SAFETY RECALL NOTICE**

**NHTSA Recall Number: 20V-356 School Bus**  
**NHTSA Recall Number: 20V-357 Non-School Bus**

## R20AW Drag Link Castle Nut Torque

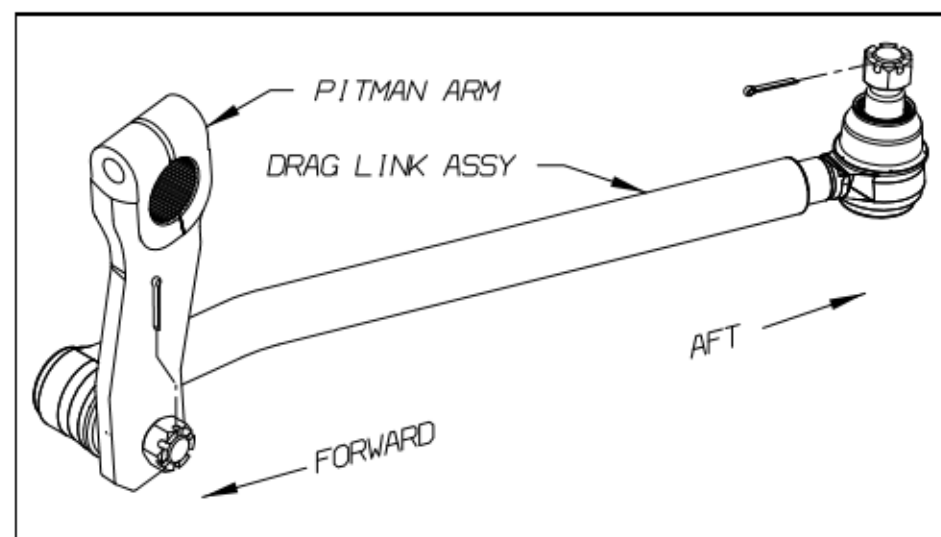
Fig. 1

**Issue:** The castle nuts on both ends of the drag link assembly may not have been installed according to manufacturer's installation specifications.

1. Park bus on a level surface, apply parking brake, switch engine off, remove ignition key and chock wheels.
2. Remove cotter pin from ball stud on forward (pitman arm) end of drag link. (Fig. 1)
3. Torque castle nut on drag link ball stud to 120 ft-lbs.
4. Remove cotter pin from ball stud on aft (steer arm) end of drag link. (Fig. 1)
5. Torque castle nut on drag link ball stud to 120 ft-lbs.
6. Install cotter pins.
7. If castle nut slot for cotter pin does not line up with through hole in each ball stud, tighten castle nut until next slot aligns with through hole. Install cotter pin and bend-over pin tails. **WARNING: Do NOT loosen castle nut to line up slot with through hole in ball stud. Always tighten castle nut to align slot with through hole.**
