TECHNICAL INSTRUCTIONS

SAFETY RECALL 20TA10

HYBRID SYSTEM SOFTWARE UPDATE

CERTAIN 2013 - 2015 PRIUS

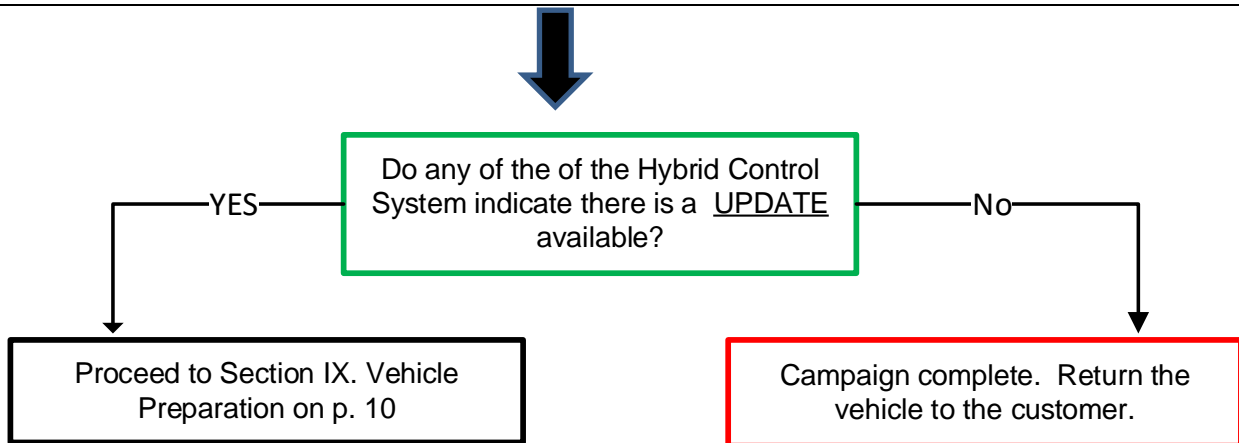
- Locate the Update column for the Hybrid Control System in the Stored Data tab.
- Determine the status of the **CID #1** for the Hybrid Control ECU; indicated by a **YES** or **NO** in the Update column.

If the Update Column listed “No” in the location specified above, no further action is necessary. The campaign is now completed. The vehicle can be returned to the customer.
