Quality Bulletin

Recall R10029: Front Seat Belt Fastener, Model Year 2007 - 2018 S60CC, S60L, V60CC, S60, XC60, V60, XC70, V70, S80, S80L

GROUP: 88	CAT/NO: R10029	ISSUING DEPARTMENT: Regulations and Compliance		CAR MARKET: United States and Canada	
REVISIONS: Updates to Section A., B., C., D., G., and I.				ISSUE DATE: 2020-12-17	STATUS DATE: 2020-12-17
Service Personnel: Read and initial		SERVICE MANAGER	SERVICE WRITER	WARRANTY ADMINISTRATOR	Page 1 of 5

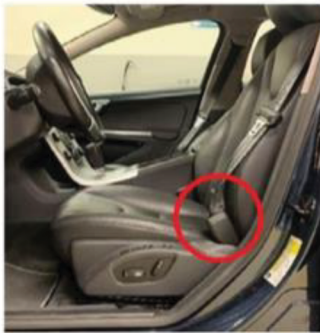
The seat belt lower fixing buckle rests in a position that is past the bolster of the seat

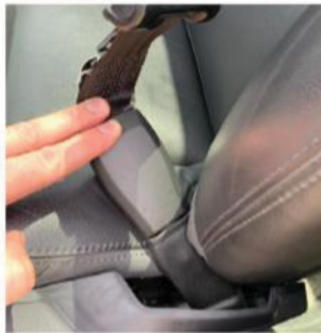
Volvo has identified an issue regarding the front seat belt fastening, mounted on the outboard side of the front seat. The front seat belt fastening cable, may under certain circumstances, suffer from wear and fatigue if repeatedly bent over the seat cushion. This could cause damage to the cable, which could result in reduced or no seat belt restraint function.

During entry, this "buckle" is permitted to fold over the lower cushion repeatedly

Seatbelt folded over onto the bottom of the seat
