## SIB 51 21 20

### RECALL 20V-379: TOP TETHER ANCHOR COVER

2020-07-09

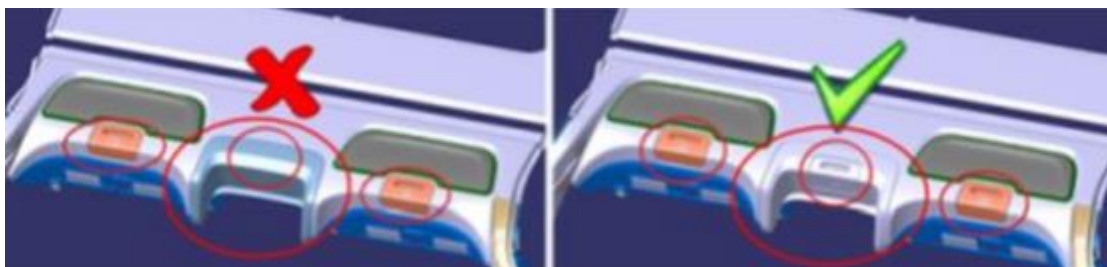
The top tether anchor at the rear center seating position, may not be accessible. If a child seat was placed on the rear center seat, the child seat's top tether would not be able to be attached to the vehicle.

An incorrect trim panel was installed during production.

1. Inspect the trim panel above the center arm rest, in the area of the rear parcel shelf (area circled below). Does the trim panel have a tether cover as shown? Note: No trim panel tether cover on left (bad). Trim panel tether cover is in place on right (OK).

If trim panel tether cover is installed, no further correction is required.

If trim panel tether cover is not installed, continue to step 2.

2. Replace the top armrest trim **and** tether cover. Repair instructions are included within **REP 52 25 280 “Removing and installing the center armrest”**.
